Technical Service Information

THM 4T60-E NO FORWARD OR REVERSE

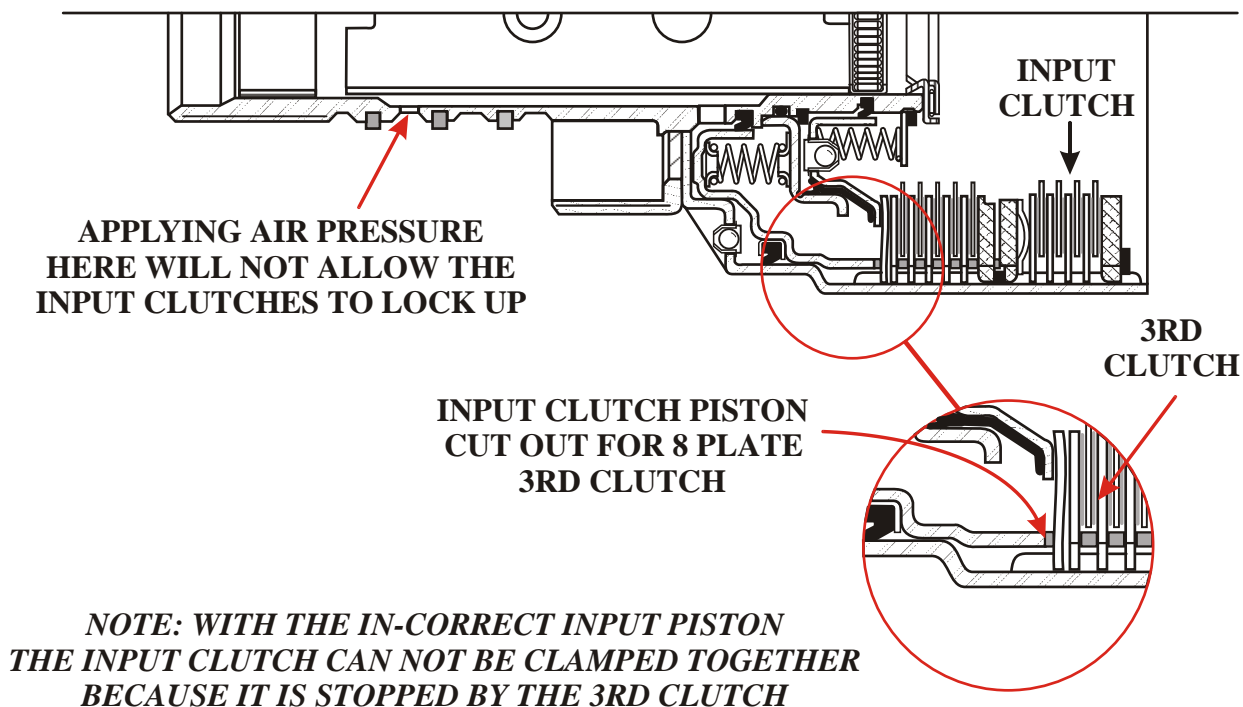
"IN-CORRECT" INPUT DRUM ASSEMBLY

CAUSE: The cause may be, during overhaul, the input piston, which has a cut out that requires 10 3rd clutch plates, was replaced with a previous design 4T60 input piston that requires 8 3rd clutch plates. This mis-assembly stops the input piston from completely clamping the input clutch together, as shown in Figure 2, causing no Forward or Reverse engagement.

Special Note: On THM 4T60 (440-T4) transaxles, that do not use the wave plate in the input clutch, this mis-assembly will create a tie-up on the 1-2 upshift.

CORRECTION: Refer to Figure 1 to identify the 4T60-E input piston. Refer to Figure 2 and locate the hole in the input drum to air check the input clutch to verify proper operation before final assembly.
