# Technical Service Information

## THM 440-T4

### CENTER GEARBOX DISTRESS (LUBE CHANGES)

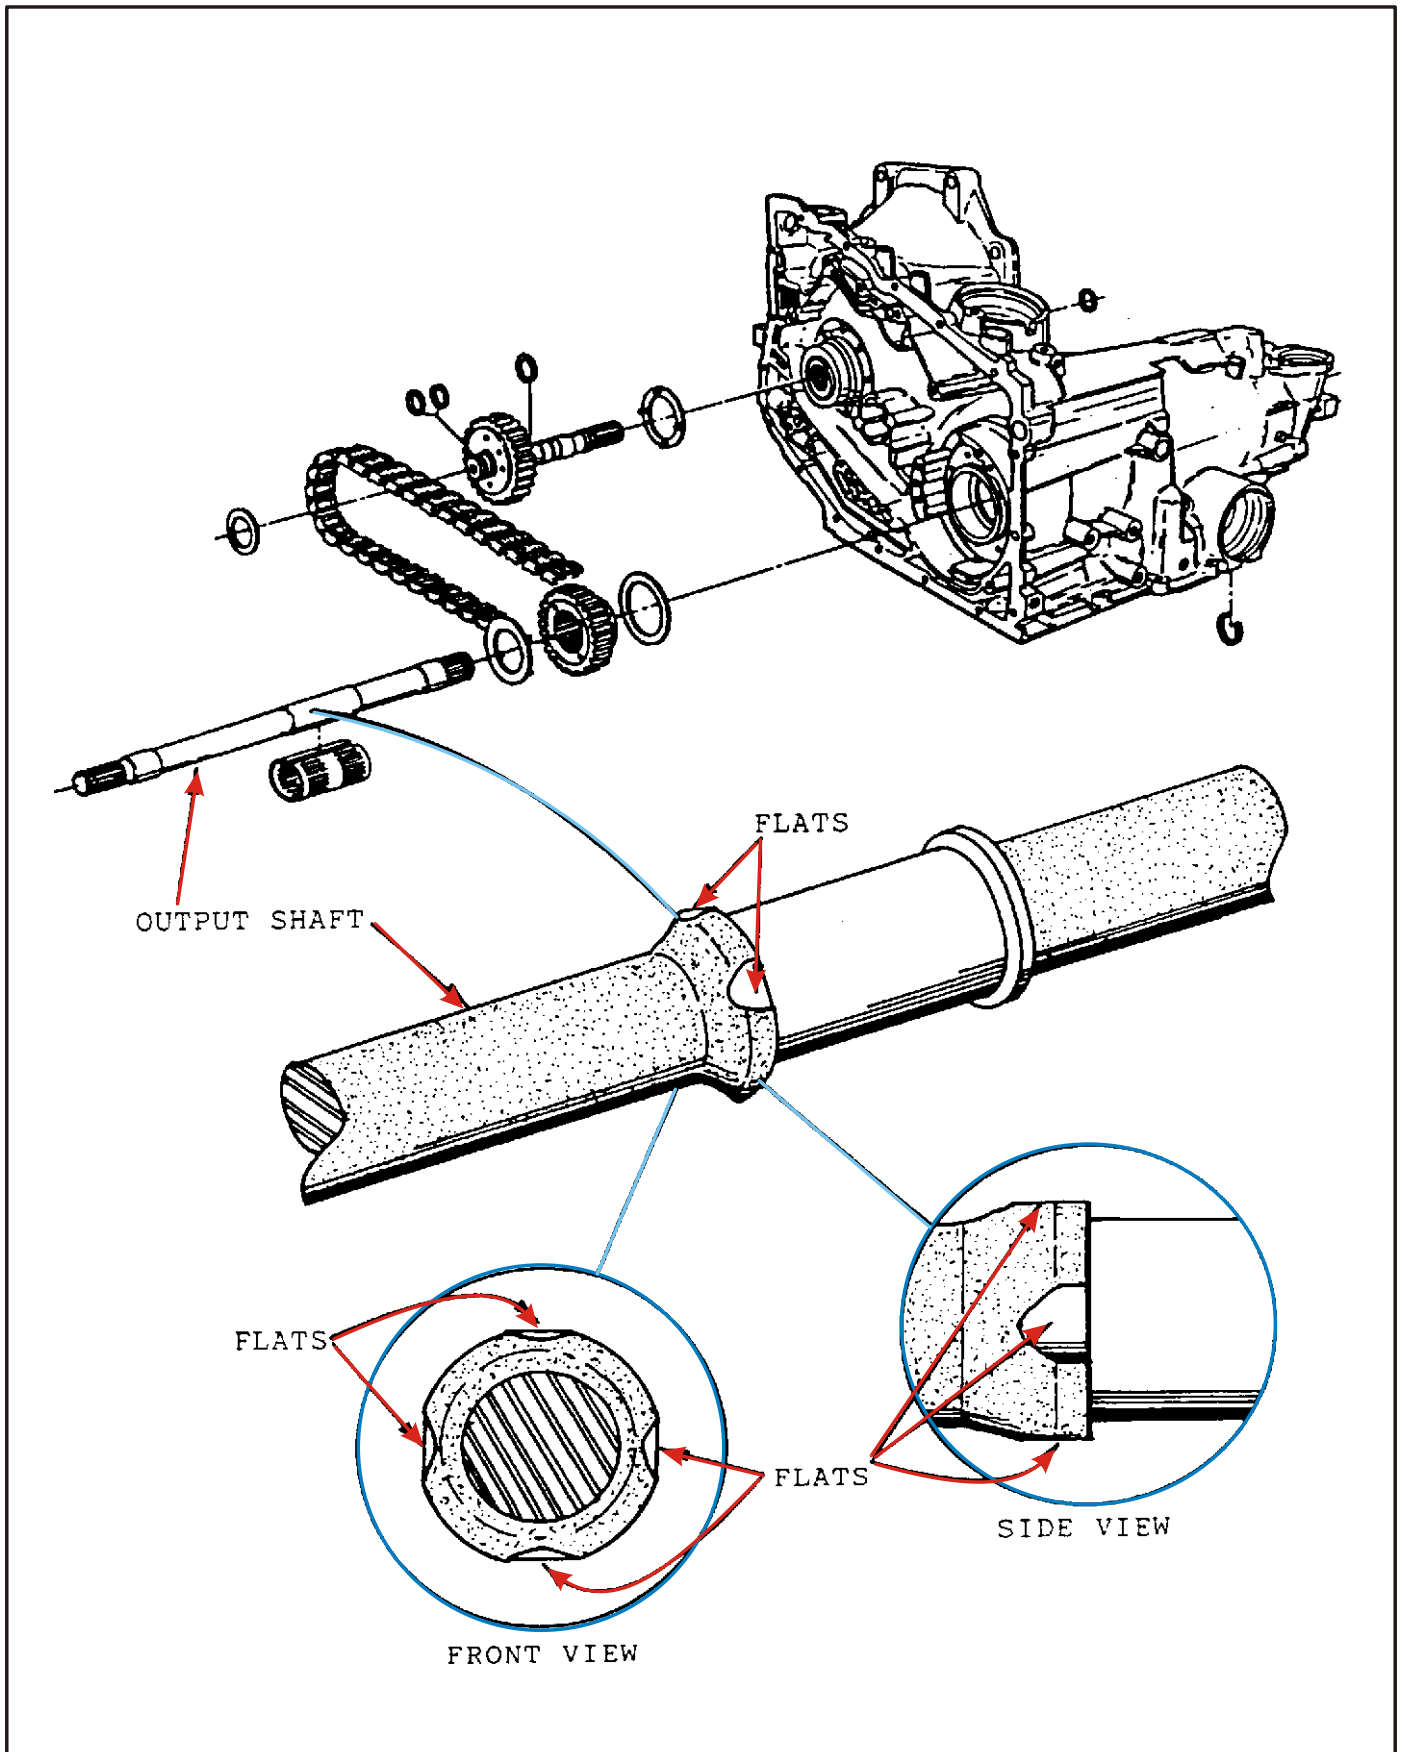
**Figure 1**

**COMPLAINT:** Repeated failure of the 3rd roller clutch and/or the input sprag.

**CAUSE:** Lack of lube oil to 3rd roller clutch and input sprag.

Grind four (4) flats on the output shaft at the front of the bearing in the locations shown in Figure 1.

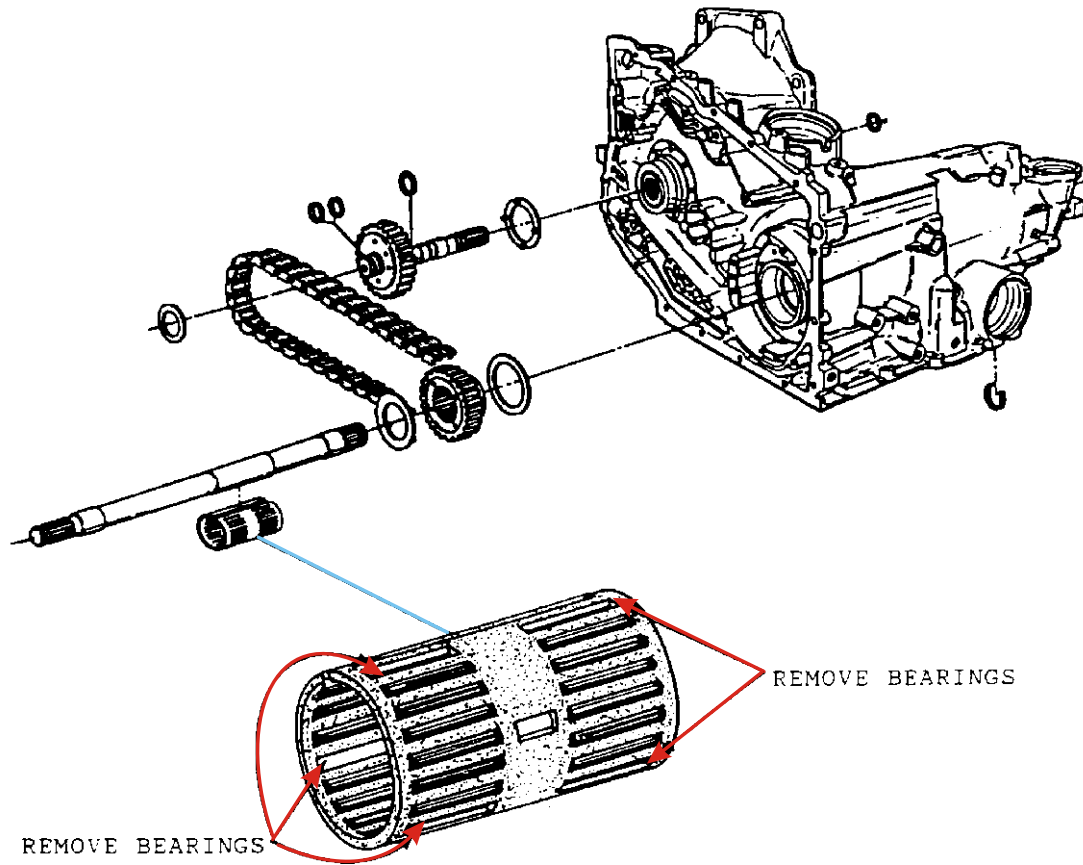
**Figure 2**

**REMOVE INDIVIDUAL NEEDLE BEARINGS IN THREE EQUALLY SPACED LOCATIONS AROUND THE BEARING TO PROVIDE THREE TROUGHS FOR ADDITIONAL LUBE OIL TO FLOW**

Remove individual needle bearings as shown in Figure 2, in three equally spaced locations around the bearing, to provide three "Troughs" for additional lube oil to flow. Removing the needles does not impair the durability of the bearing assembly.
