# Technical Service Information

## CHRYSLER A500/518

### PREMATURE OVERDRIVE CLUTCH FAILURE (SCREEN)

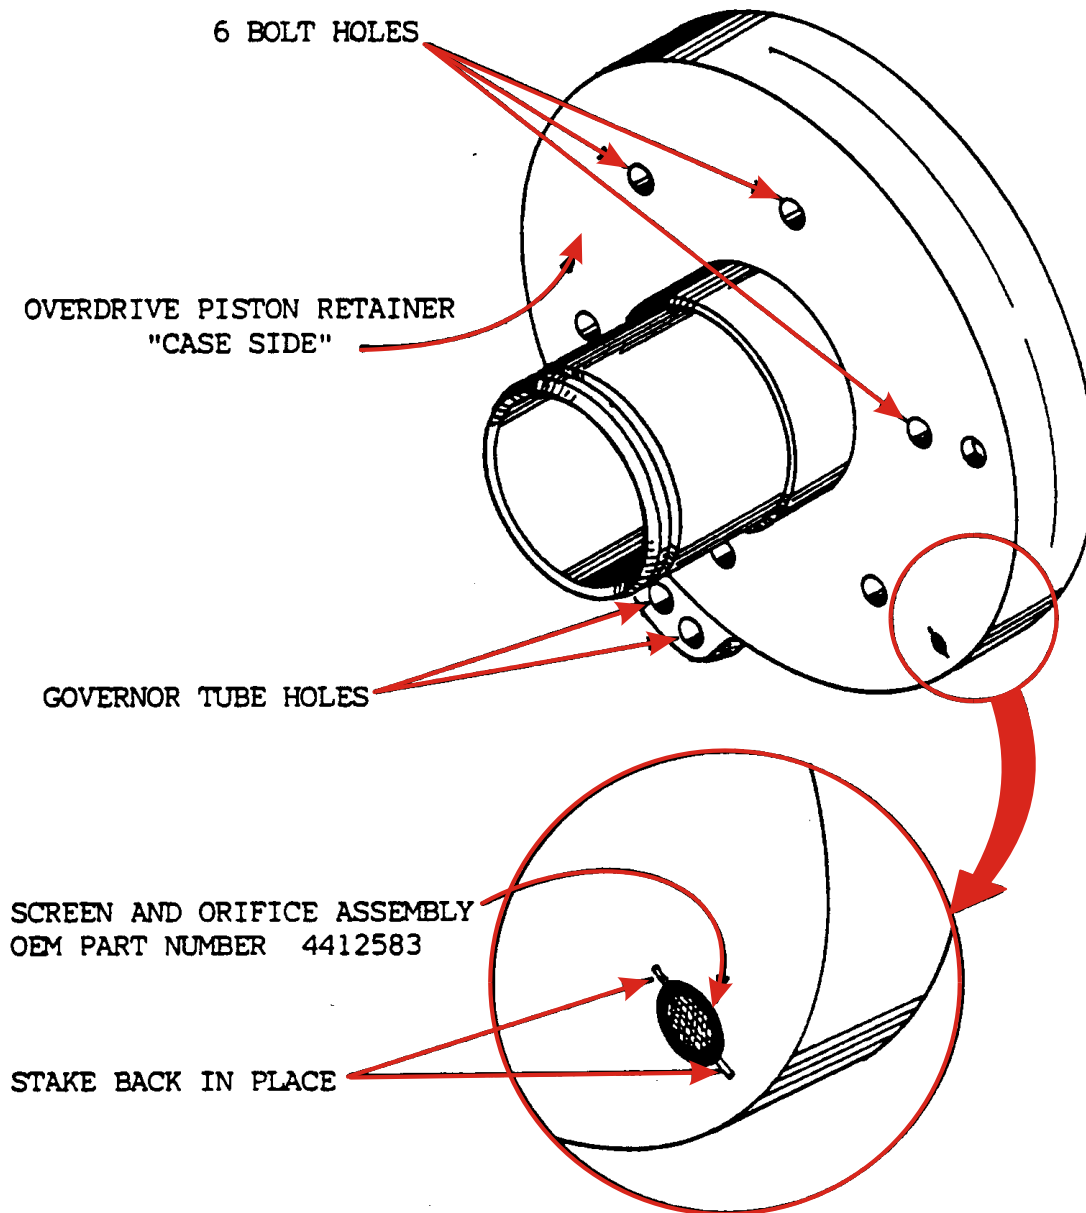
Figure 1

**COMPLAINT:** The overdrive clutches, located in the extension housing, "Wiped Out" at a very low mileage. Early symptoms may be a "Harsh" 3-4 shift, or a "Slipping" 3-4 shift.

**CAUSE:** The cause may be the Screen and Orifice Assembly blown out of the overdrive piston retainer (See Figure 1).

**CORRECTION:** Replace the Screen and Orifice Assembly with a new one, available under OEM part number 4412583, and make sure that you "STAKE" it in place after installation. Refer to Figure 1.

NOTE: This Screen and Orifice Assembly should be checked as a routine procedure, during a normal overhaul to insure that it has been "STAKED" in place. The factory did not start the staking process until March, 1989. "Don't let this one burn you".
