CHRYSLER REAR DRIVE PREMATURE PLANETARY FAILURE

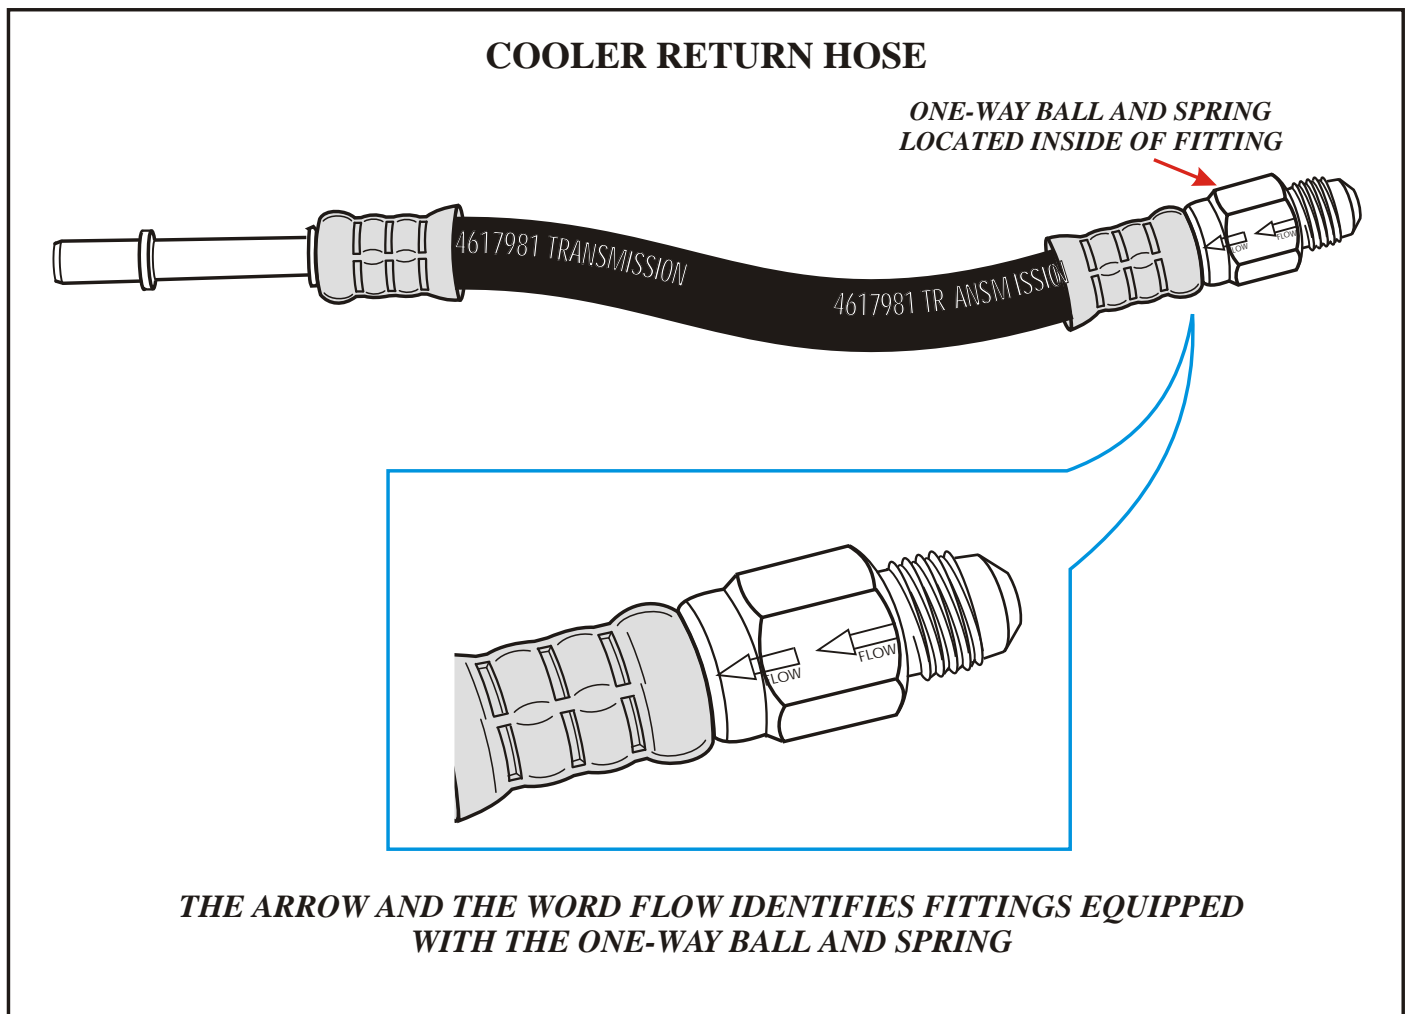
CAUSE: The cause may be, the one-way ball and spring located in the return cooler hose as shown in Figure 1, may be sticking and inhibiting cooler flow to the return cooler fitting which is the rear cooler fitting on the transmission.

CORRECTION: Locate the return hose which is near the radiator as shown in Figure 2. The threaded fitting will have an arrow and the word *flow* identifying the one-way ball and spring. Remove and discard the hose shown in Figure 1 and reconnect the existing lines with a suitable hose. After making the repair ensure that there is a minimum of 1 quart of fluid flow in 20 seconds when the rear cooler line is placed into a container and the transmission selector is in Neutral.

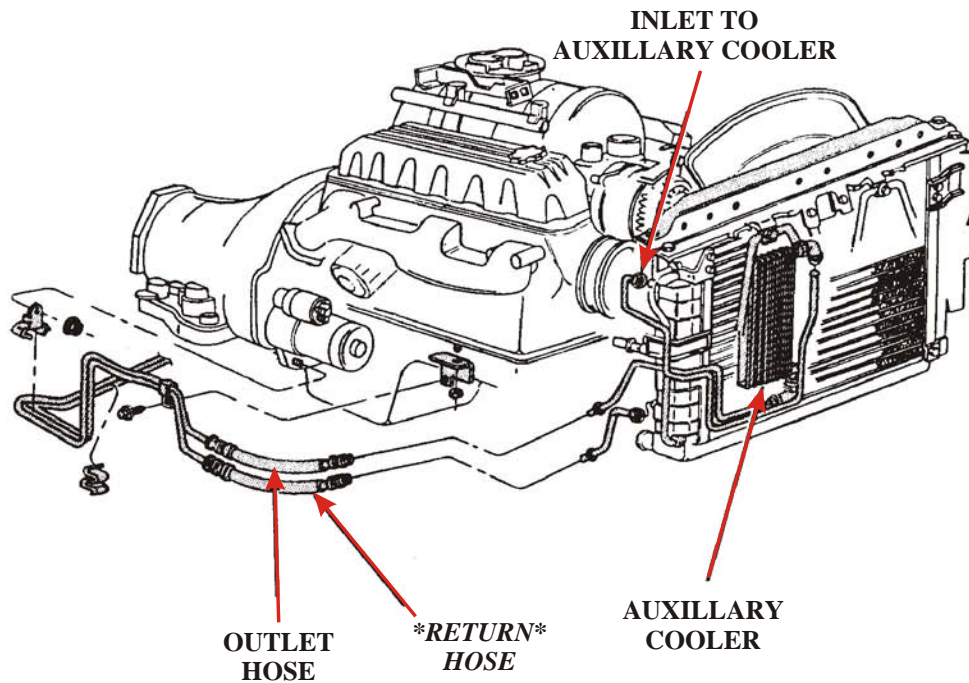
Figure 2

COOLER RETURN HOSE LOCATION
