# Technical Service Information

## THM 440-T4 HARSH 4-3 DOWNSHIFT (NEW PROM)

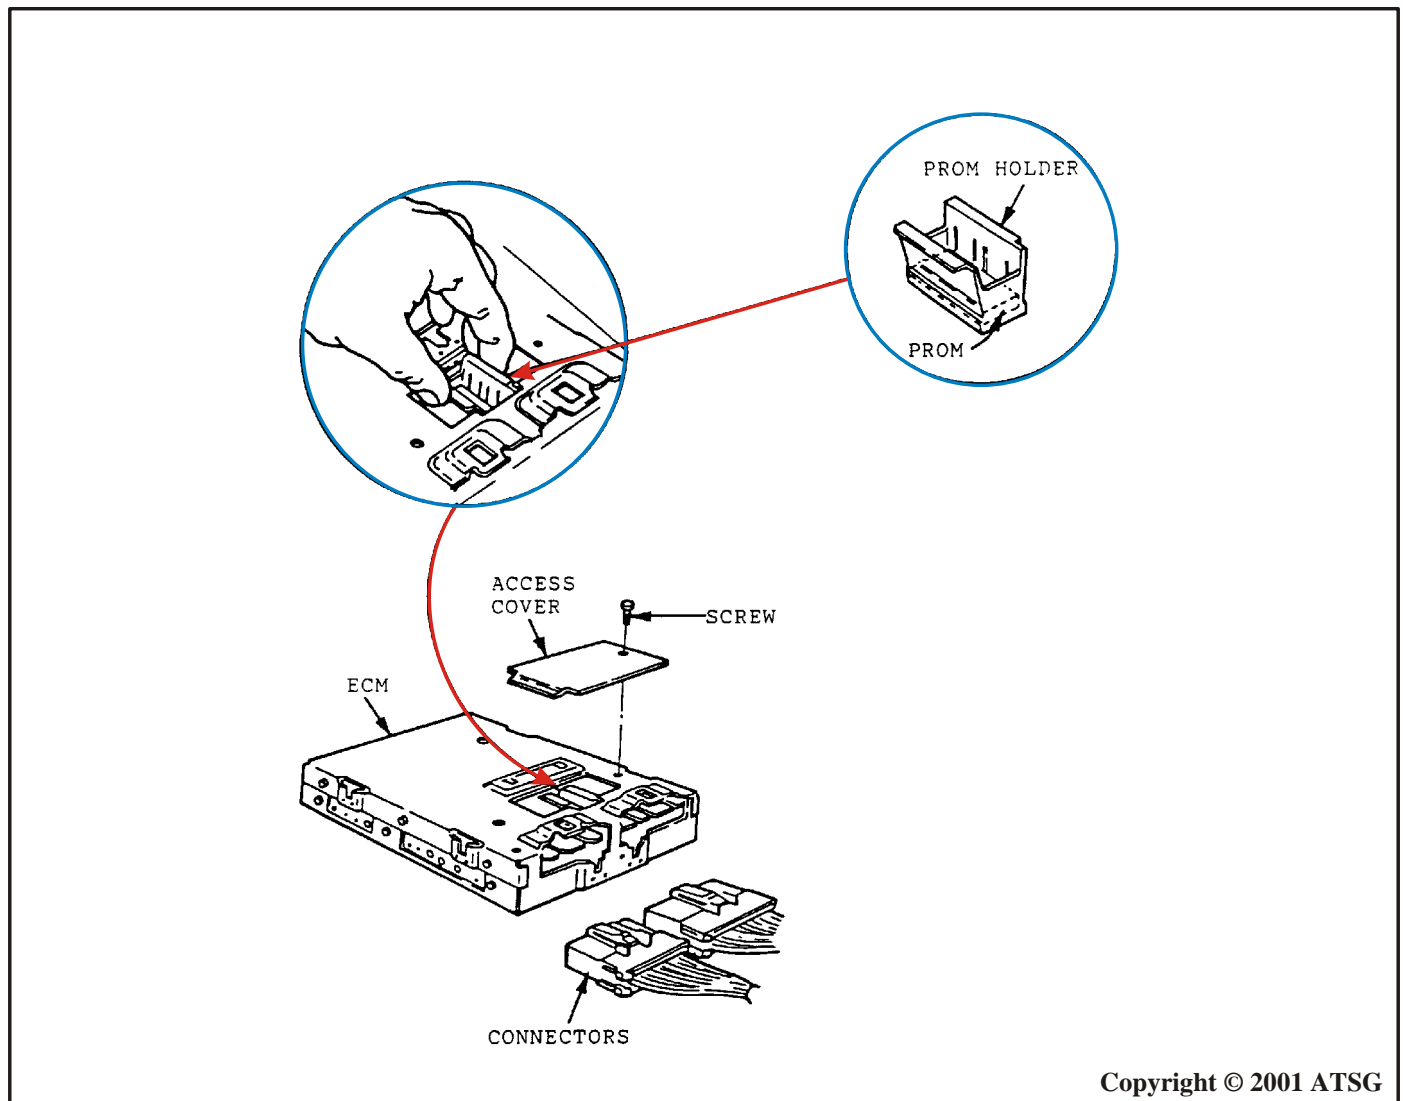
Figure 1

**COMPLAINT:** Harsh 4-3 downshift on 1985 Oldsmobile 98 vehicles.

**CAUSE:** Converter clutch not releasing on the 4-3 downshift.

**CORRECTION:** Replace the PROM in the ECM with updated OEM part number 16047215
