Technical Service Information

THM 200-4R NEW FILTER

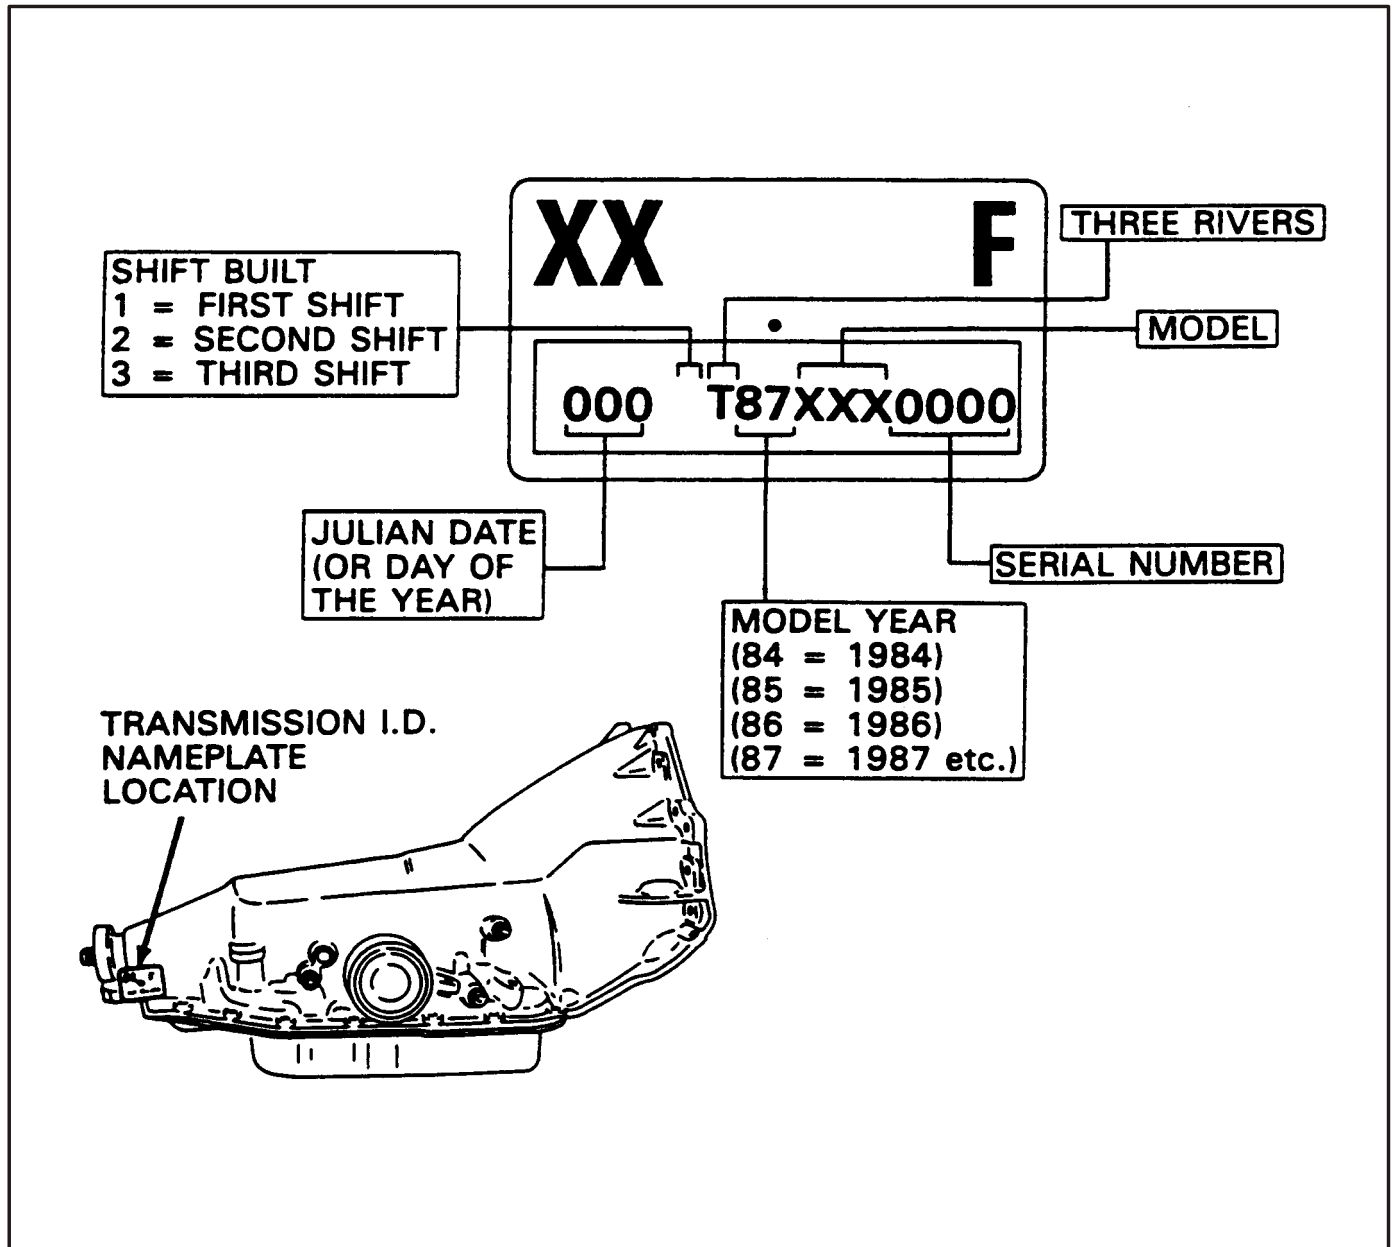
Figure 1

TRANSMISSION IDENTIFICATION INFORMATION (Figure 1) Note that the specifications given in this bulletin are at low end of the range printed in the service manual and only need to be used to correct a 1st/2nd gear noise condition.
