Technical Service Information

FORD AOD-E/4R70W SLIPS OR CHATTERS FORWARD REVERSE IS OK

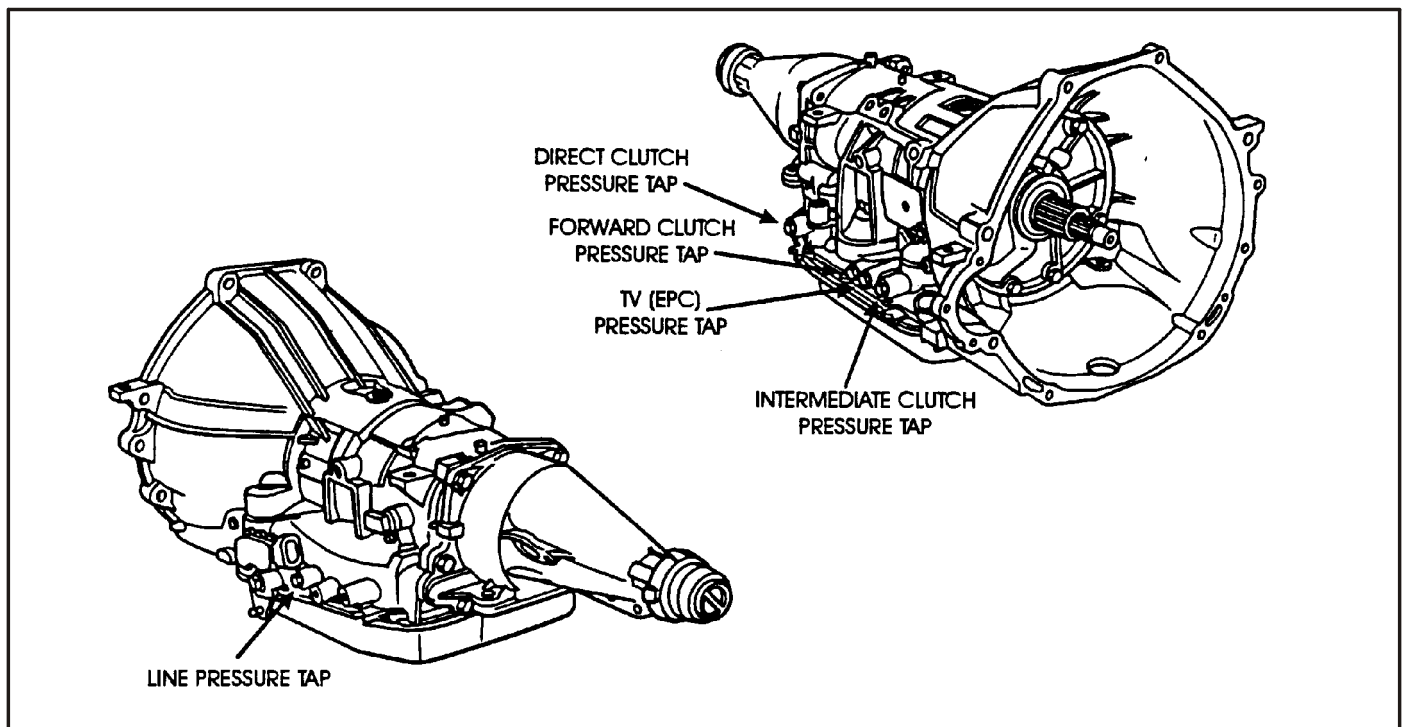
Figure 1

CAUSE: The cause may be, a partially clogged Shift Solenoid No. 2, which will stroke the 3-4 shift valve far enough to exhaust some of the forward clutch oil.

CORRECTION: Install two pressure gages to check line pressure and forward clutch pressure, as shown in Figure 1. With the transmission in Drive, both gages should read the same and should be approximately 55-75 PSI. If the forward clutch gage reads lower than the line pressure gage, *and all internal parts are known to be good*, replace the Shift Solenoid Assembly with OEM part number F5AZ-7G484-A (See Figure 2).

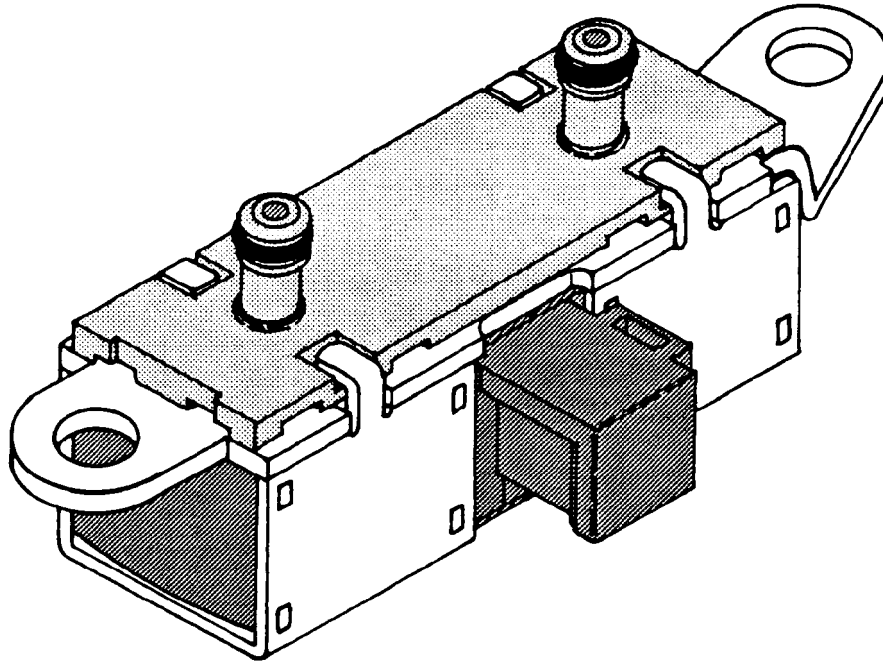
Figure 2

**SHIFT SOLENOID ASSEMBLY
PART NUMBER F5AZ-7G484-A**

Shift Solenoid Assembly (Latest Design Level) F5AZ-7G484-A
