Technical Service Information

THM 4L80-E

VIBRATION AND/OR LEAK AT EXTENSION HOUSING

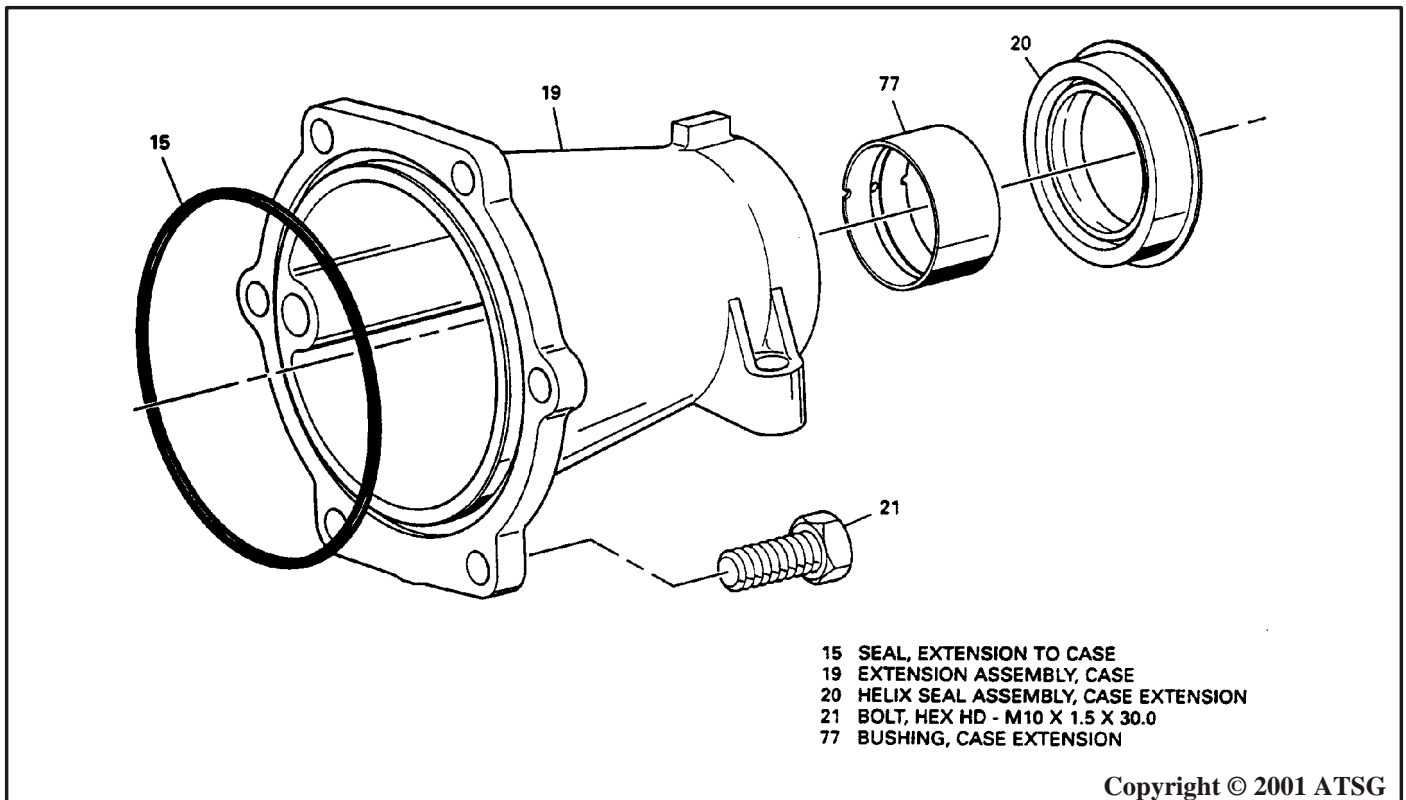
Figure 1

COMPLAINT: Some 1993 2WD model THM 4L80-E/4L80-EHD transmissions may leak transmission fluid from the extension housing seal even after seal replacement, and/or a vibration may be present in all ranges at all vehicle speeds.

CAUSE: The cause may be, the extension housing bushing not seated in the proper position, due to an oversized extension housing bore. This will allow the bushing to move rearward and interfere with the extension housing seal, creating the leak.

CORRECTION: If the extension housing bushing has moved, the extension housing **MUST** be replaced with OEM part number 8677464. Attempts to repair the extension housing by staking, or using Lock-tite to secure the bushing have been unsuccessful. Also install new extension housing seal, and lathe-cut "O" ring seal (See Figure 1).
