Technical Service Information

ACURA 4 SPEED HYDRAULIC SLIPPING OR NO FIRST GEAR

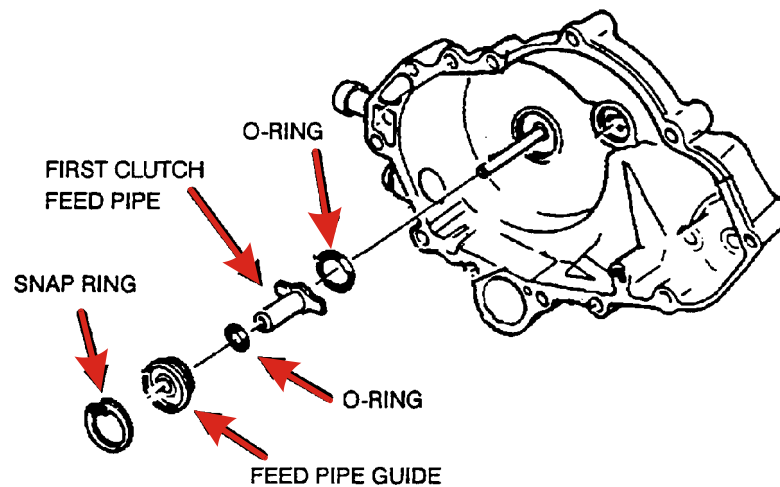
Figure 1

COMPLAINT: Slipping or no 1st gear.

CAUSE: Snap ring is not fully seated causing a sever leak at the first clutch feed pipe.

CORRECTION: Replace the o-ring and reinstall the snap ring pressing down all the way around the snap ring to make sure it is properly seated.
