Technical Service Information

THM 4L60-E 2ND GEAR START, 2-3 SHIFT ONLY OR LACK OF LINE PRESSURE RISE

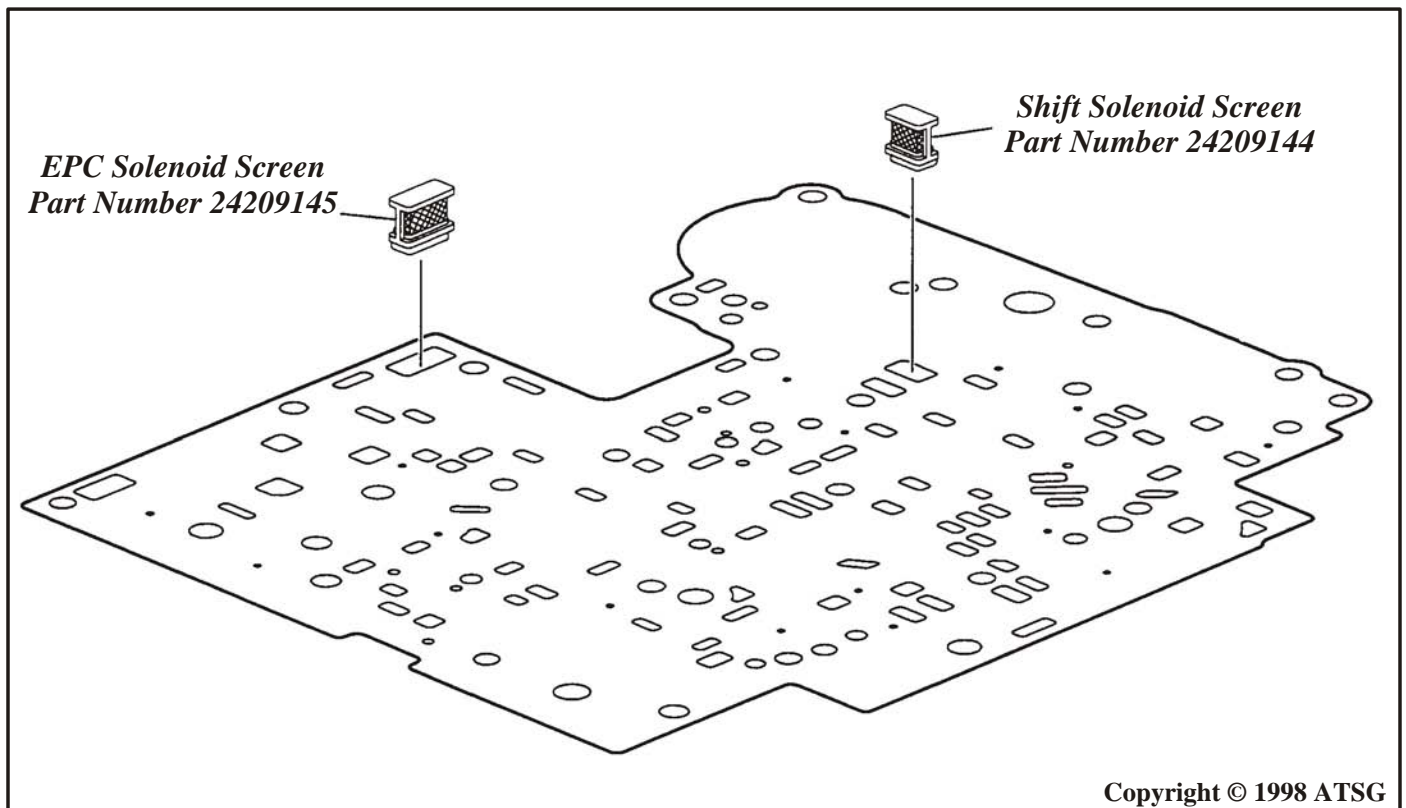
COMPLAINT: Before and/or after rebuild the vehicle exhibits a 2nd gear start with only a 2-3 shift and possibly a lack of proper line pressure rise with throttle opening.

CAUSE: The cause may be, one or both of the screens in the spacer plate collapsed shut, and restricting solenoid feed oil or actuator feed oil to the Pressure Control Solenoid.

CORRECTION: Replace both screens in the spacer plate as shown in Figure 1, with the part numbers listed below. These *new part numbers* are screens with a larger micron screen that will pass more oil easier.

Electronic Pressure Control Solenoid Screen	24209145
Shift Solenoid Screen	24209144
