Technical Service Information

THM 4L80-E VENT SHIELD LOCATION

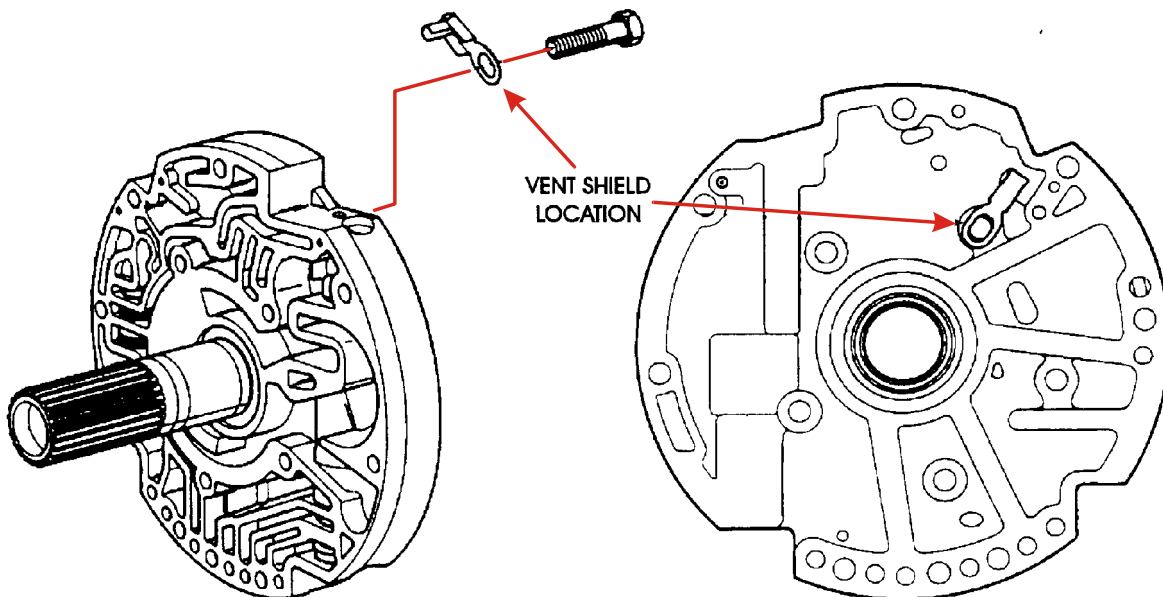
CHANGE: Beginning at start of production for all 1994 model THM 4L80-E/4L80-EHD transmissions, there was a Vent Shield added to the back side of the pump cover, and retained by, a pump cover to pump body retaining bolt as shown in Figure 1.

REASON: To eliminate fluid from exhausting from the transmission air vent.

PARTS AFFECTED:
(1) VENT SHIELD - Added to the oil pump assembly in model year 1994 (See Figure I).

INTERCHANGEABILITY:
The Vent Shield will retro-fit back to all previous models

SERVICE INFORMATION:
Vent Shield, Oil Pump 24200357
