# Technical Service Information

## THM 4L60 (700-R4) NO AND/OR DELAYED REVERSE

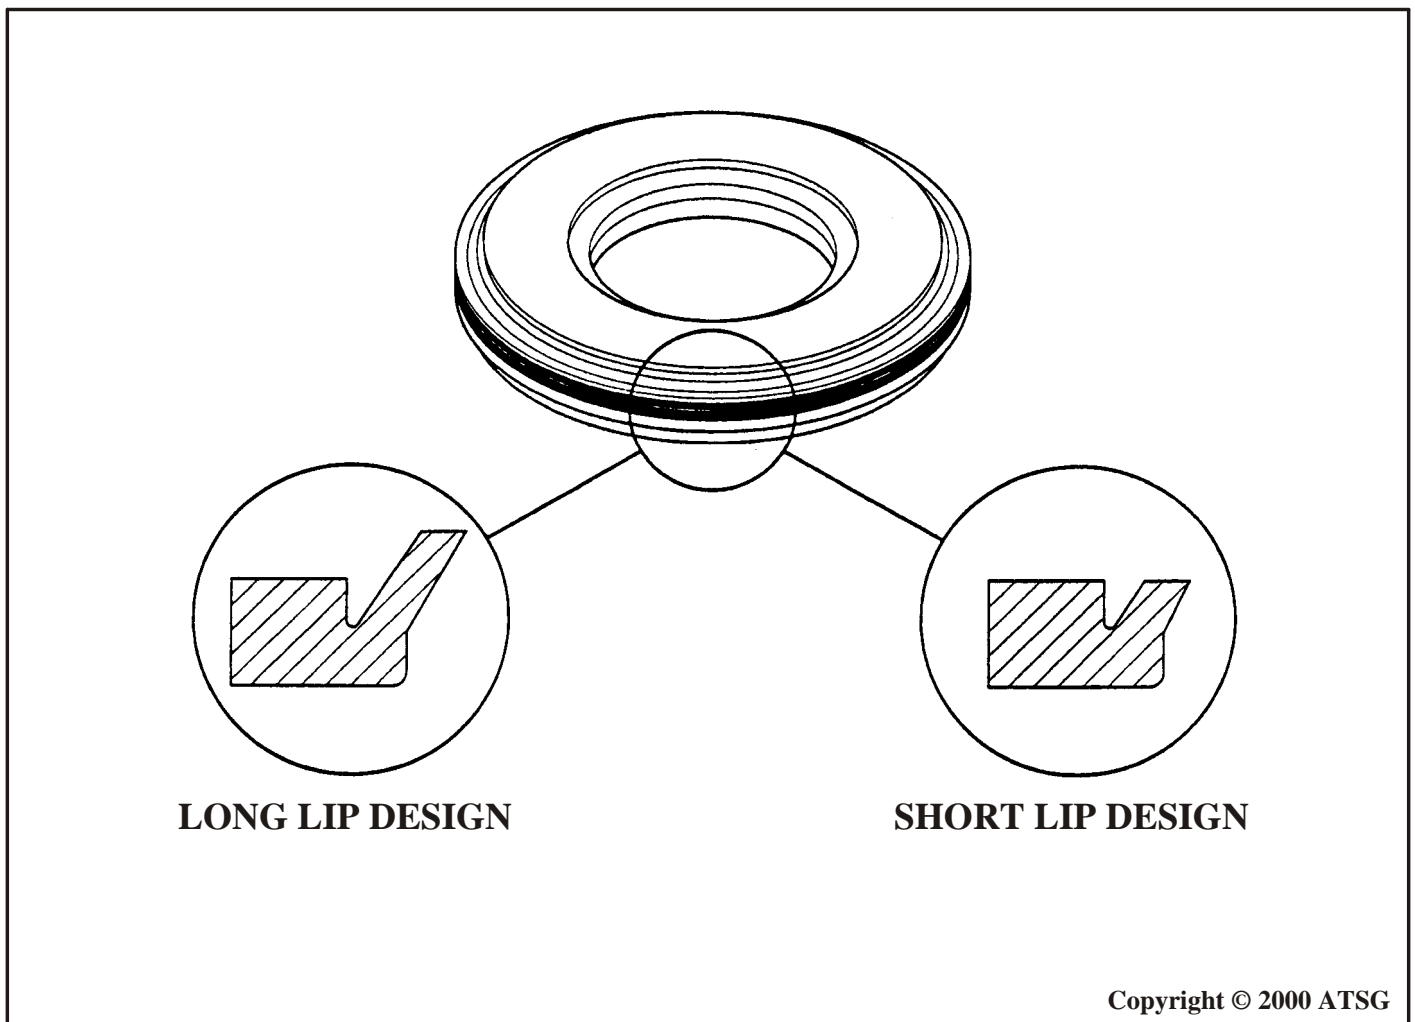
Figure 1

**COMPLAINT:** Some 1989-1991 THM 4L60 (700-R4) transmissions may exhibit a no reverse or delayed reverse condition, especially when the outside temperatures drop near 20° Fahrenheit.

**CAUSE:** The cause may be a "Short Lip" design seal installed on the reverse input clutch piston outer seal (See Figure 1).

**CORRECTION:** Install the "Long Lip" design seal on the reverse input clutch piston outer seal (See Figure 1). NEVER install the short lip design seal, as the manufacturer has now gone back to the long lip design on all models.
