1998 DODGE INTREPID 3.2L VIN J

DTC'S P1695 AND P1698

Technical Service Information

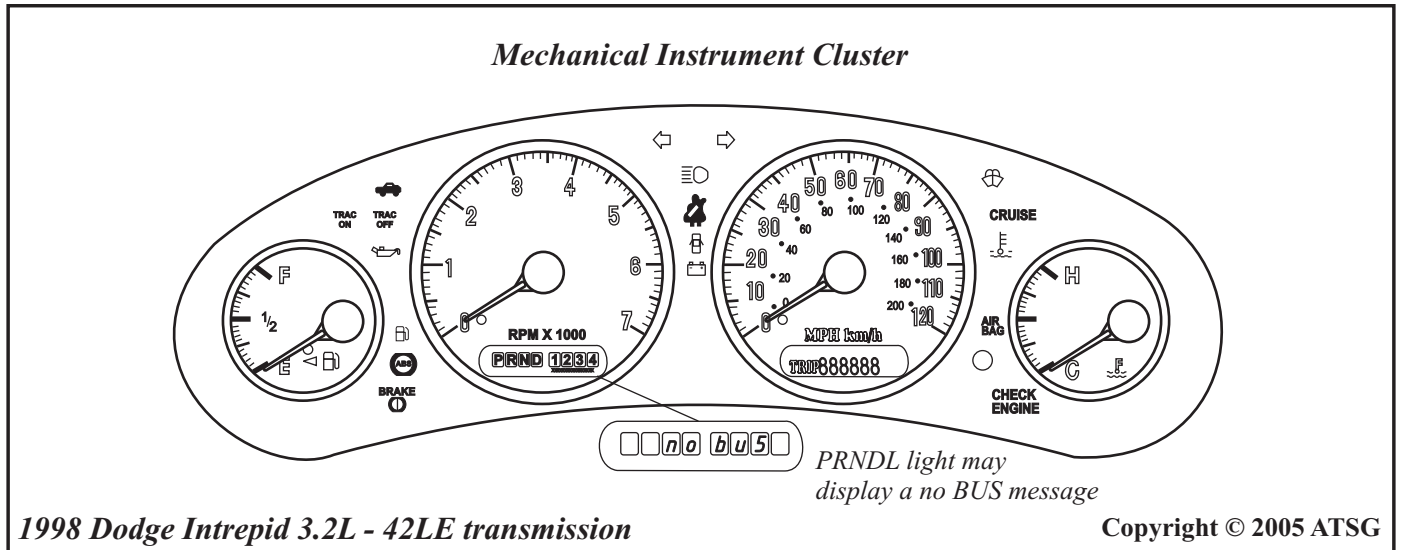
Figure 2

It may also be noted that the engine starts and runs well and the transmission shifts properly yet in the Mechanical Instrument Cluster [MIC] (Figure 2), the Tachometer does not work, the speedometer does not work and the coolant temperature gauge does not work, the MIL is illuminated, while the fuel gauge is working as well as the PRNDL display other than when a Bus error message may appear.

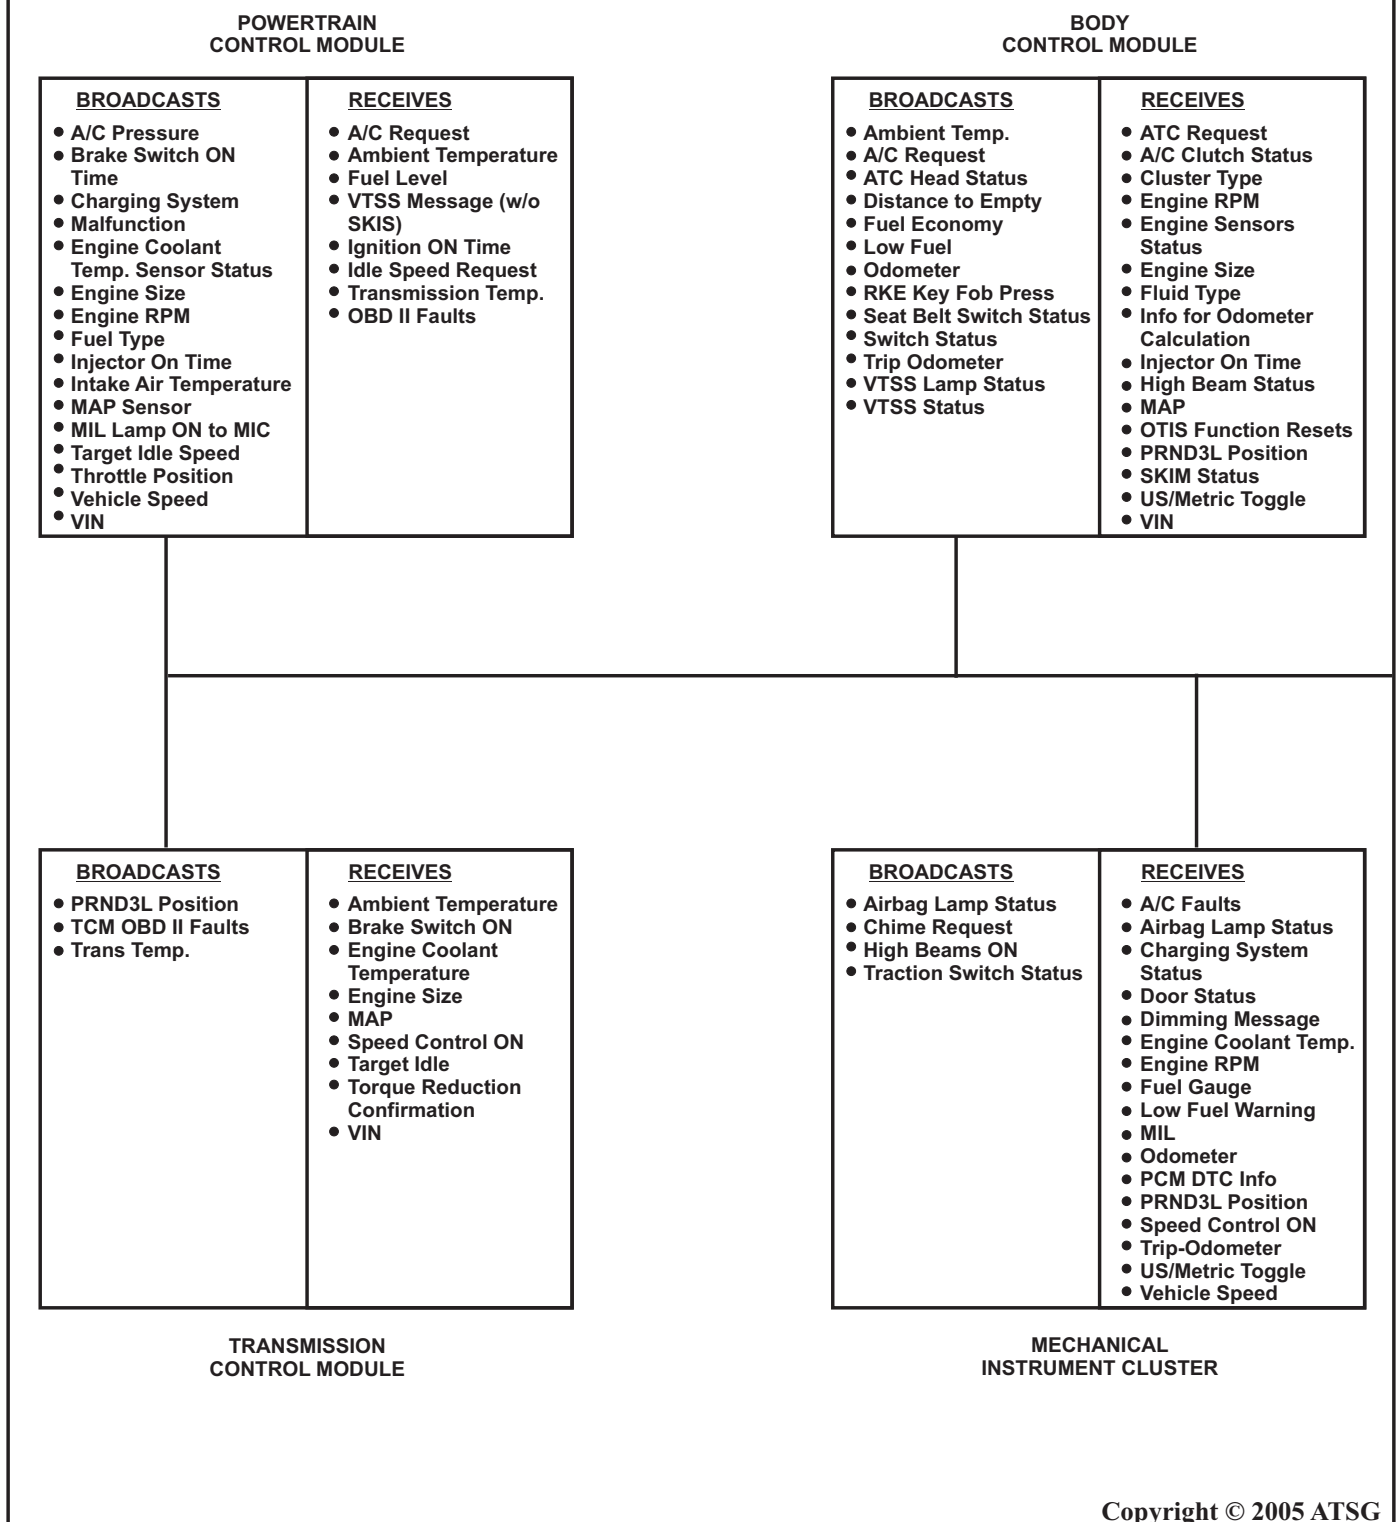
Figure 3

A partial flow chart provided in figure 3 and wiring diagram in figure 4 reveals the type of information that is being broadcasted and received among the modules. It can be seen that the PCM broadcasts the RPM, VSS and ECT information and the MIC receives it. It is also noticed that the BCM broadcasts the Fuel Level information and the TCM broadcasts the PRNDL information, both of which are also received by the MIC. Since the RPM, VSS and ECT gauges are inoperable while the Fuel Level and PRNDL display are, it is sensible to conclude that the PCM is the module having problems communicating with the MIC.

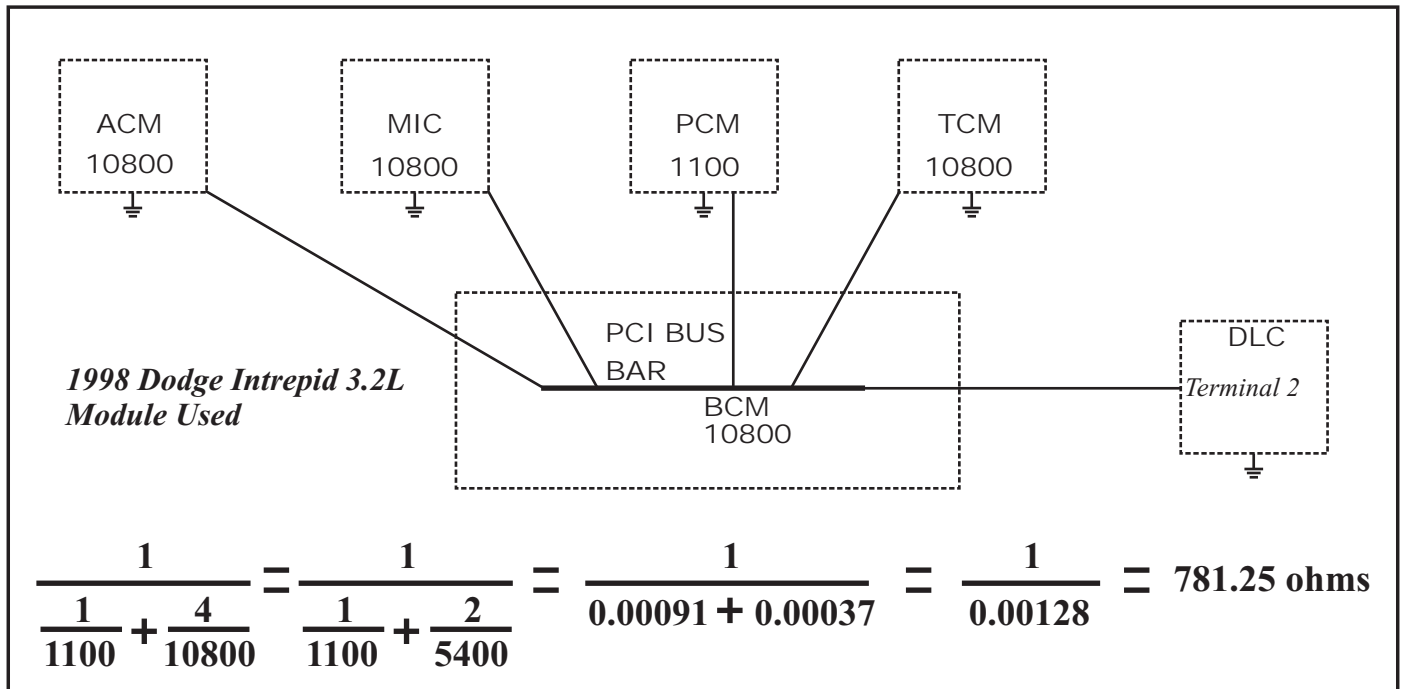
Figure 5

There are a total of 5 modules being used in this 1998 Dodge Intrepid (See Figure 5). The: 1. PCM 2. MIC 3. ACM (Airbag) 4. TCM 5. BCM

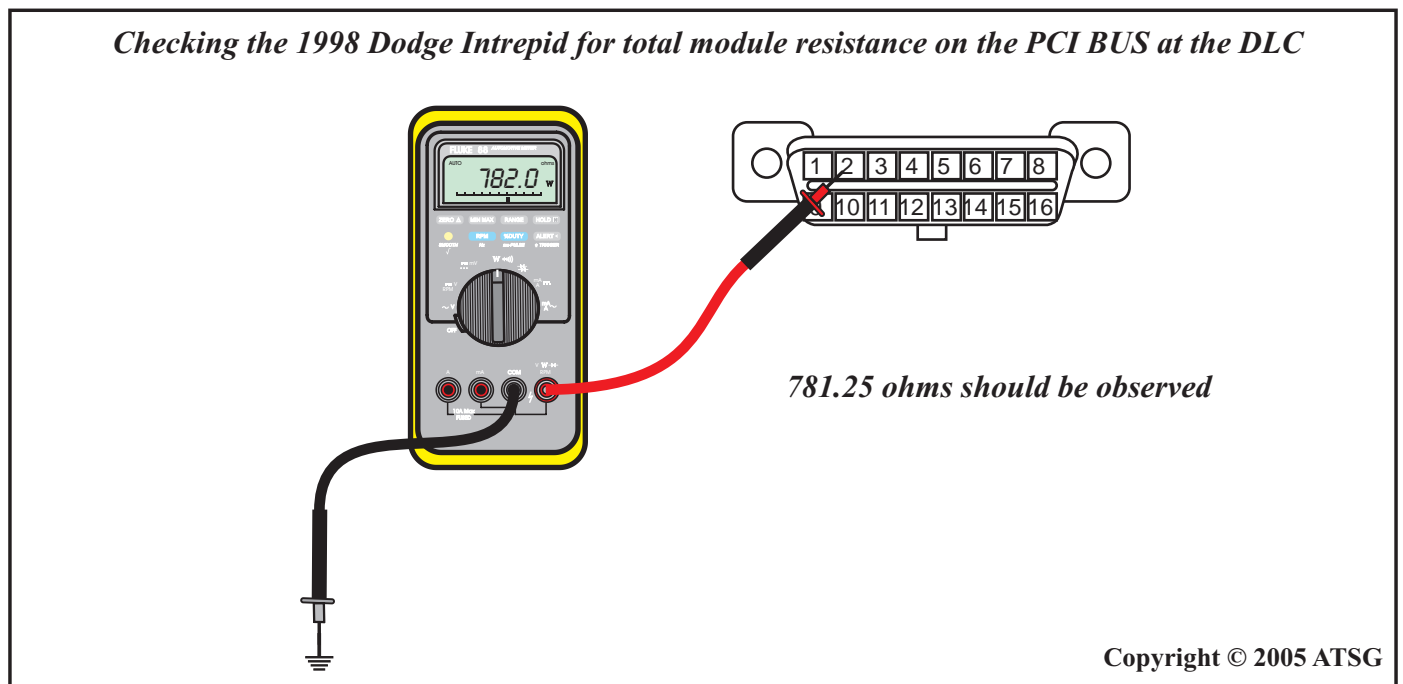
Figure 6

By adding and dividing the resistance of each module on the circuit as seen in figure 5, a quick check of the entire PCI circuit can be performed at terminal 2 in the Data Link Connector (See Figure 6). If the entire circuit measures correctly, it can be determined that the system is neither shorted or open and that the PCM itself is defective.

CORRECTION: If the entire PCI BUS measures correctly, replace the PCM.
