MAZDA G4A-HL NO 3-4 UPSHIFT

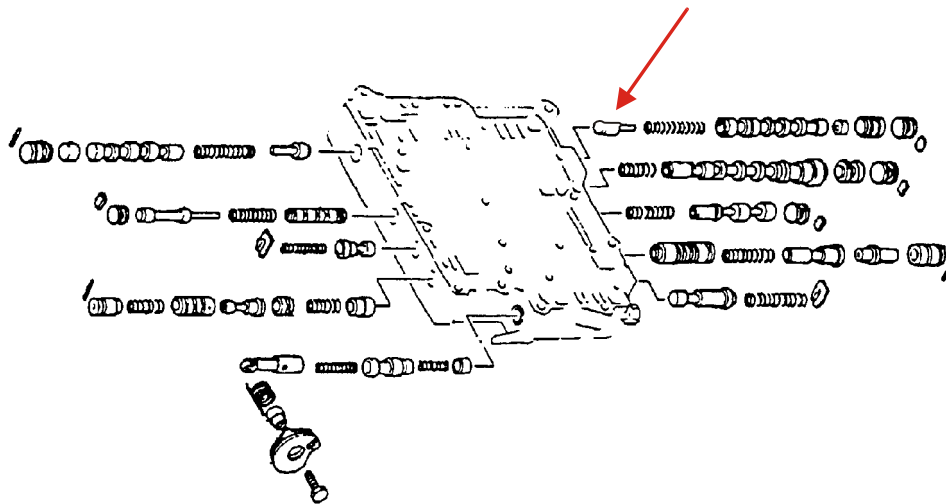
G4A-HL MAIN VALVE BODY

COMPLAINT: G4A-HL hydraulically controlled transmissions in Mazda 323 cars can loose the 3-4 shift while all other ranges function normally. A pan and servo examination reveal nothing abnormal.

The cause may be that the 3-4 shift rear plug in the main valve body (SEE FIGURE 1) travels to far and jams. This prevents the 3-4 shift valve from stroking.

3-4 SHIFT REAR PLUG
