Technical Service Information

JF506-E NO REVERSE SLIPS FORWARD

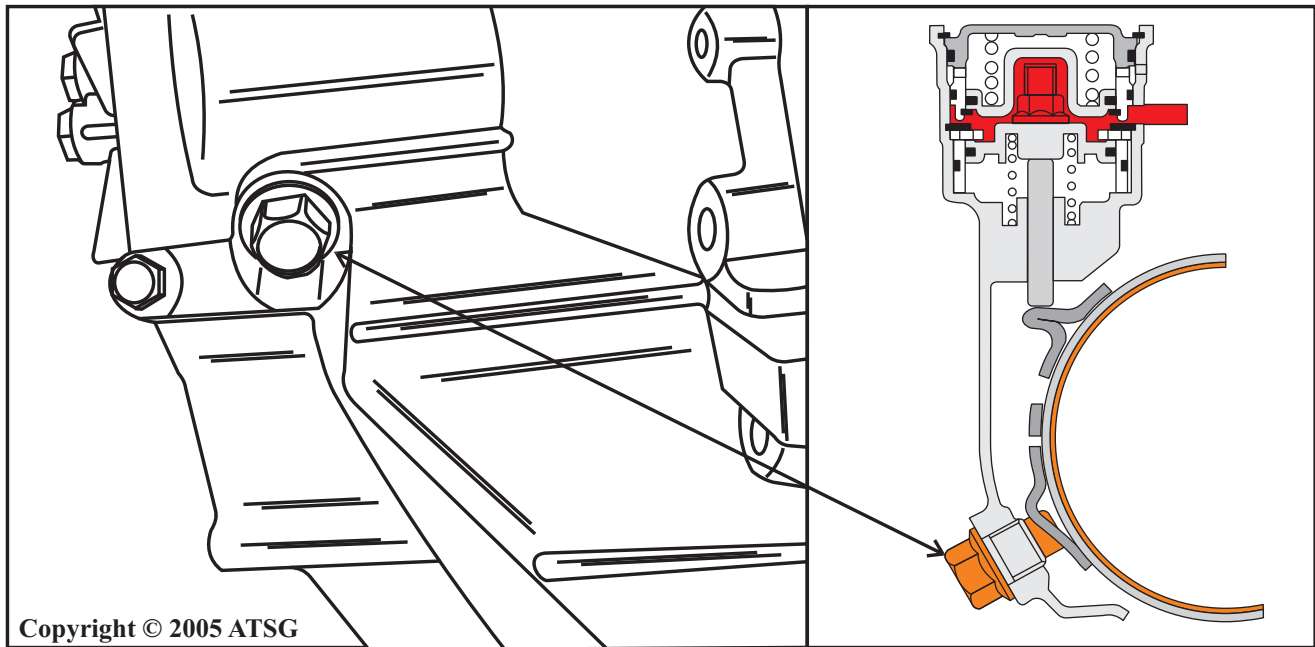
Figure 1

CAUSE: One cause may be that the Reduction band anchor bolt (Figure 1) was accidentally mistaken for the fill plug. When the bolt was removed the band dropped out of position.

CORRECTION: In most cases the transmission will need to be removed and disassembled to gain access to the band to place it back into it position.

One in car repair method would be to back out the band adjusting stud until ONLY 7/8" of the threads are exposed, any further and the band can spin past the adjustment pin and transmission removal becomes absolute. The next step is to drill a hole through the entire Band Anchor bolt using an "R" drill so the hole can be tapped for 1/8" pipe plug. Next, acquire a foot long piece of music wire 0.102" in thickness. Bend the wire with a slight bend at one end and a larger bend at the opposite end to be used as a handle. Slide the wire through the Band Anchor bolt and use the wire to grab the anchor end of the band into position. In some cases, the band may be slightly wedged between the drum and the case and will require light tapping to work it free. Once the anchor end of the band is positioned correctly, carefully screw the anchor bolt into place. Care must be taken to not miss the anchor hole wedging the band into the drum. Once the anchor bolt is in place, tighten the band adjusting stud to 70 inch pounds and then back it out 2 1/2 to 3 turns and tighten the lock nut. *(If available, read the Tasc Force Tips: A Case of Mistaken Identity Part 2: Impossible? by Ed Lee in the April 2005 edition of Transmission Digest page 18).*
