Technical Service Information

SATURN TAAT DELAYED AND OR NO REVERSE

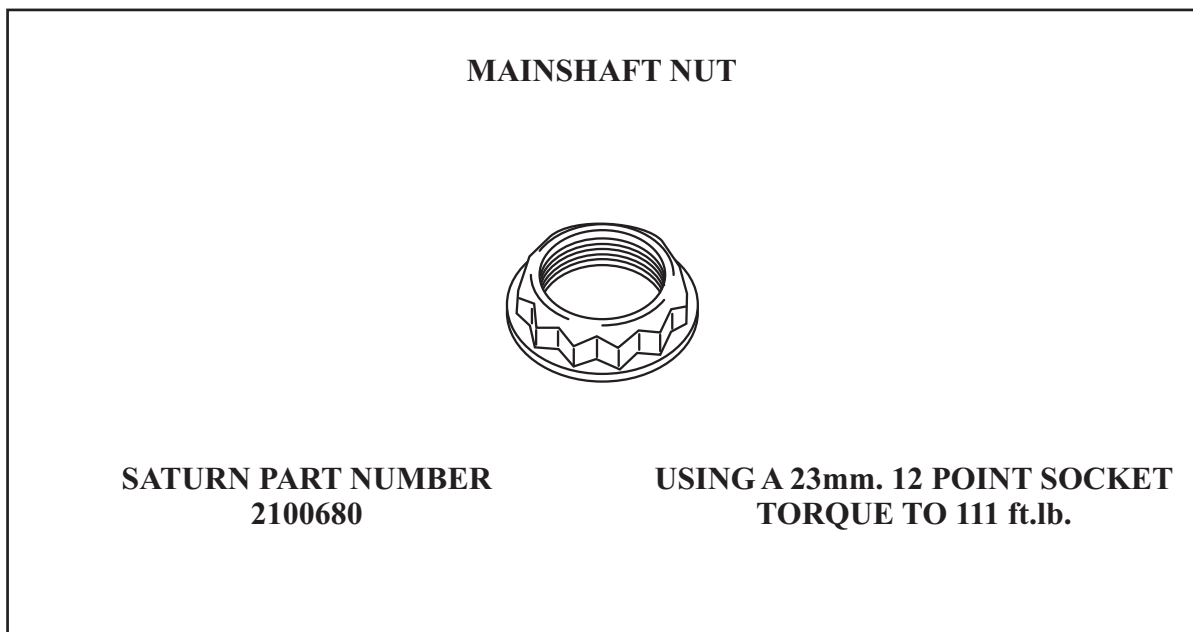
Figure 1

CAUSE: The cause may be, a loose Mainshaft Nut, as shown in Figure 1, causing a leak in the 2nd clutch circuit. When the nut loosens the mainshaft tends to walk back and forth in the mid case. This causes a gap between the 1st Clutch and the nut, which is where the leak in the 2nd Clutch circuit appears. In Figure 2 the cutaway shows how the 2nd Clutch is fed around the outside of the feed pipe for the 3rd clutch. **Notice** that the area over and under the nut are all part of the 2nd Clutch circuit.

MAINSHAFT ASSEMBLED

CORRECTION: Install a new Mainshaft nut, which has a factory thread locker, as part of every repair. Using a 23mm. 12 point socket torque the new nut to 111 ft.lb.
