1996 SEMINAR INFORMATION

"THE BEST FIX IN '96"

AUTOMATIC TRANSMISSION SERVICE GROUP
9200 S. DADELAND BLVD. STE 720
MIAMI, FLORIDA 33156
(305) 670-4161

INTRODUCTION

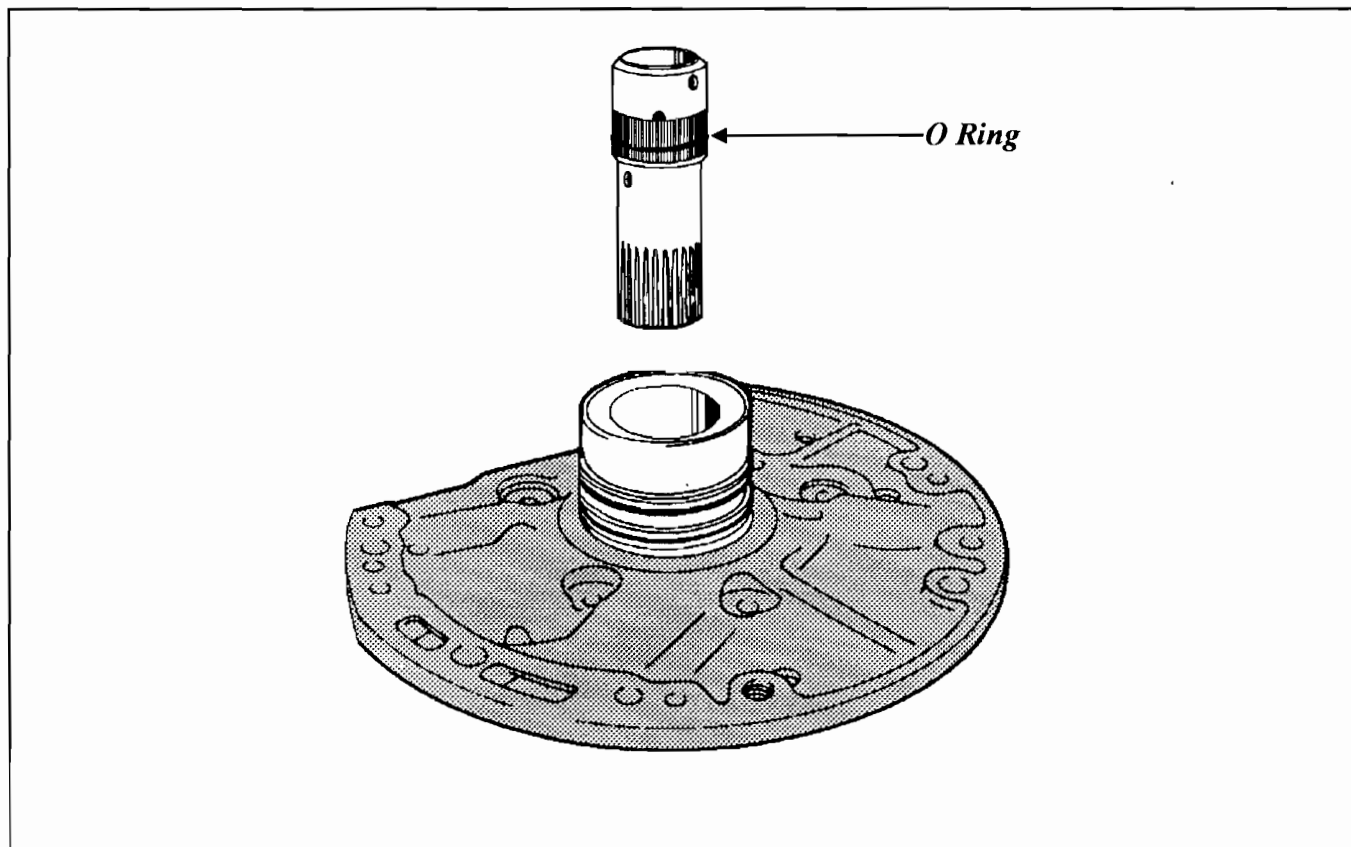
Figure 1

Cause: There is an O ring on the stator shaft that deteriorates causing a loss of converter release pressure. This allows the converter clutch to drag shuddering the engine and causing premature failure of the converter clutch. (See Figure 1).

Correction: It is best to replace the pump cover with a known good one. However, the stator shaft can be pressed out of the cover if care is taken not to distort the cover during the shaft removal process. Replace the O ring and align the holes in the shaft to the cover and carefully press the shaft into place (See Figure 1).

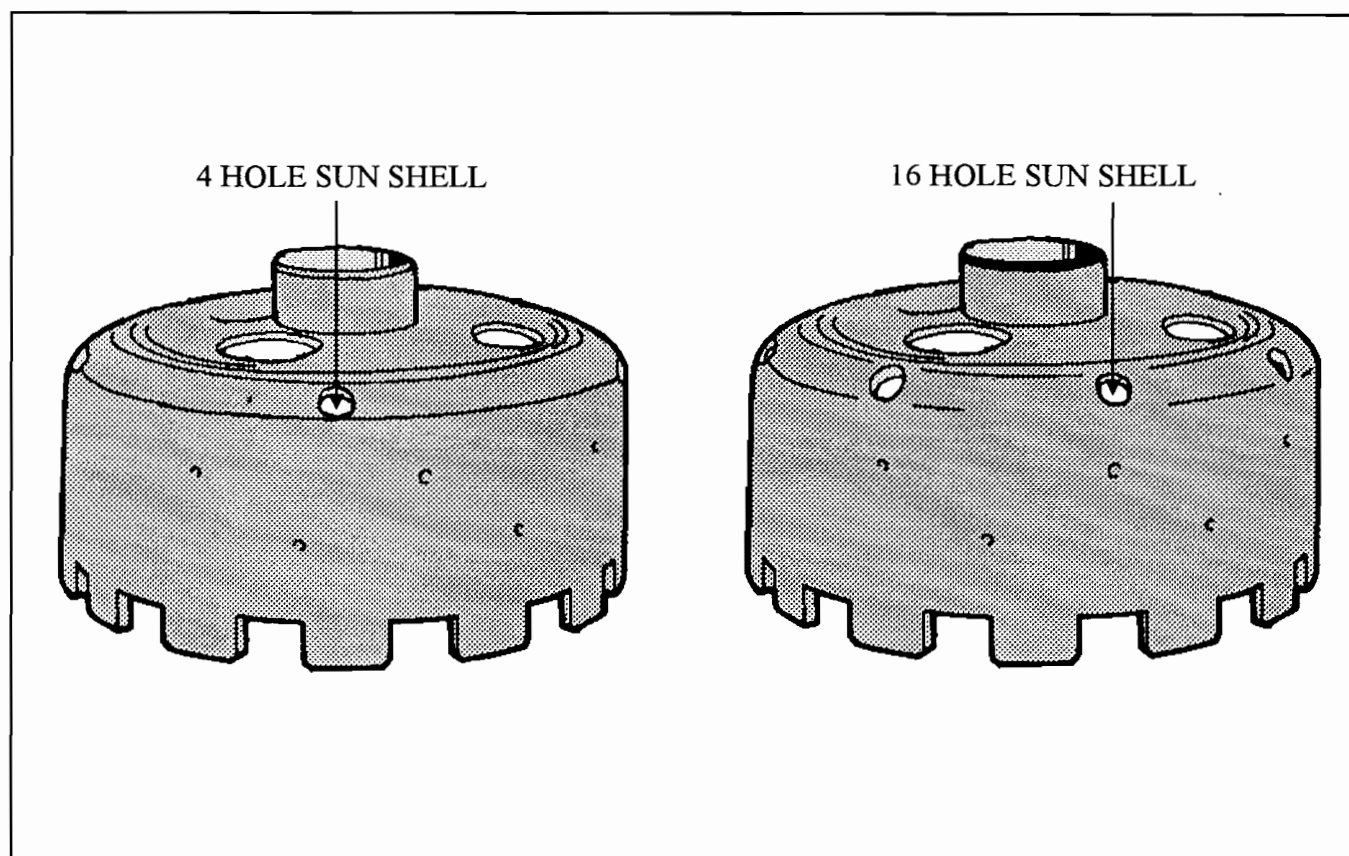
Figure 5

Cause: One cause may be that during overhaul the wrong sun shell was replaced. 3 speed KM units use a 4 hole sun shell for pulse generator A signal while all 4 speed units use a 16 hole sun shell.

Correction: Check the original sun shell for the correct hole count and replace the sun shell with the correct application (See Figure 5).

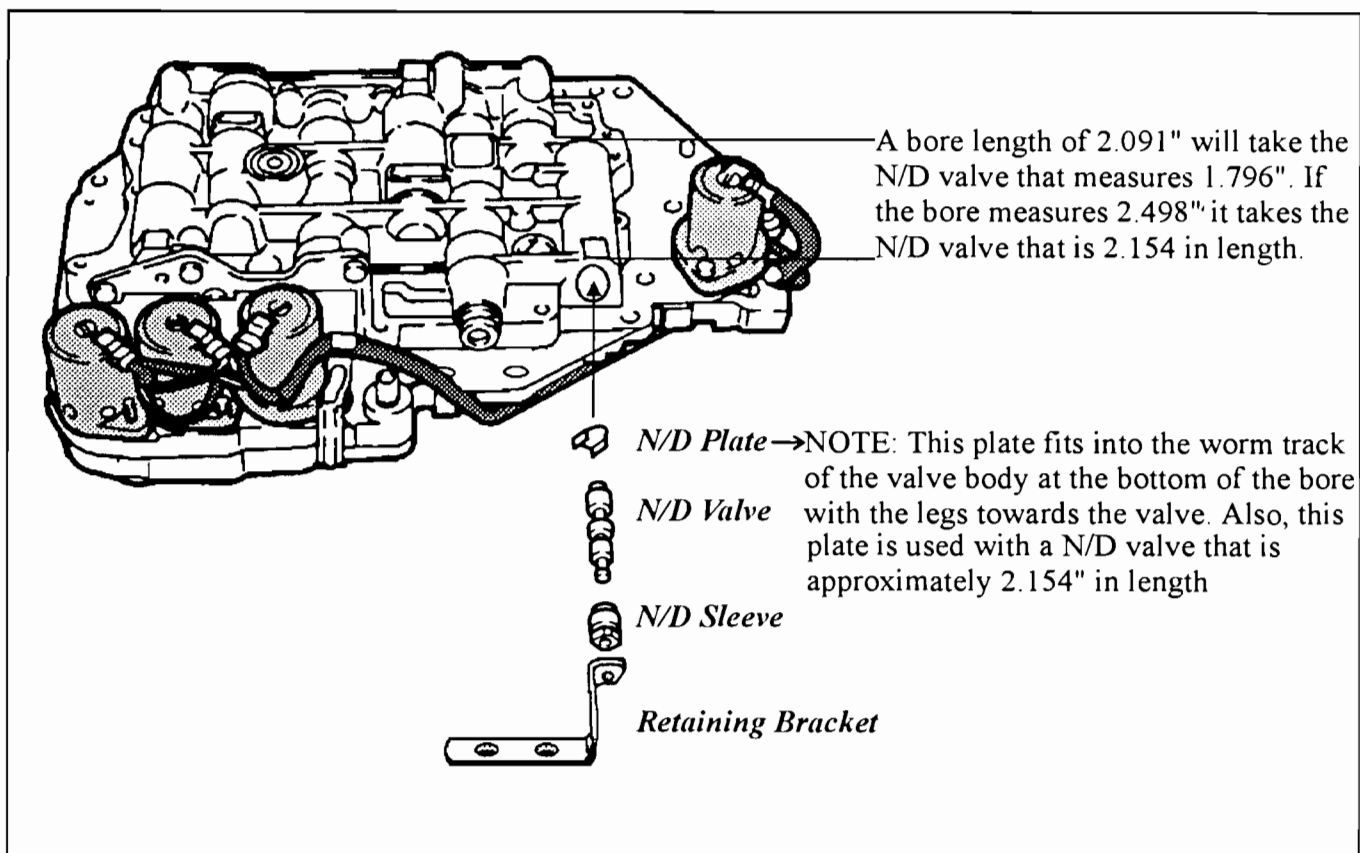
Cause: One cause may be an incorrect assembly of the Neutral to Drive valve. During the valve body cleaning either the N/D plate was installed backwards or on some models, the N/D sleeve can be installed backwards. Also, there are two different style N/D valves. One style, the N/D valve measures approximately 1.796" in length while the other measures approximately 2.154" in length. Only the longer valve takes the plate at the bottom of the bore. The shorter valve does not take the plate. The bore depth is also substantially different due to the different lengths of the valve. Never put the shorter valve in where the longer valve belongs.

Correction: Use Figure 6 below for the correct N/D valve line up. Notice that the fingers on the N/D plate faces the valve and NOT the back of the bore.

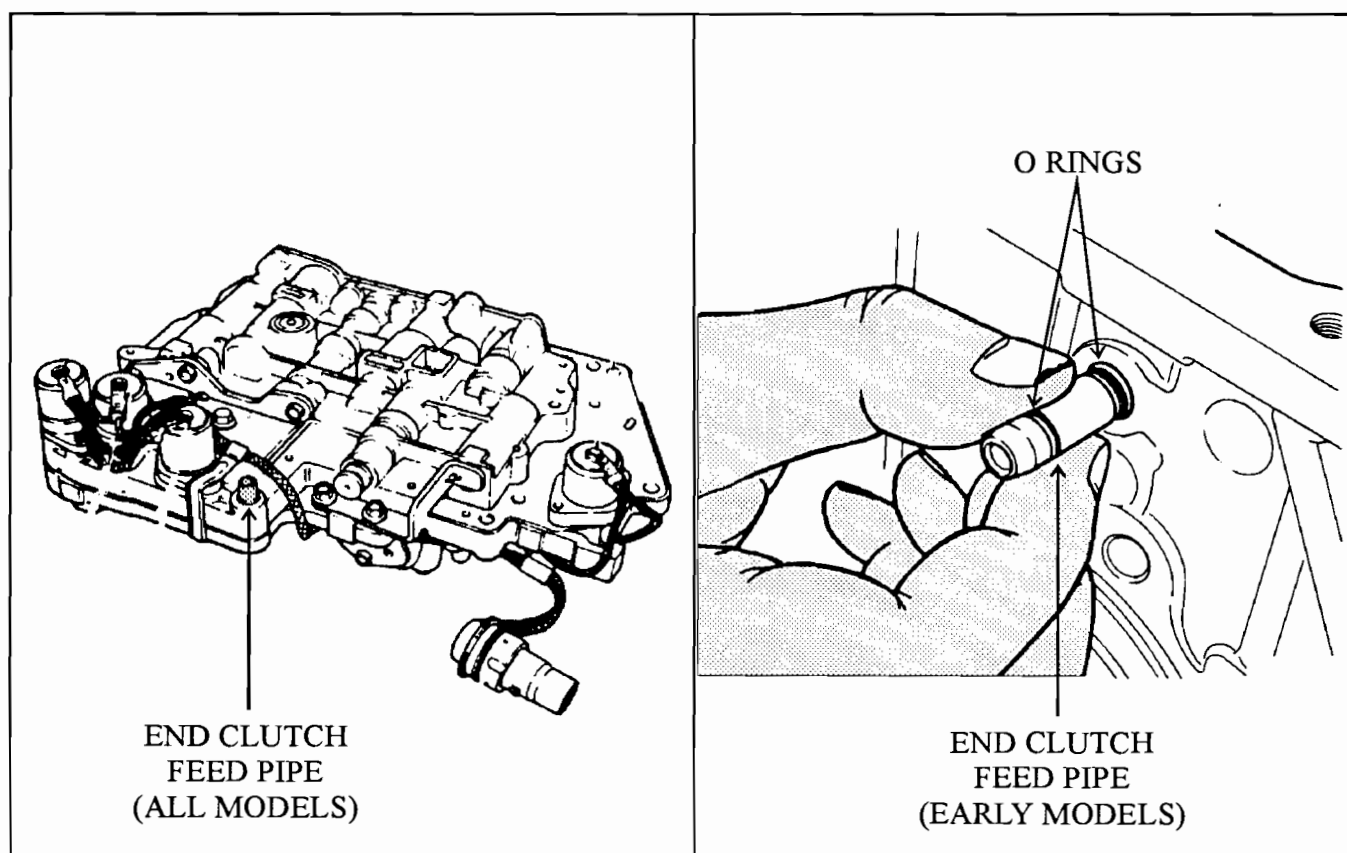
Figure 7

Cause: One cause may be a missing end clutch feed pipe or a missing or damaged feed pipe O ring.

Correction: Check for a missing end clutch feed pipe from the solenoid mounting block to case as shown in Figure 7. Early models had a feed pipe with two O rings on it coming out of the back of the case. Check this feed pipe for missing or damaged O rings (See Figure 7).

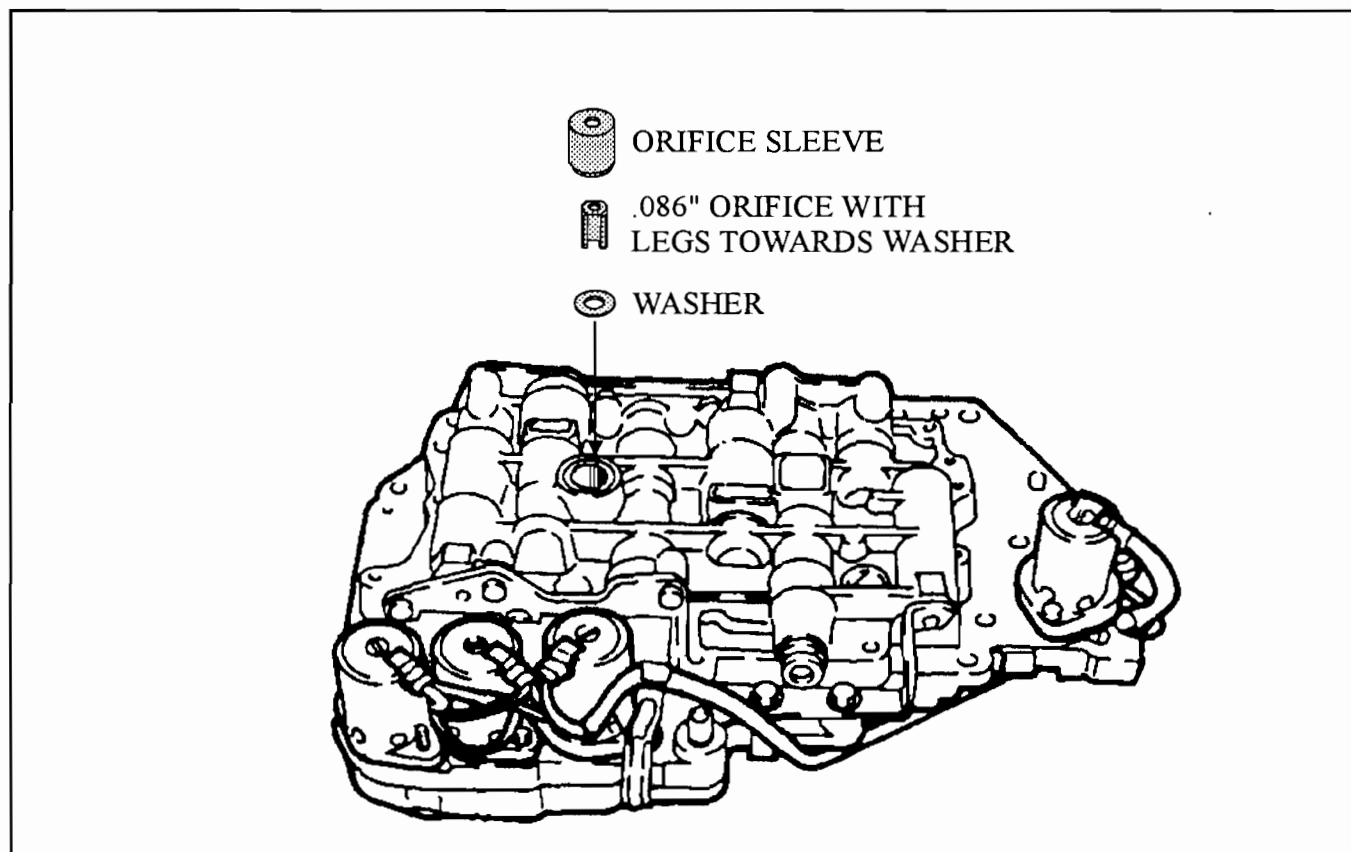
Figure 8

Cause: During the rebuilding process, the low/reverse clutch feed orifice may fall out of the valve body without the technician being aware of it. The valve body is then installed back onto the transaxle with the orifice missing providing un-orificed oil to the low/reverse clutch resulting in a harsh engagement. If the technician saw the orifice fall out of the valve body and the orifice was reassembled incorrectly, the orifice becomes ineffective resulting in the same condition.

Correction: Install the washer into the feed orifice bore first followed by the feed orifice with the legs towards the washer. Place the orifice sleeve over the orifice and press the sleeve down into the bore (See Figure 8). The design of the orifice is to control the flow rate of the low/reverse clutch oil for a controlled engagement as well as providing a rapid release of the oil when the low/reverse clutch is disengaged. The orifice used is approximately .086". If an improper orifice is used in its place, a slow release of the low/reverse clutch could be the result which would cause the low/reverse clutches to drag in forward gears causing premature failure.

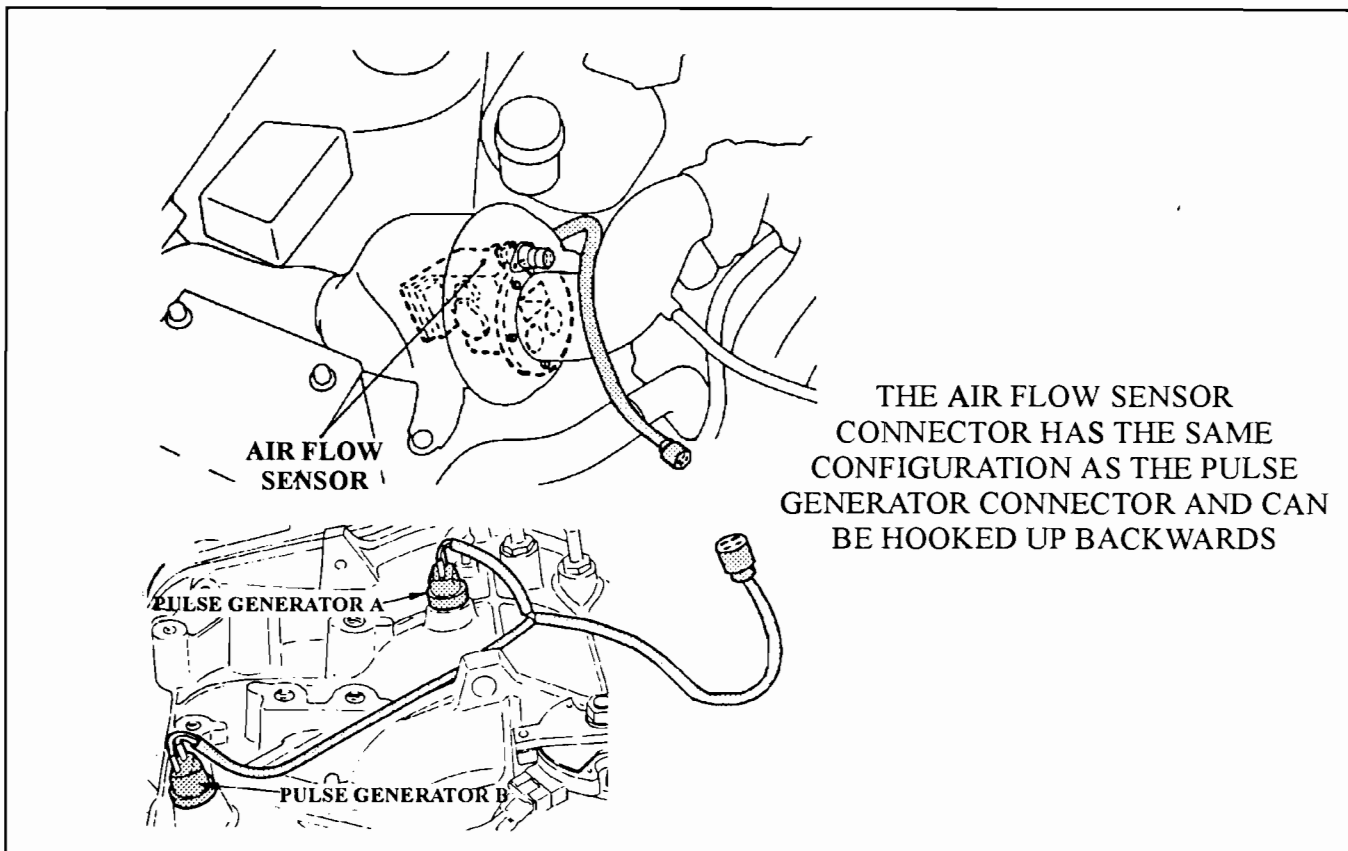
Figure 9

Cause: On 1985 to 1987 Mitsubishi Galant vehicles, the Air Flow Sensor has the same connector as the Pulse Generator connector and can be hooked up backwards (See Figure 9).

Correction: Swap the connector plugging into the Air Flow Sensor with the connector plugging into the Pulse Generators.

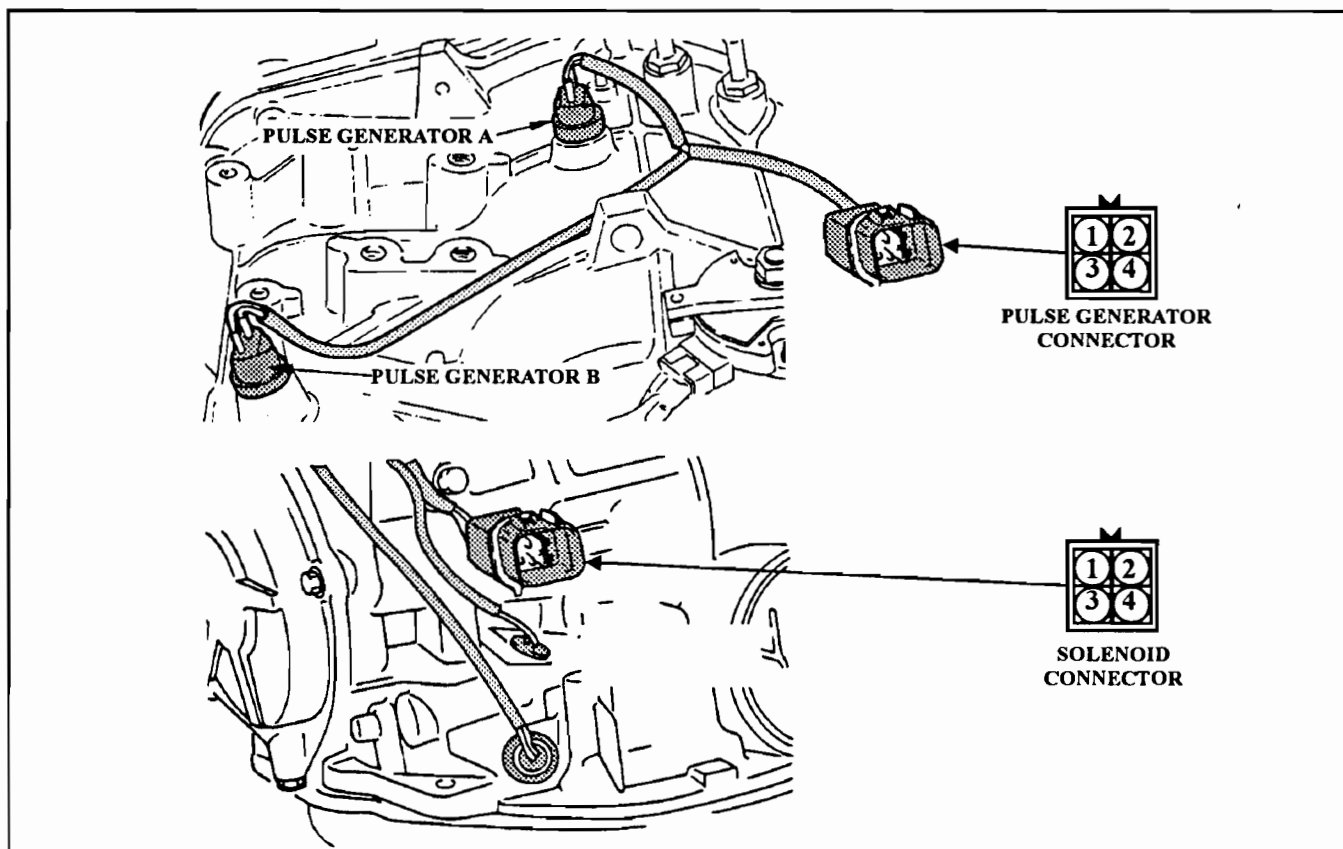
Figure 10

Cause: Some F4A units have the same connector configurations for both the pulse generators and solenoids. This allows the opportunity to plug the external harness into the wrong transaxle connectors (See Figure 10).

Correction: Swap the external wiring harness connector plugged into the pulse generator connector with the solenoid connector.

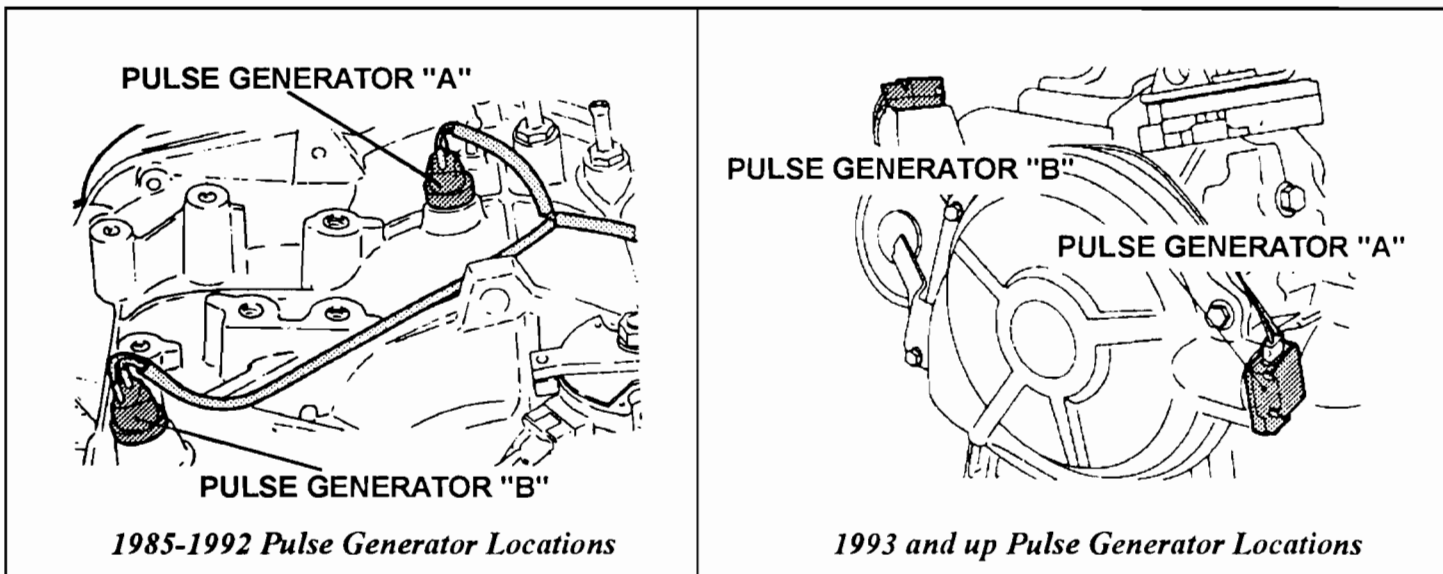
Figure 11

Cause: The wrong design transaxle was installed and the TCU does not receive the proper pulse generator A signal. 1985 to 1992 transaxles had pulse generator A sending a pulse signal from the sunshell to the TCU. The sunshell would stop moving in 2nd and 4th gears when the band is applied. In 1993, pulse generator A was moved to the end cover to read turbine shaft speed. The turbine shaft is constantly sending an rpm reading via the pulse generator in all forward and reverse movement. When this second design transaxle (Pulse Generator A reading the turbine shaft) is installed in a first design vehicle, the TCU receives a signal in 2nd and 4th gears and interprets this signal as a slip. When the first design transaxle is installed in a late design application, pulse generator A provides a 0 rpm signal to the TCU in 2nd gear. The TCU failsafe's the transaxle to third gear.

Correction: Identify the year of the vehicle by build date and install the proper transaxle. 1985 to 1992 have pulse generator A reading the sun shell. 1993 and up have pulse generator A in the end cover (See Figure 11).

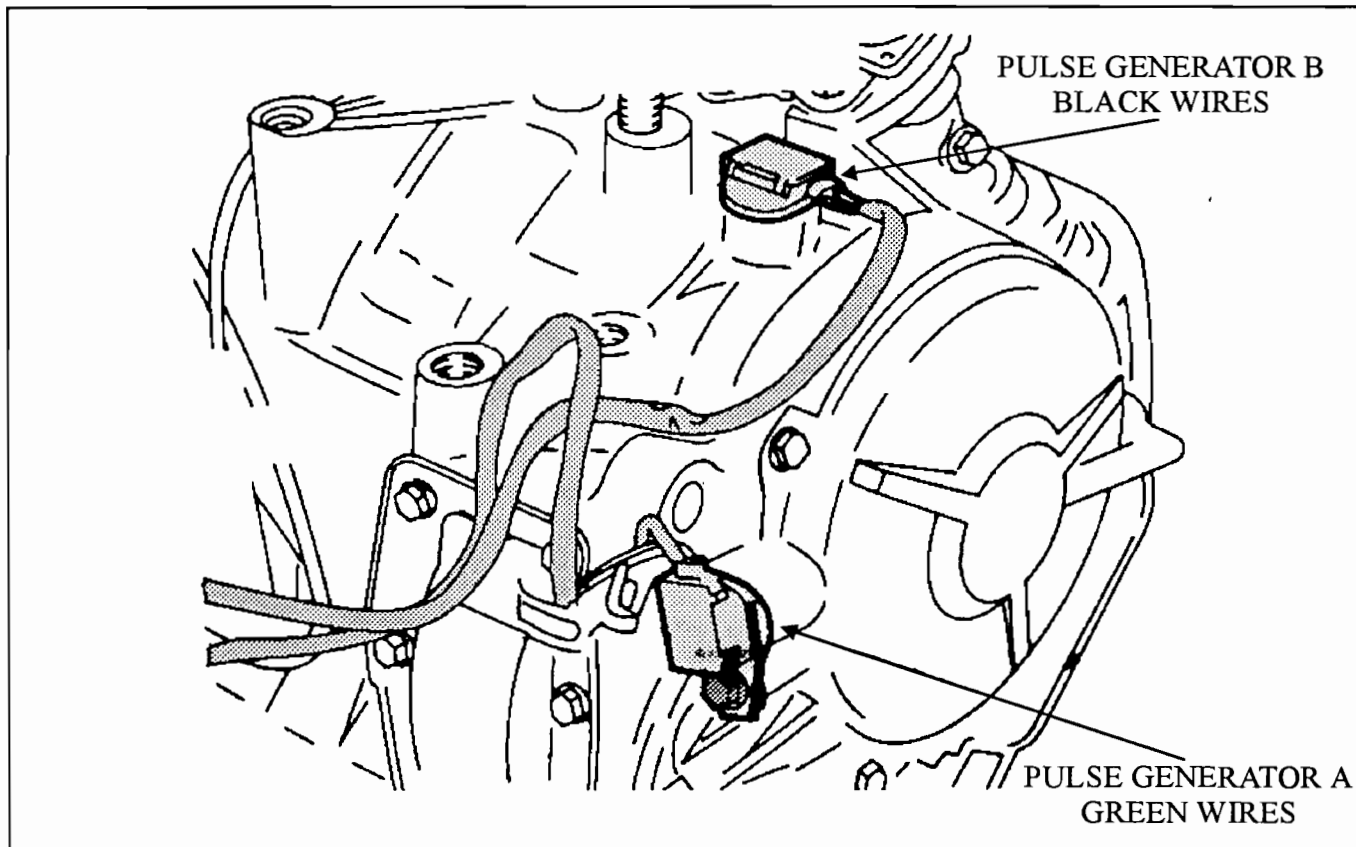
Figure 12

Cause: One cause may be that the pulse generators have been installed backwards. The qualification is that this is only applicable with units that have the pulse generator A moved to the end cover to read the turbine shaft (See Figure 12). With the pulse generators plugged in backwards, pulse generator B is now reading the turbine shaft and the computer thinks the vehicle is moving forward when reverse is selected. A safety design is built into the TCU to prevent reverse from engaging while a forward motion is detected.

Correction: Swap the pulse generator wires so that the solid green wires go to the end cover and the solid black wires go to the top of the case (See Figure 12).

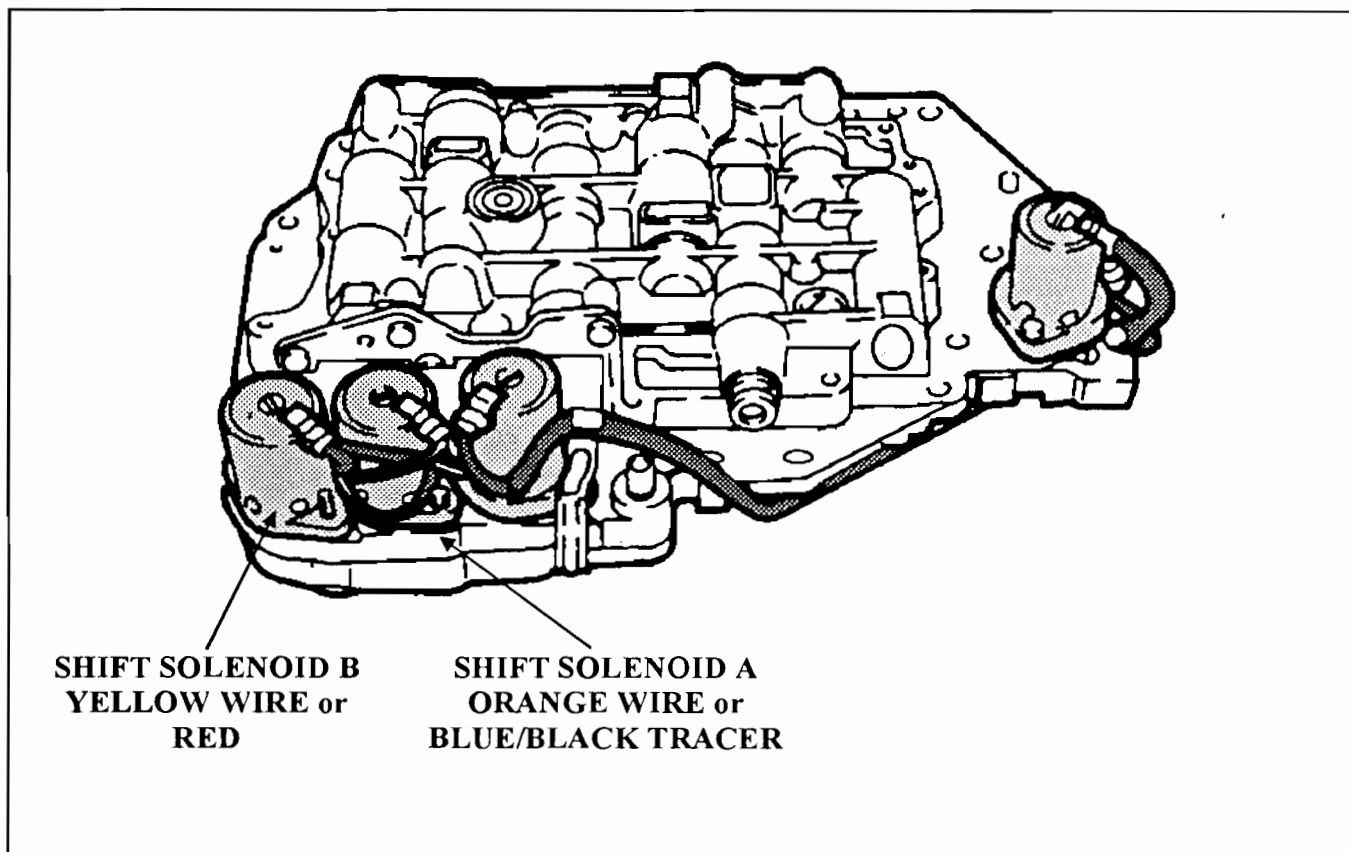
Figure 13

Cause: One cause may be that shift solenoid A and B have been mis positioned.

Correction: Swap shift solenoids A and B. On Mitsubishi and Chrysler units, shift solenoid A can be identified with an orange wire and shift solenoid B has a yellow wire. Hyundai units use a blue wire with a black stripe for shift solenoid A and a red wire for shift solenoid B (See Figure 13).

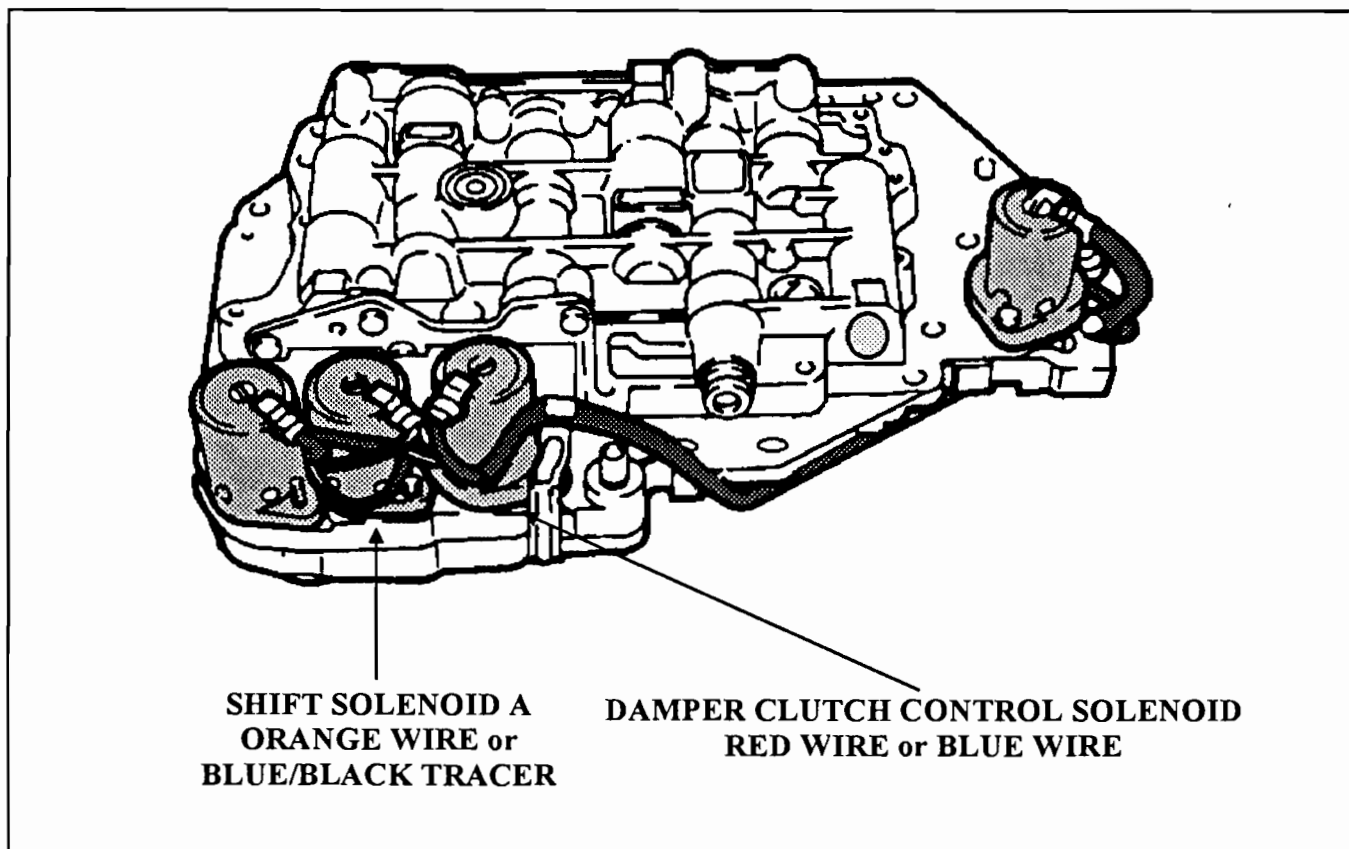
Figure 14

Cause: One cause may be that shift solenoid A and the damper clutch control solenoid have been mis positioned. When the accelerator pedal is not depressed, the TCU energizes shift solenoid B to put the transaxle in 2nd gear. This prevents engine creeping when stopped. As soon as the accelerator pedal is depressed, the TCU energizes shift solenoid A for a first gear take off. If shift solenoid A was placed in the damper clutch control solenoid location, this would engage the converter clutch and stall the engine.

Correction: Swap shift solenoid A and with the damper clutch control solenoid. Shift solenoid A can be identified with either an orange wire or a blue with a black tracer wire. The damper clutch control solenoid can be identified with either a red wire or a blue wire. Another way of identifying the two is by their resistance values. Both shift solenoids measure 20 to 25 ohms while the damper clutch and pressure control solenoid measure 2 to 5 ohms (See Figure 14).

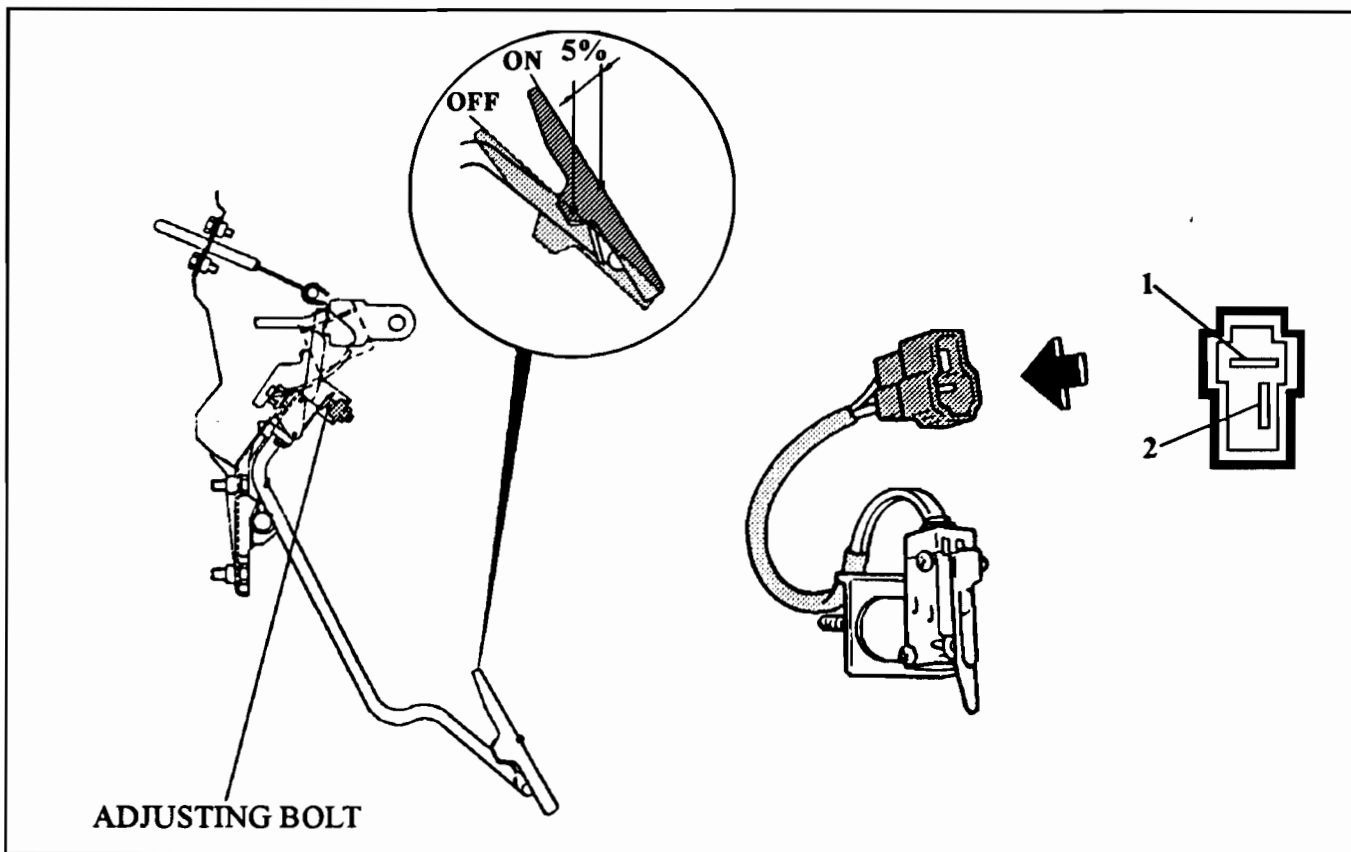
Figure 15

Cause: The accelerator switch is out of adjustment or defective. Another possible cause is that the driver is keeping their foot rested on the accelerator pedal. The reason is that the TCU is programmed to prevent a coast downshift into first gear when coming to a stop. When the accelerator pedal is released and the brake is being applied, the transaxle will coast down to second gear and stay in second gear when stopped to reduce engine creeping. When the accelerator pedal is depressed, the switch indicates this action to the TCU and the computer immediately puts the transaxle into first gear for take off. If the accelerator switch is defective, out of adjustment or being constantly depressed, the transaxle will coast down and clunk into first gear when coming to a stop.

Correction: Check the switch for proper operation by placing an ohm meter across terminals 1 and 2 as shown in Figure 24 below. Continuity should be seen with the pedal released and go to open when the pedal is depressed approximately 5%. The switch can be adjusted using the adjustment bolt shown in Figure 15. If the switch can not be adjusted, replace the switch.

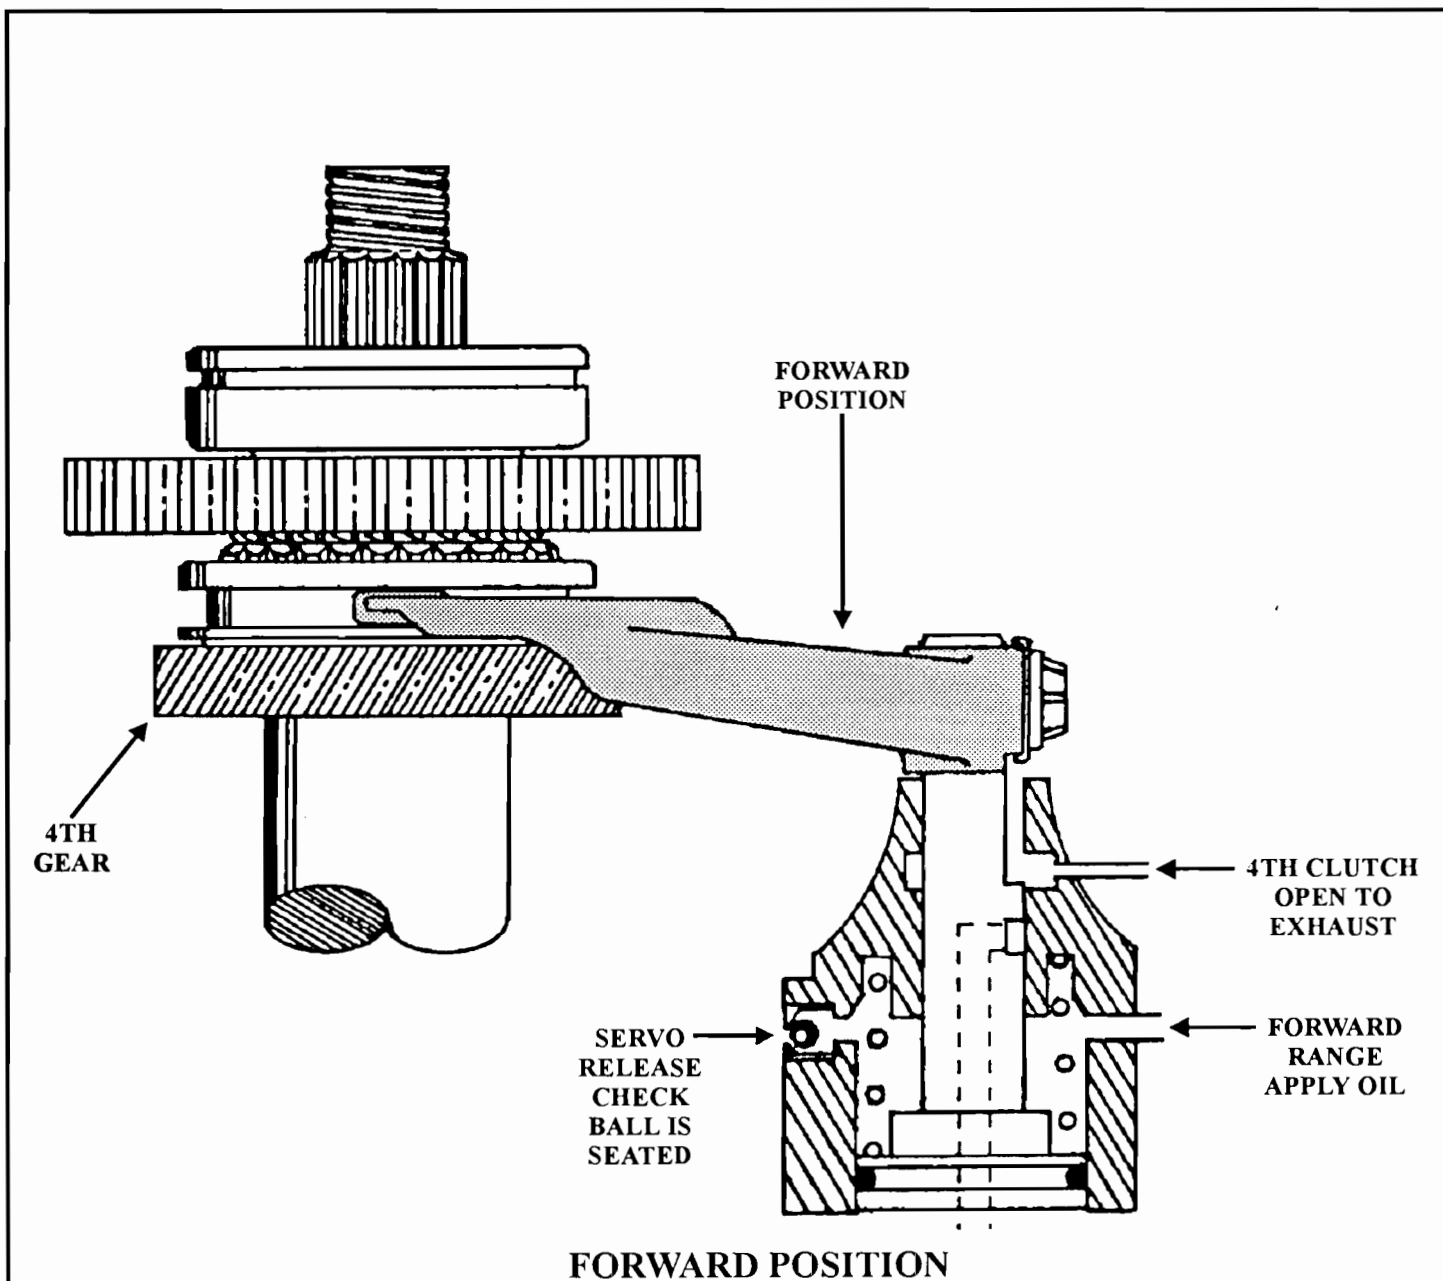
Figure 16

- 8- A worn servo body.**
- 9- Grooves cut into the 4th clutch drum by the steel plate lugs or
Grooves cut into the 4th clutch hub by the friction plate teeth.

- 7- Make certain Linkage is adjusted properly and is tight.
- 8- Check clearance between reverse servo shaft and servo body and replace servo body if necessary. (Refer to figures 16 and 17)**

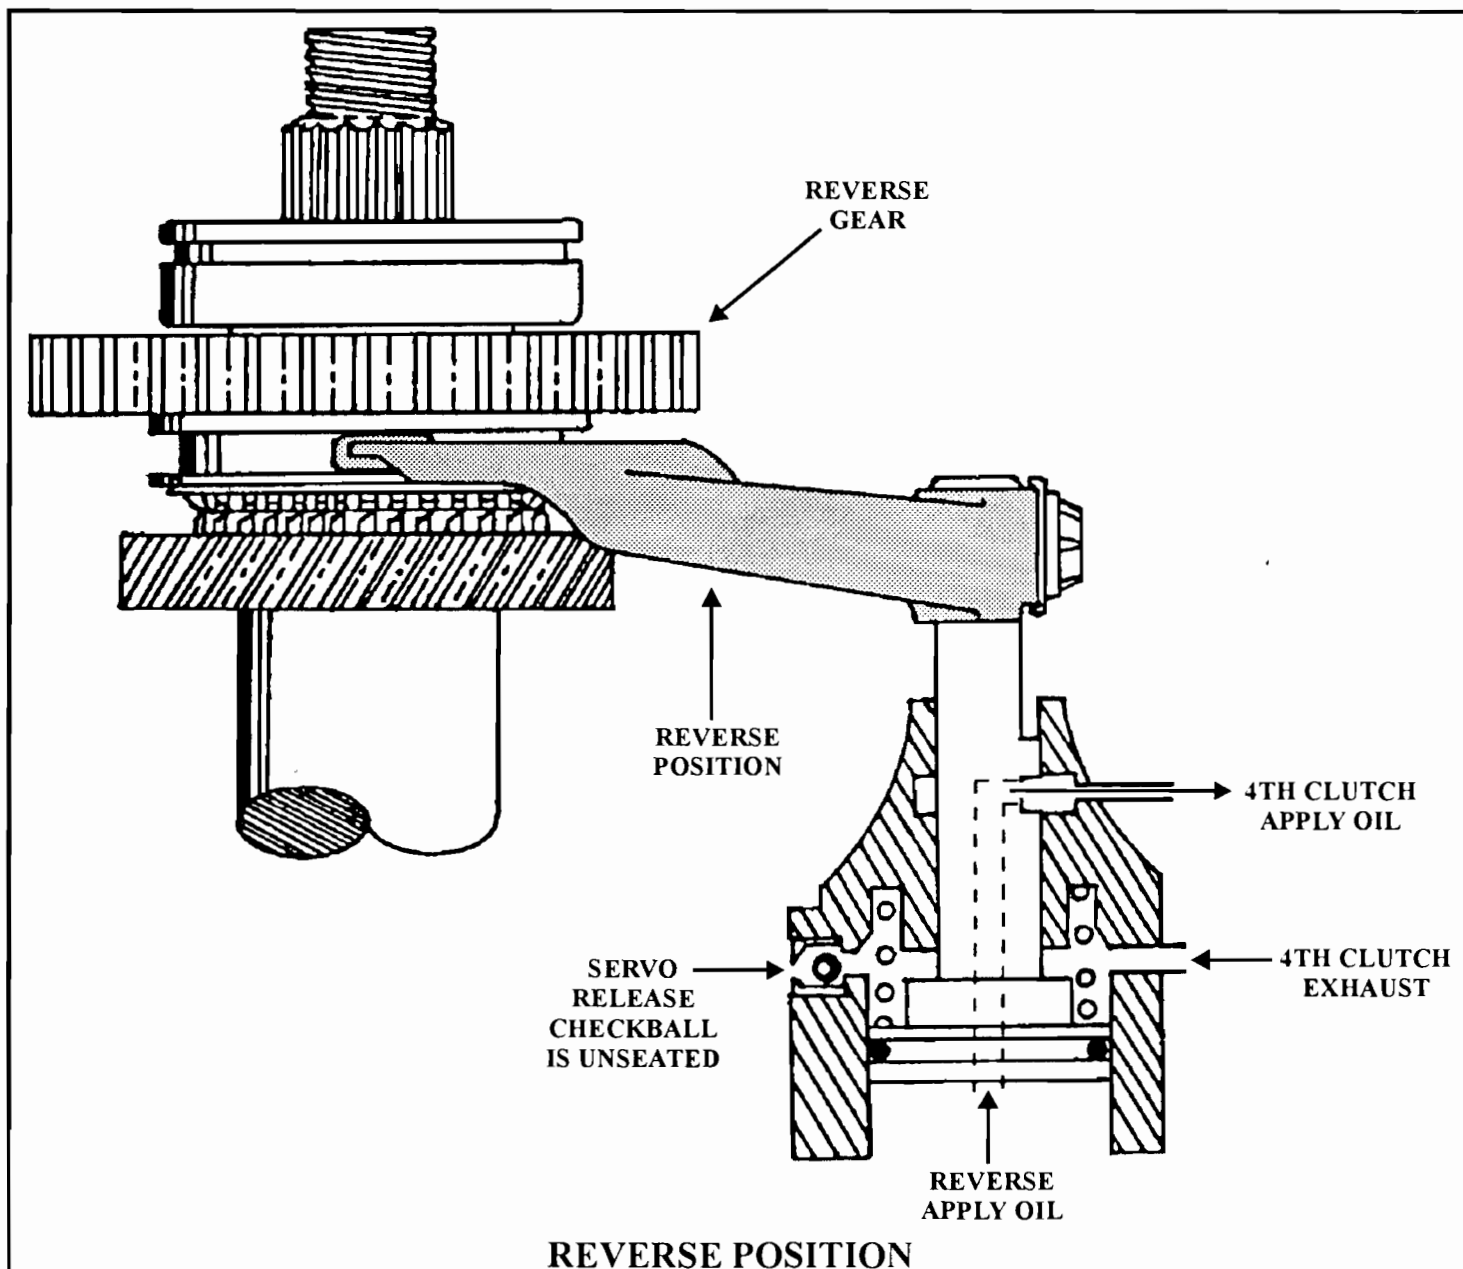
Figure 17

At this time, if there is significant leakage between the servo shaft and the servo body, 4th clutch oil will not be able to exhaust and the 4th clutch will not be able to release which will keep the mainshaft engaged resulting in

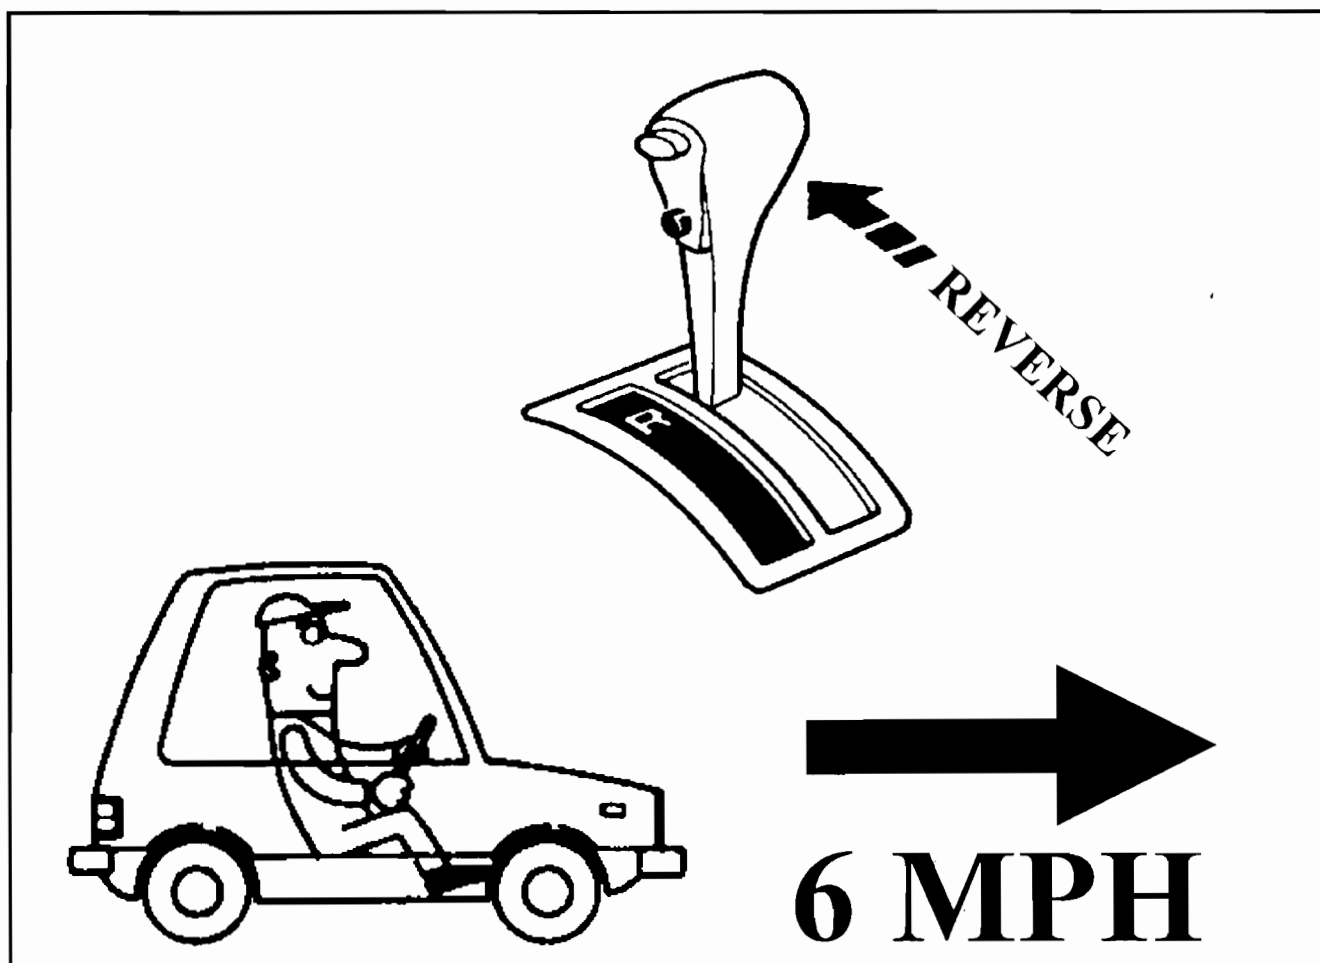
Figure 25

CAUSE: Most solenoid shifted Honda/Acura transaxles have a REVERSE INHIBITOR feature which prevents reverse engagement should reverse be selected while the vehicle is moving forward at a speed greater than 6 mph. (Refer to figure 25)
If the Vehicle Speed Sensor is faulty and is showing vehicle speed above 6 mph, causing the transaxle computer to think the vehicle is moving faster than 6 mph, reverse will be prevented because the computer will command 1st gear causing the 1-2 shift valve to block oil from operating the reverse servo and the 4th clutch.

CORRECTION: Check the VSS with a volt or ohm meter. If the meter never drops to 0 volts or Infinity on the OHMS scale when the front wheels are rotated by hand, replace the Vehicle Speed Sensor.

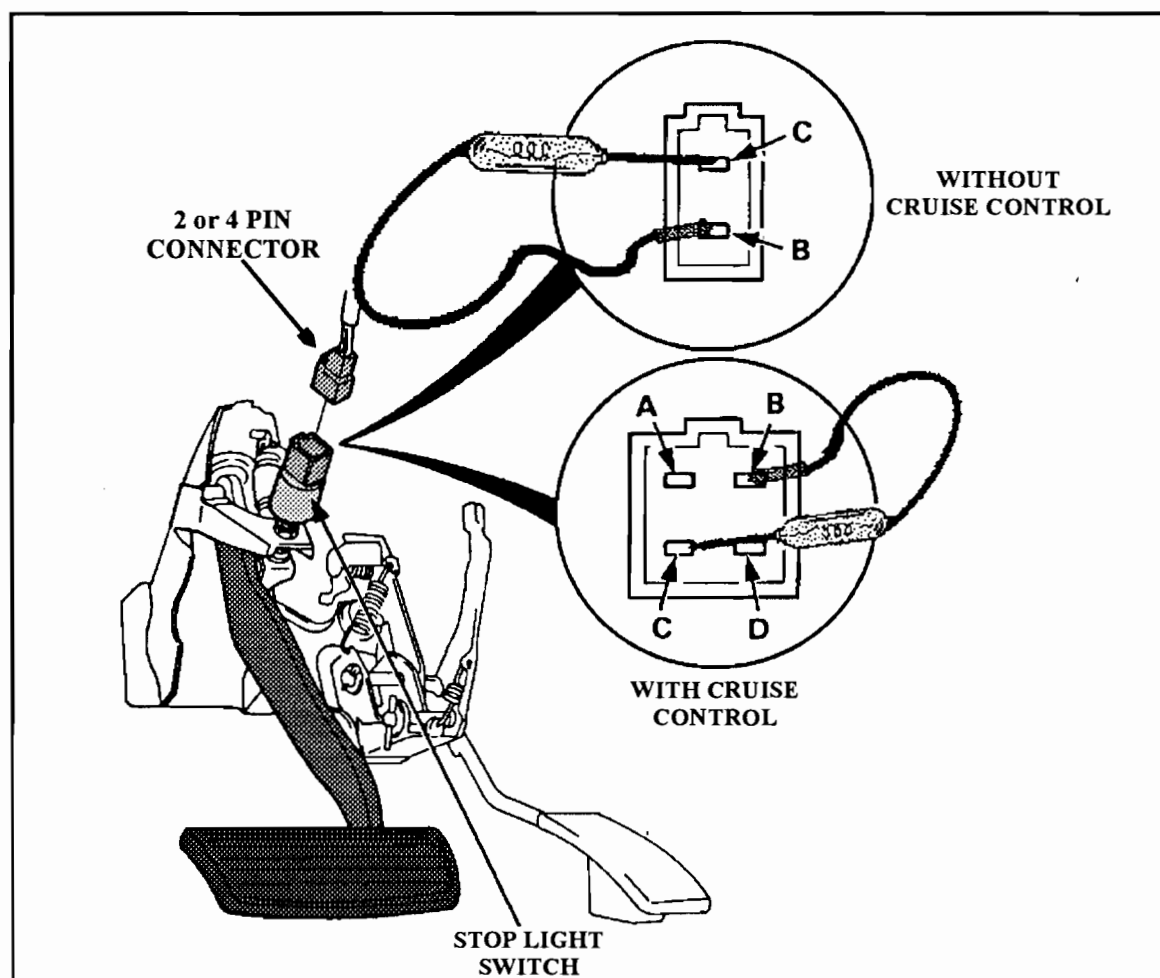
Figure 26

CAUSE: This can be caused by a faulty stop light switch. On most solenoid shifted Honda/Acura transaxles the A/T Control Unit will command 2nd gear when the brake pedal is depressed, thereby preventing vehicle creep. If the stop light switch is stuck on, the A/T Control Unit will not command 1st gear when the brake pedal is released, causing the vehicle to pull off in 2nd gear.
The stop lights may also remain on even though the brake pedal is released.

CORRECTION: Check for battery voltage at terminals "B" and "C" at the stop light switch connector as shown in figure 26. If battery voltage is present when the brake pedal is released, check the "B" and "C" wires for a short to power. If none exists, replace the stop light switch.
