1996 SEMINAR INFORMATION

"THE BEST FIX IN '96"

AUTOMATIC TRANSMISSION SERVICE GROUP
9200 S. DADELAND BLVD. STE 720
MIAMI, FLORIDA 33156
(305) 670-4161

INTRODUCTION

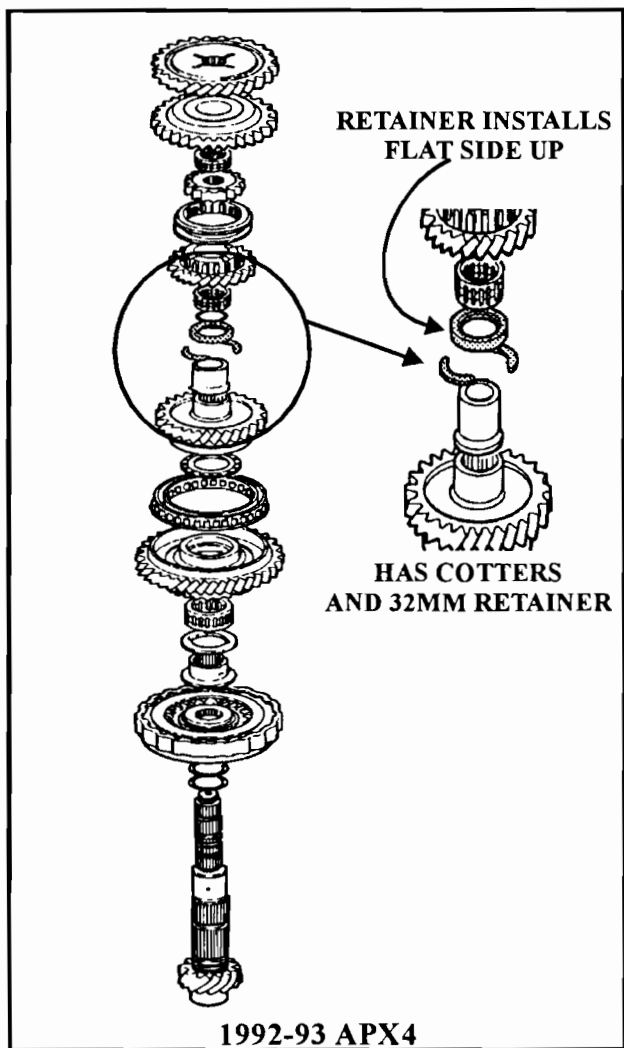
Figure 27

CAUSE: The 32mm cotter retainer located on the countershaft has been installed upside down (Refer to figure 27) causing all endplay in the countershaft to be removed.
The countershaft is now bound up resulting in a reverse bind-up condition.

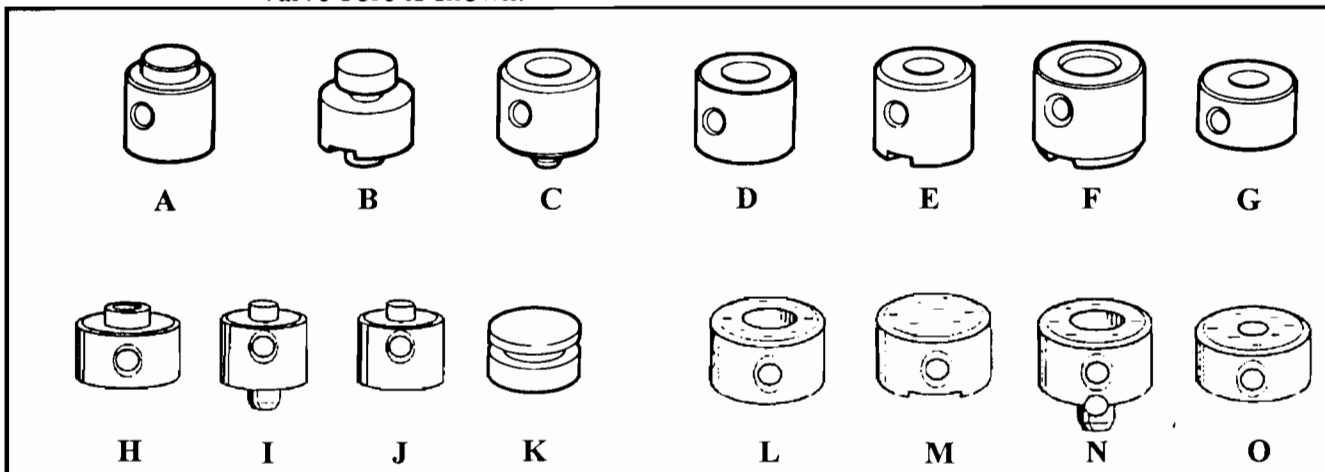
Figure 29

CAUSE: A bore plug that is installed in the wrong bore or one that is installed backwards.

CORRECTION: If the valves have to be removed for cleaning, keep the bore plug with the valve it goes with and refer to figure 29 where the various types of bore plugs are illustrated and the correct direction in which they are to be installed in the valve bore is shown.

- A-**Plugs with 1 projected tip and 1 flat end are installed with the flat end toward the spring.
- B-**Plugs with a projected tip on each end are installed with the smaller tip toward the spring.

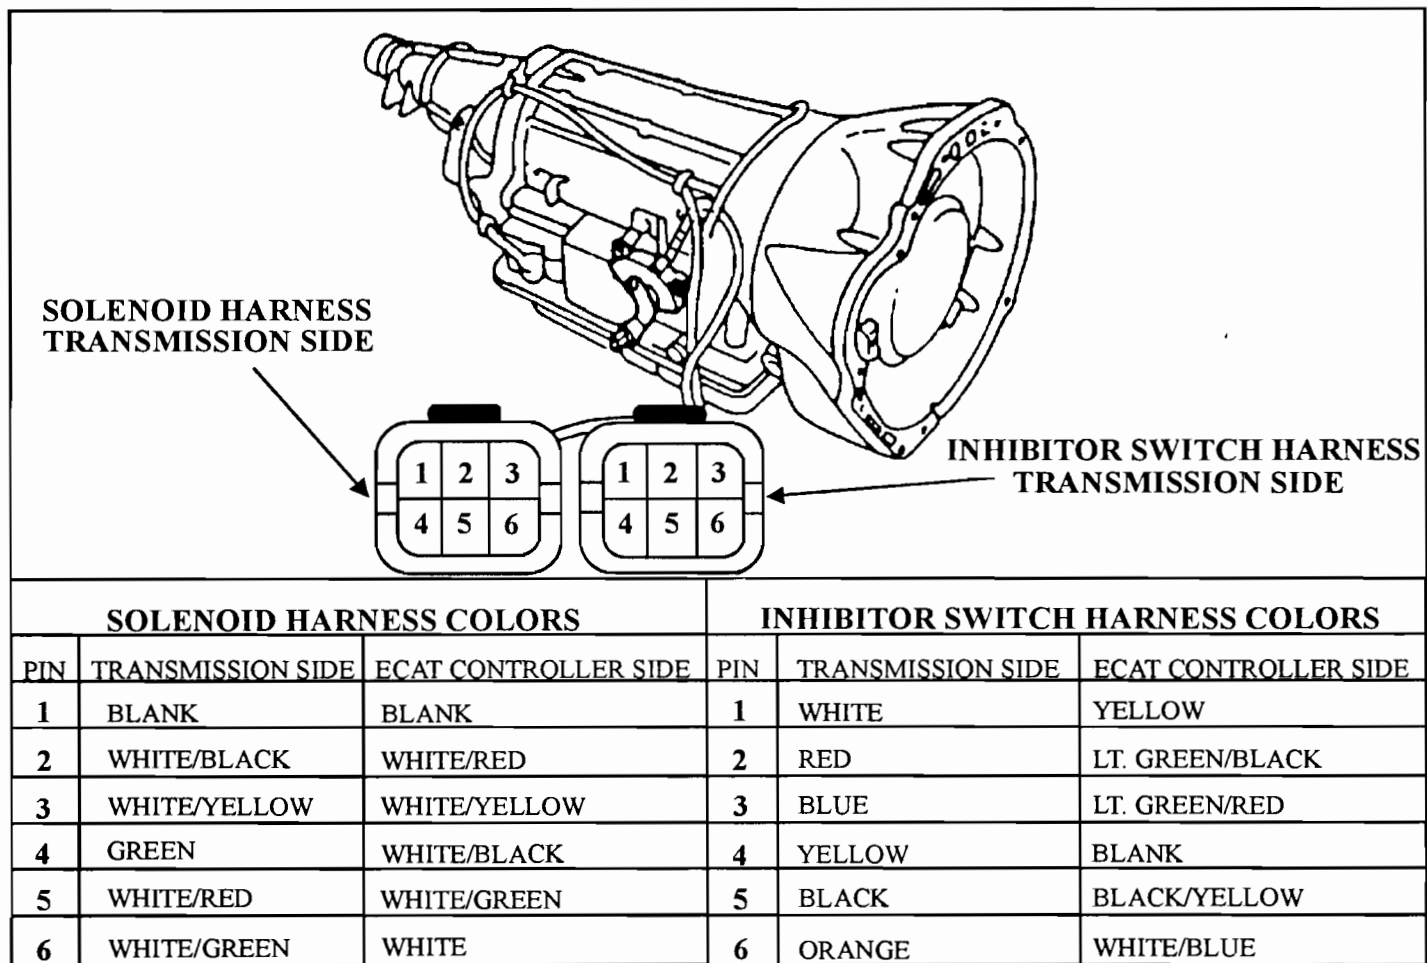
CAUSE: The cause may be, the "Computer" side shift solenoid harness was connected to the "Inhibitor Switch," and the "Computer" side "Inhibitor switch" harness was connected to the shift solenoids. This will result in "NO" voltage sent to the shift solenoids, a 3rd gear start in the Drive range. This will also result in "Trouble Codes" being stored and causing the "HOLD" light to flash because the ECAT control unit now will see "Open Circuit's" at the solenoid wiring harness.

CORRECTION: Refer to Figure 33 to correctly identify "Inhibitor Switch" and "Solenoid" common wiring colors and switch the "Computer" side connectors to cure the problem.

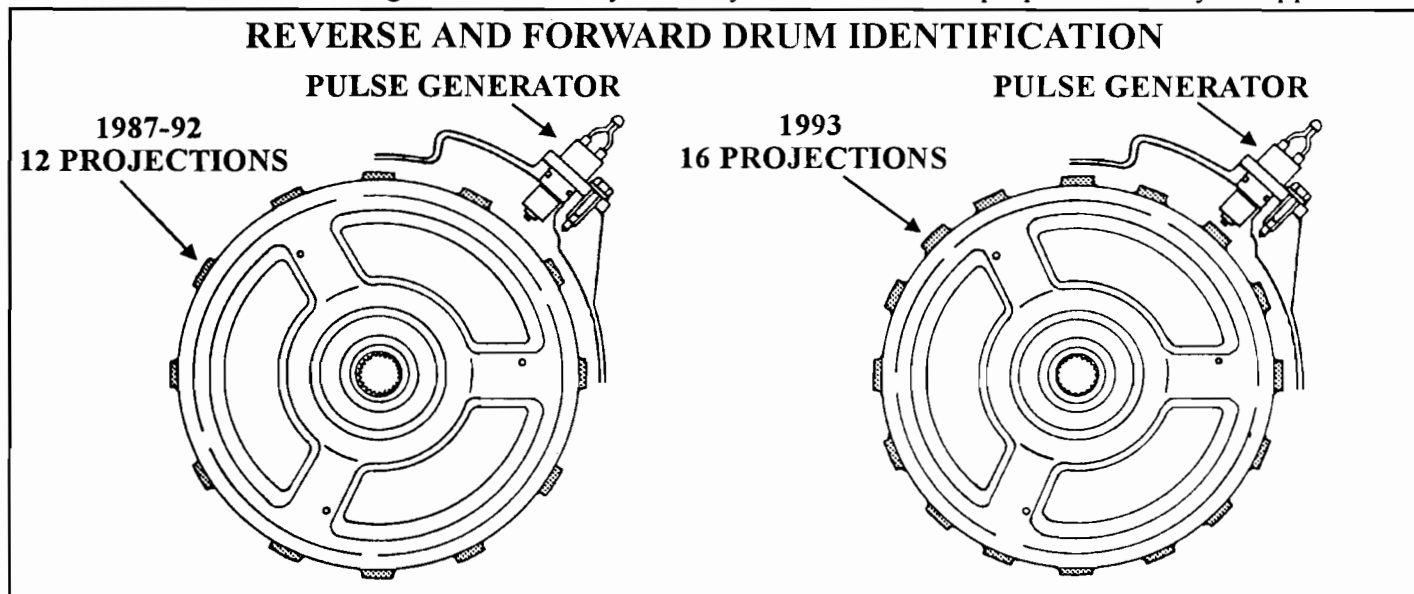
Figure 34

CAUSE: The cause may be, a mismatched 1993 Reverse and Forward drum was installed into as 1987-92 vehicle. **REASON:** 1987-92 Reverse and Forward drums have 12 "Projections." 1993 Reverse and Forward drums have 16 "Projections." These "Projections" are picked up by the "Pulse Generator" converting drum or turbine speed into an A.C. current or frequency that is sent to the ECAT computer. When a 16 "Projection" drum is installed into an 1987-1992 vehicle, drum or turbine speed will automatically be faster and may change shift strategy. (See Figure 34)

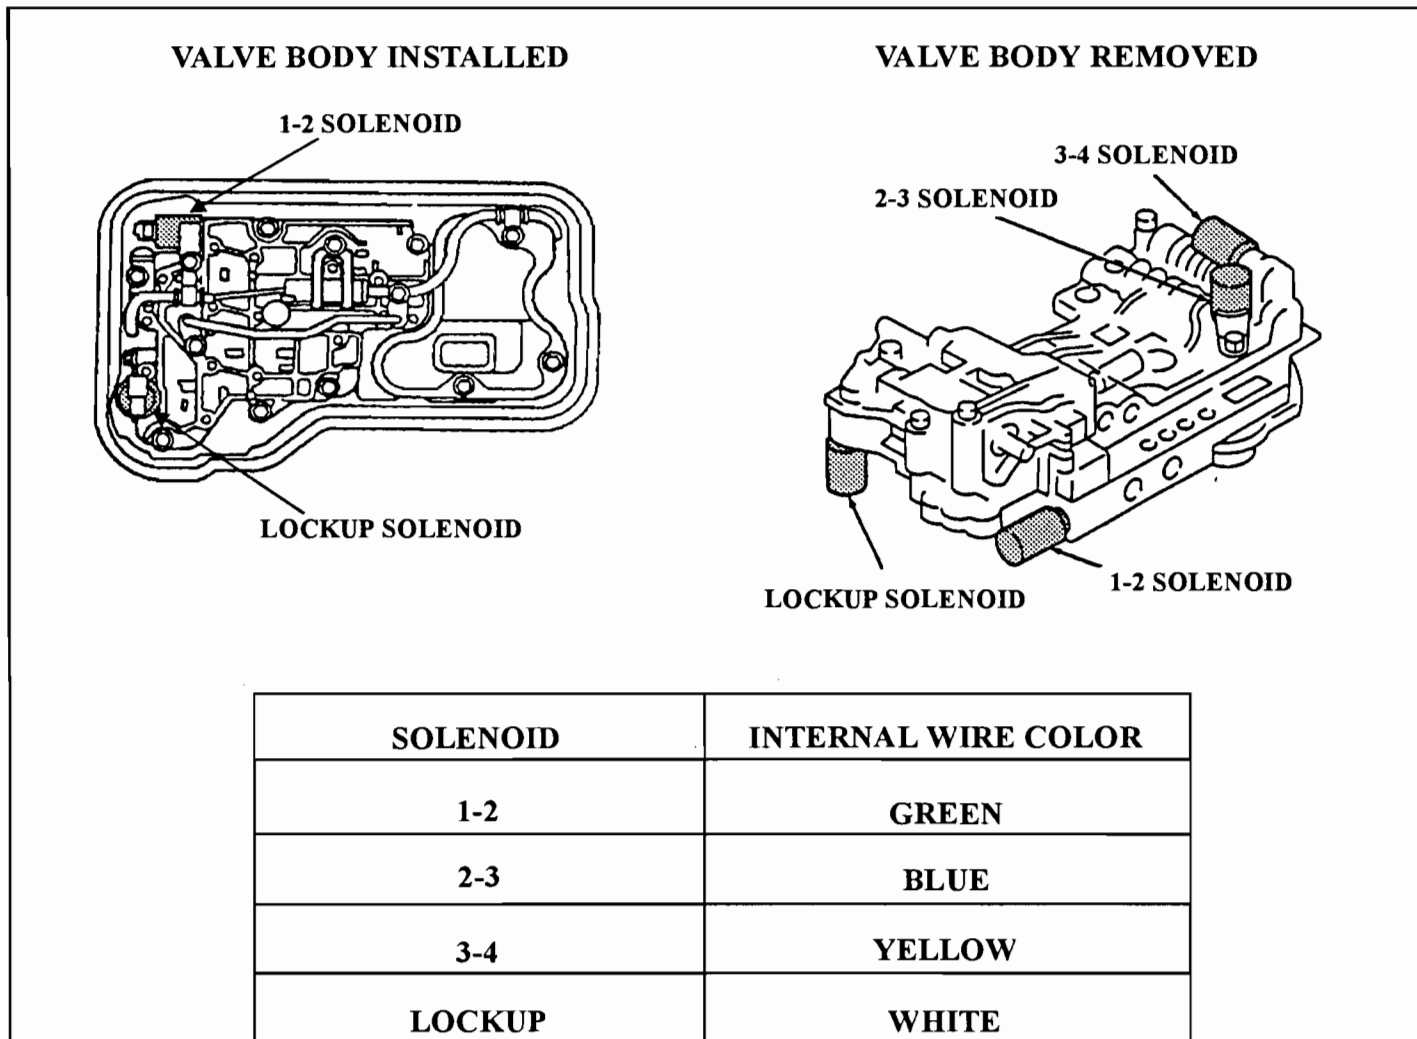
CAUSE: The cause may be, the 1-2 shift solenoid wire was placed into the Lockup solenoid and the Lockup solenoid wire was placed into the 1-2 shift solenoid. When the solenoids are connected backwards it produces a 1-Lockup-3 upshift.

CORRECTION: Refer to the color code and solenoid application chart in Figure 45 to correctly identify and connect each solenoid.
