Technical Service Information

DODGE/CHRYSLER/JEEP 45RFE NO MOVEMENT AFTER OVERHAUL

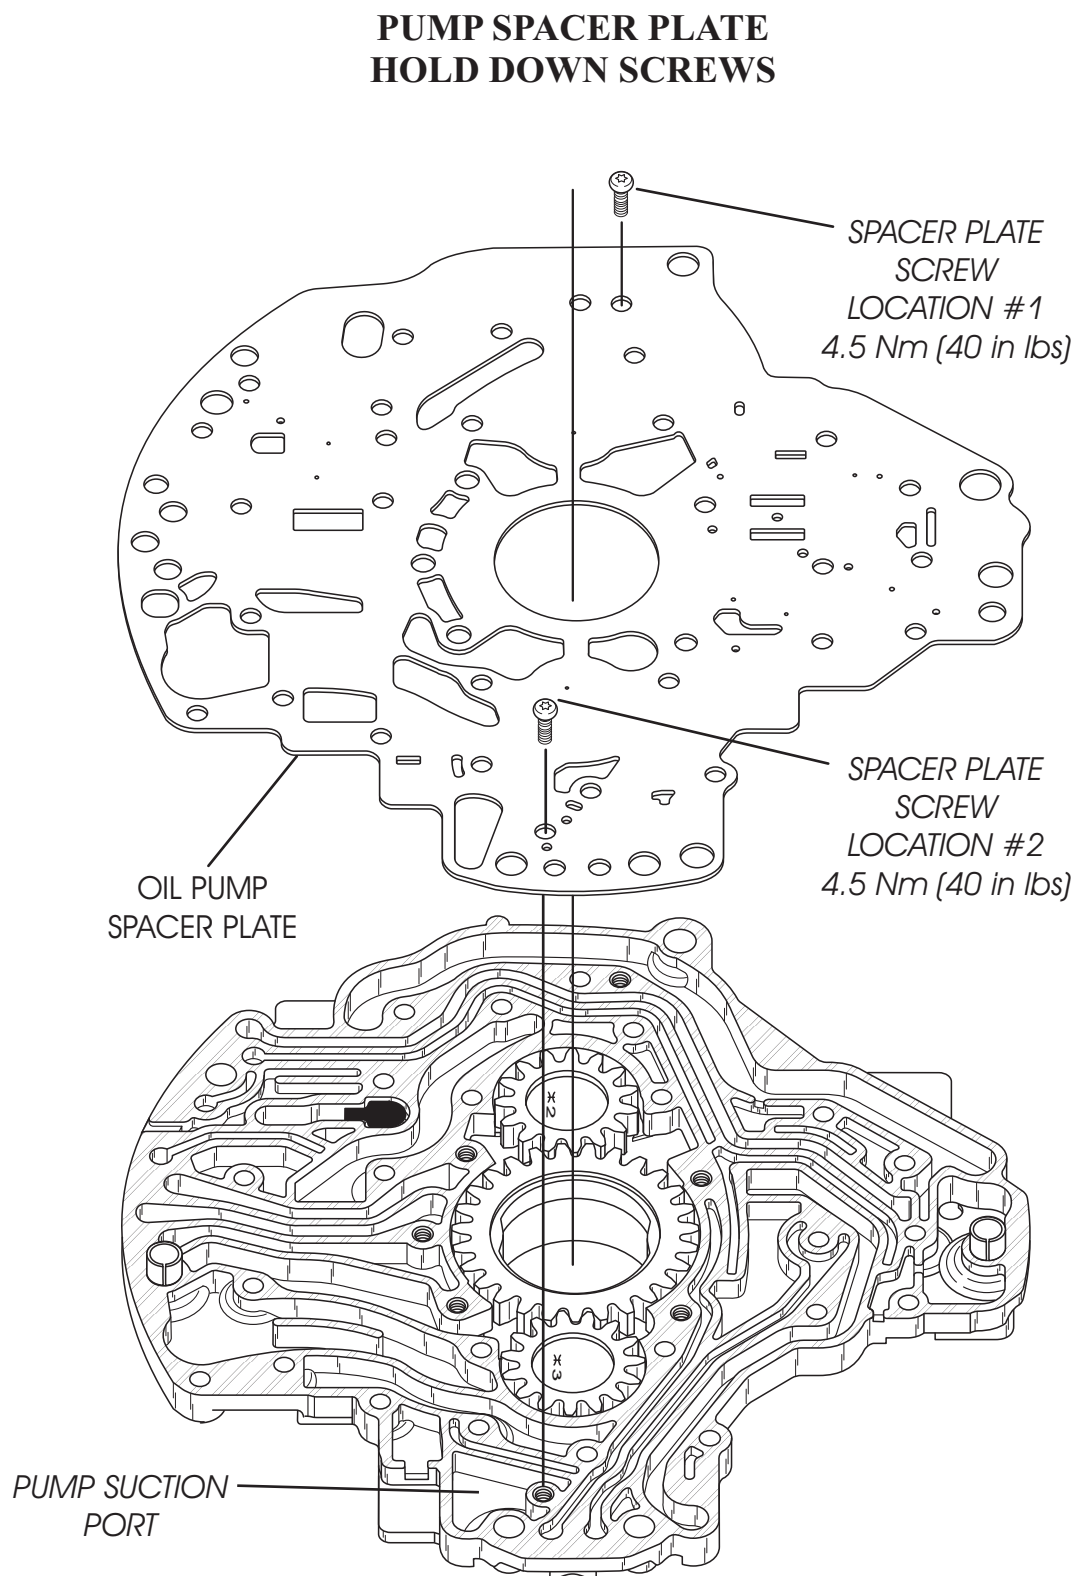
Figure 1

CAUSE: One cause may be the Pump Spacer Plate Hold Down Screws in the pump assembly missing. With all the bolts holding this pump together, a brief glance at the pump spacer plate hold down screws may make them appear unnecessary, however, when the location of one of the screws is taken into consideration, their necessity is understood. The pump spacer plate hold down screw locations are shown in the diagram in Figure 1. Take a look at the Spacer Plate Screw Location #2. This Spacer Plate Screw location is directly adjacent to the Pump Suction Port. With this screw missing from the plate, a hole/leak of approximately .190" is immediately opened in the pump suction circuit. Much like having a tremendous amount of pump gear clearance. This huge leak flows to the outside of the pump and creates enough of an air leak that the pump cannot create enough vacuum to pick up transmission fluid from the pan through the filter.

CORRECTION: Install and tighten the Pump Spacer Plate Hold Down Screws to 4.5 Nm (40 in lbs).
