# Technical Service Information

## FORD/MAZDA CD4E/LA4A-EL CONTINUOUS FRONT SEAL LEAK OR SEAL BLOW-OUT

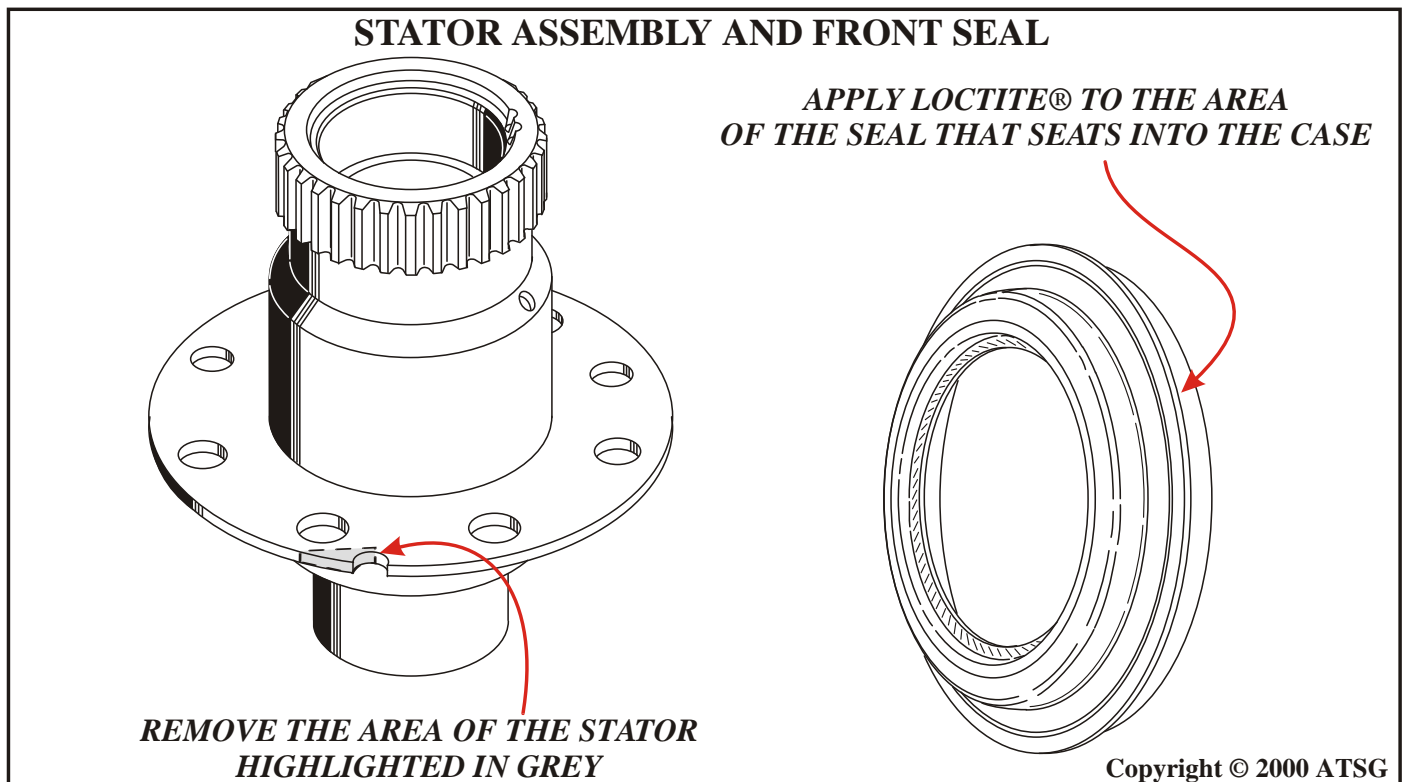
Figure 1

**CAUSE:** One cause may be, an undersized front seal drain back passage in the bellhousing, and another cause may be that the wrong torque converter was installed in the vehicle.

1. Remove the stator from the front of the bellhousing. Remove the area highlighted in gray, as shown in Figure 1, with a bench grinder.
- Note: Heating the bellhousing up in a parts washer will ease Stator removal.*
2. With a 3/16" or 13/64" drill bit, drill at an angle through the area shown in Figure 2.
3. Refer to Figure 3 to see the modified drain back passage from the front side of the bellhousing.
4. Apply Loctite ® to the front seal outer diameter before installing it in bellhousing, as shown in Figure 1.
5. Remove the transaxle if necessary, and ensure that the proper torque converter has been installed for the vehicle. Refer to Figure 4 for proper converter identification.

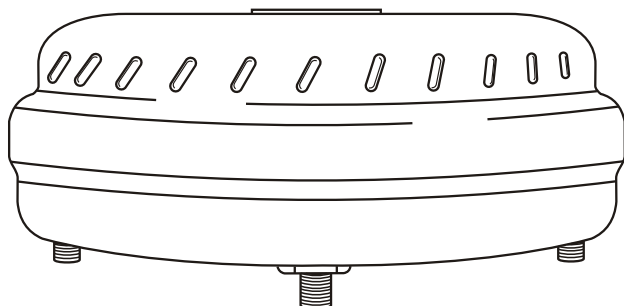
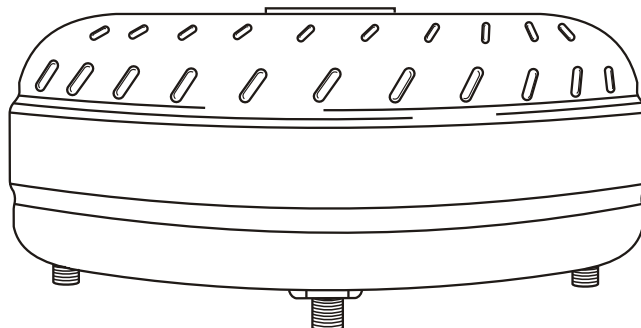
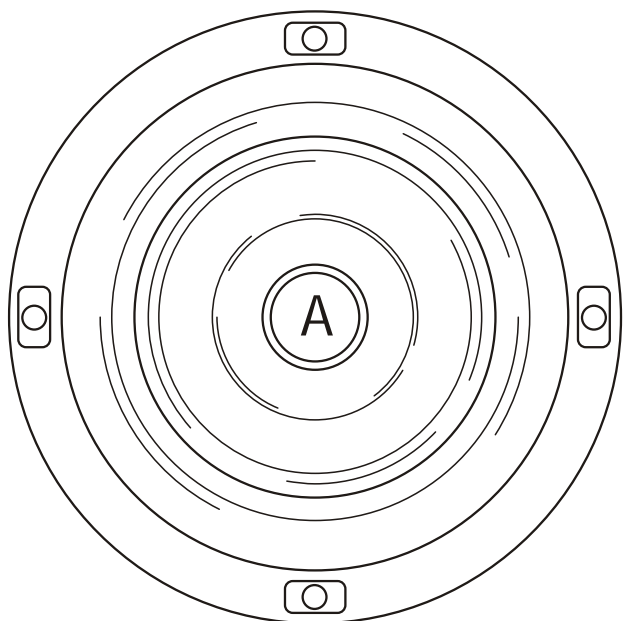
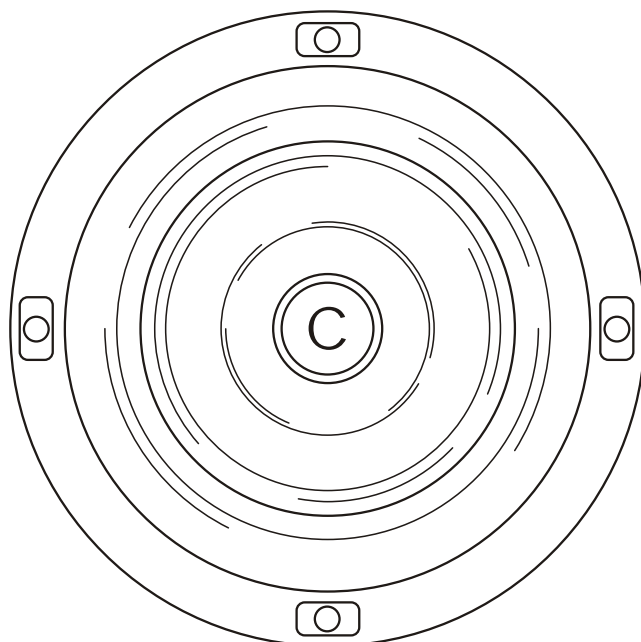
Figure 4

PART NUMBER	F-67	F-69
DIAMETER	10.50"	11"
HEIGHT	3.710"	4.125"
STAMP	"A"	"C"
MODEL	PROBE 626 MX6 CONTOUR MYSTIQUE	CONTOUR MYSTIQUE
ENGINE SIZE	2.0L	2.5L
