"2008" SEMINAR INFORMATION

AUTOMATIC TRANSMISSION SERVICE GROUP

"Shiftin' Great in 2008" ***Seminar Information***

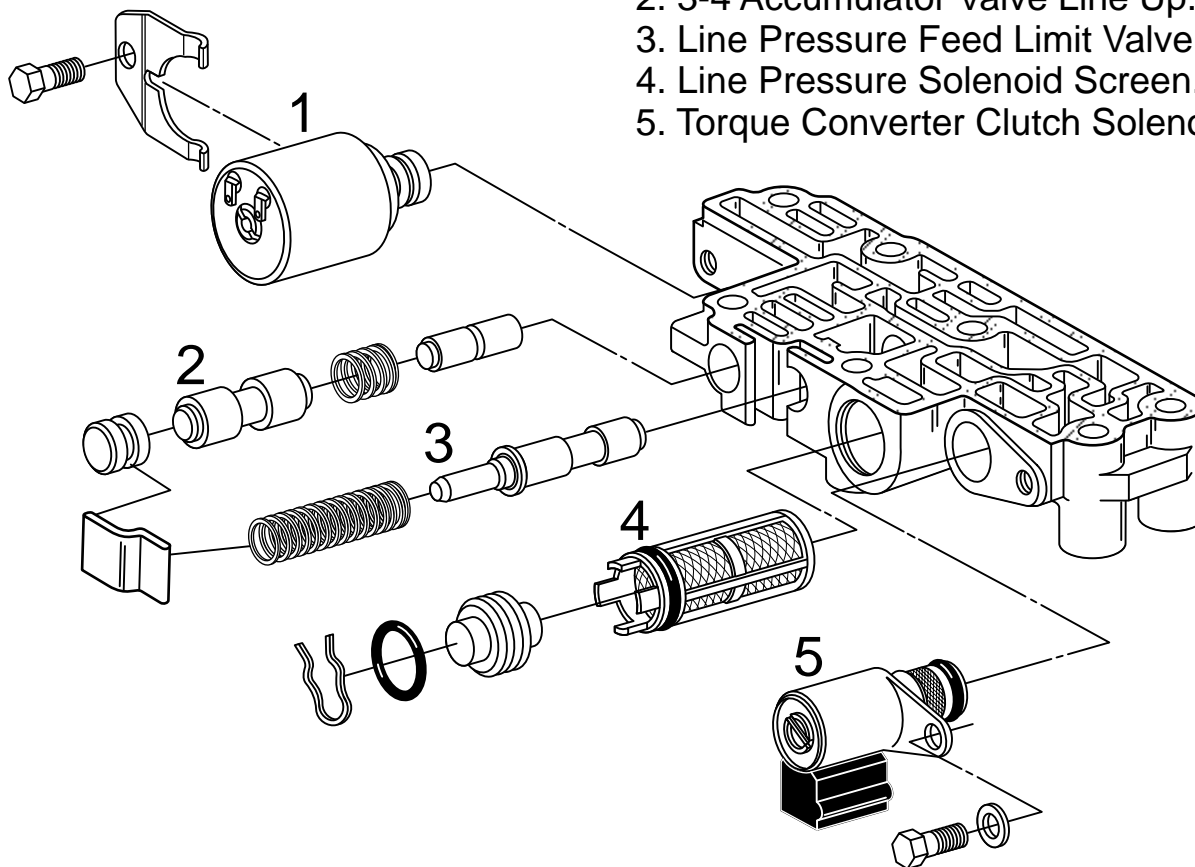
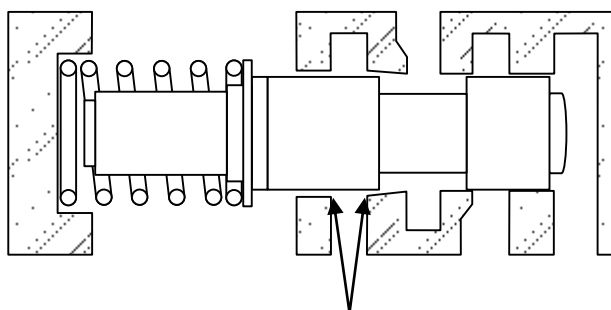
Figure 1

CAUSE: One cause may be a worn Feed Limit Valve bore in the Adapter Case Valve Body.

The responsibility of the Feed Limit Valve is to regulate line pressure before it is fed to the Force Motor/Pressure Control Solenoid. As the valve bore wears, the valve and spring will lose it's ability to regulate properly, as bore wear becomes more severe, excessive exhaust of line pressure occurs creating the soft or flared shifts, slipping and other complaints.

Valve body casting may wear in this location
allowing line pressure to exhaust excessively.

CORRECTION: Replace the Adapter Case Valve Body.

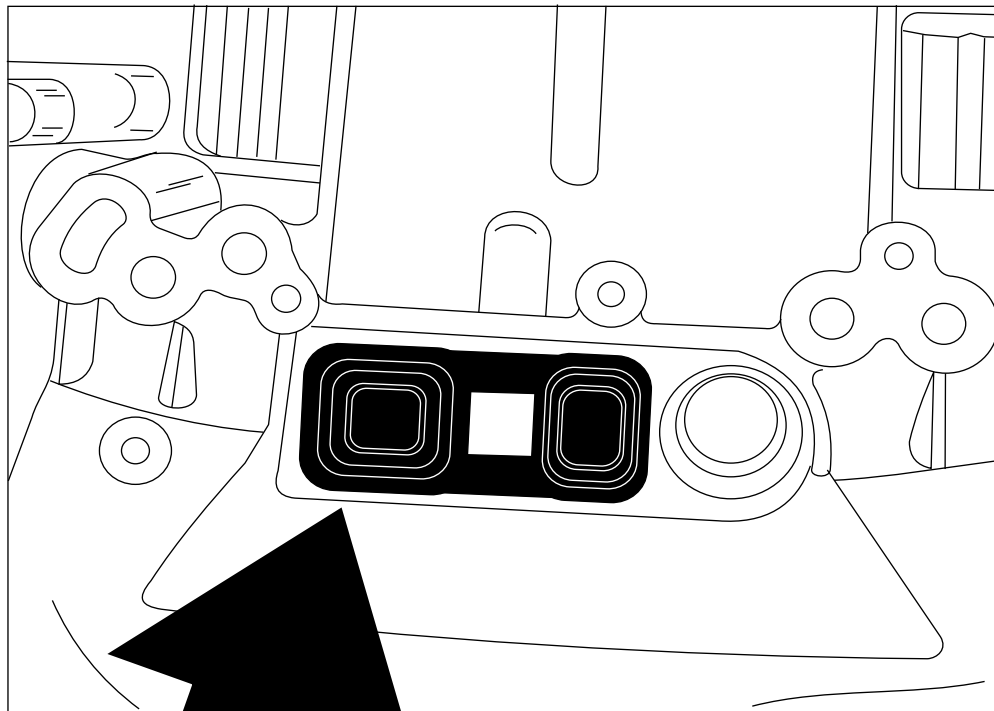
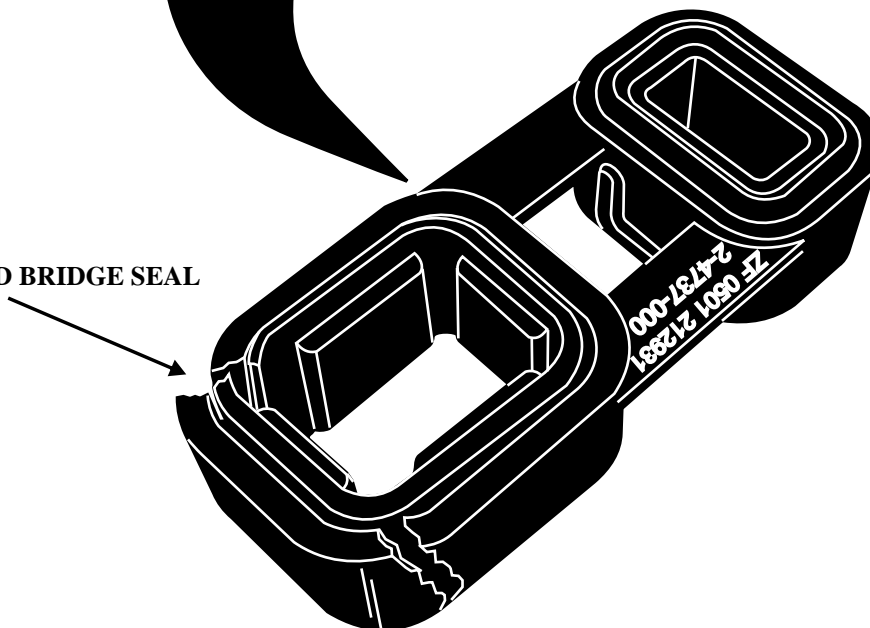
Figure 1

CAUSE: The rubber "bridge seal" that goes between the Mechatronic (valve body) Assembly and the pump had blown out, (Refer to Figure 1).
With the "Bridge Seal" being damaged, a significant loss of system pressure occurred, this caused a lack of sufficient clutch pressure resulting in slippage. The TCM recognized this as the Input Speed Sensor maintained a reading when it should have been zero rpm while in gear with the brakes applied.
At this time the TCM commanded the transmission back into park in an effort to prevent any further transmission damage from occurring.

ENOUGH LINE PRESSURE IS LOST
FROM THE DAMAGED BRIDGE SEAL
TO CAUSE THE TCM TO PUT THE
TRANSMISSION BACK INTO PARK

DAMAGED BRIDGE SEAL

CORRECTION: Replace the bridge seal. BMW vehicles equipped with "shift by wire" are controlled by an "E" type valve body referred to as a "Mechatronic Module". The alternative is an "M" type valve body which has a conventional manual valve and gear selector lever. The "E" type does not have a manual valve, it has a rod that is actuated by solenoids which moves the internal linkage to engage and disengage park as well as other gear selection. There is a pre-loaded barrel spring mounted on a rotating lever that operates the park rod with the tension of the spring pushing the lever and rod into the park position. To release park, the MV3 and MV2 solenoids are energized. (Refer to Figure 2).
The park rod, as well as the location of the MV2 and MV3 solenoids can be seen in Figure 3. The MV3 Solenoid is mounted on the back side of the park lock cylinder which is on the valve body. Inside the cylinder there is a piston which connects to the rotating lever. When the MV3 Solenoid is OFF, a shaft extends out from the solenoid, pushing the rear of the piston and lever into the park position. When a command is requested to release park, the MV3 Solenoid is energized and the shaft retracts. At this time the MV2 Solenoid is also energized and it supplies fluid pressure to a chamber inside the front area of the cylinder which pushes the piston, rotating lever and park rod into the released position.

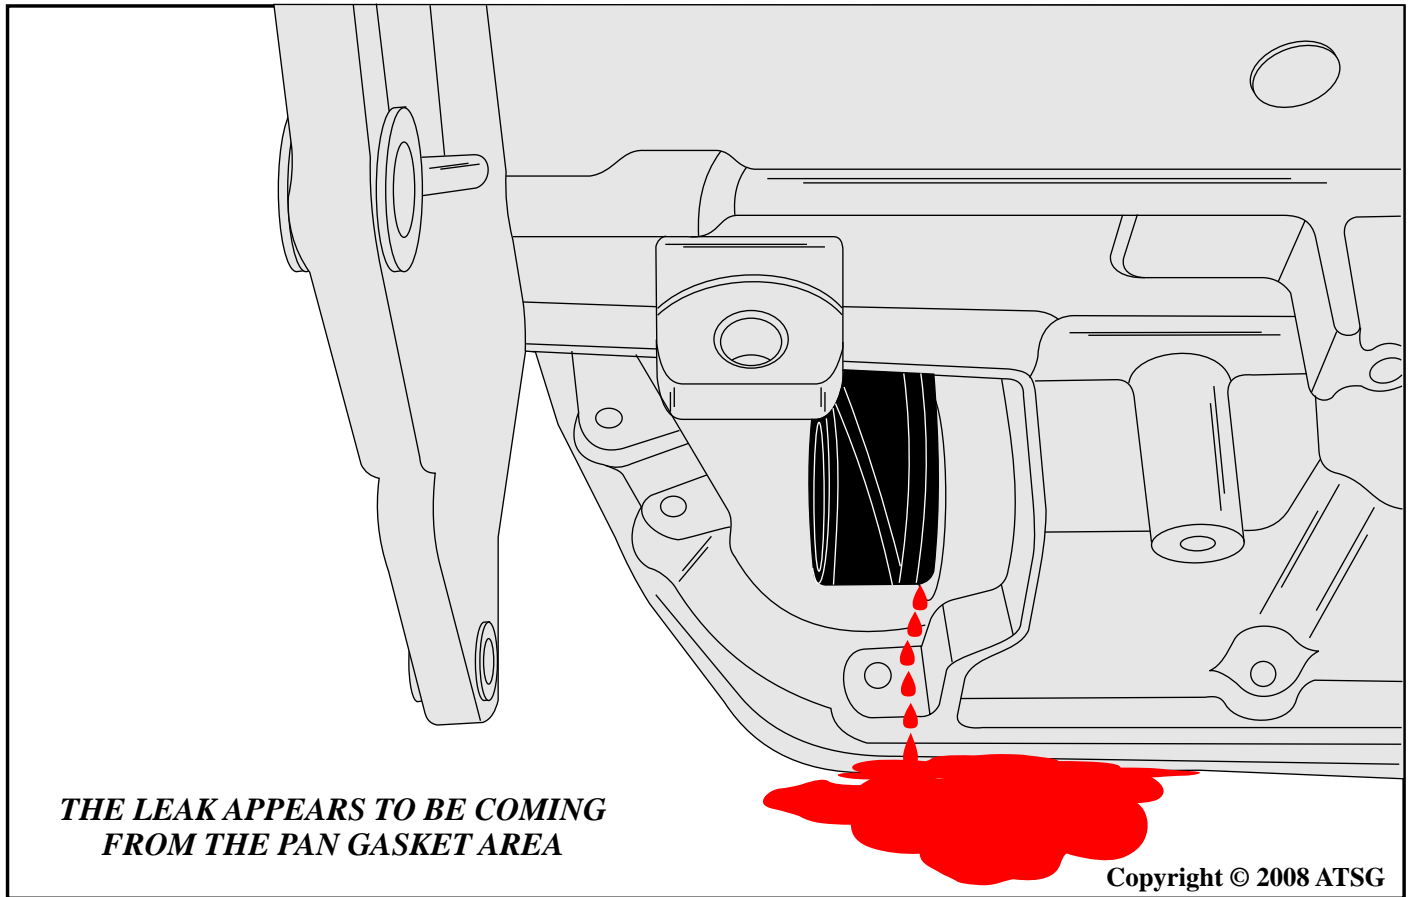
Figure 1

COMPLAINT: The transmission appears to be leaking from the pan gasket, (Refer to Figure 1).

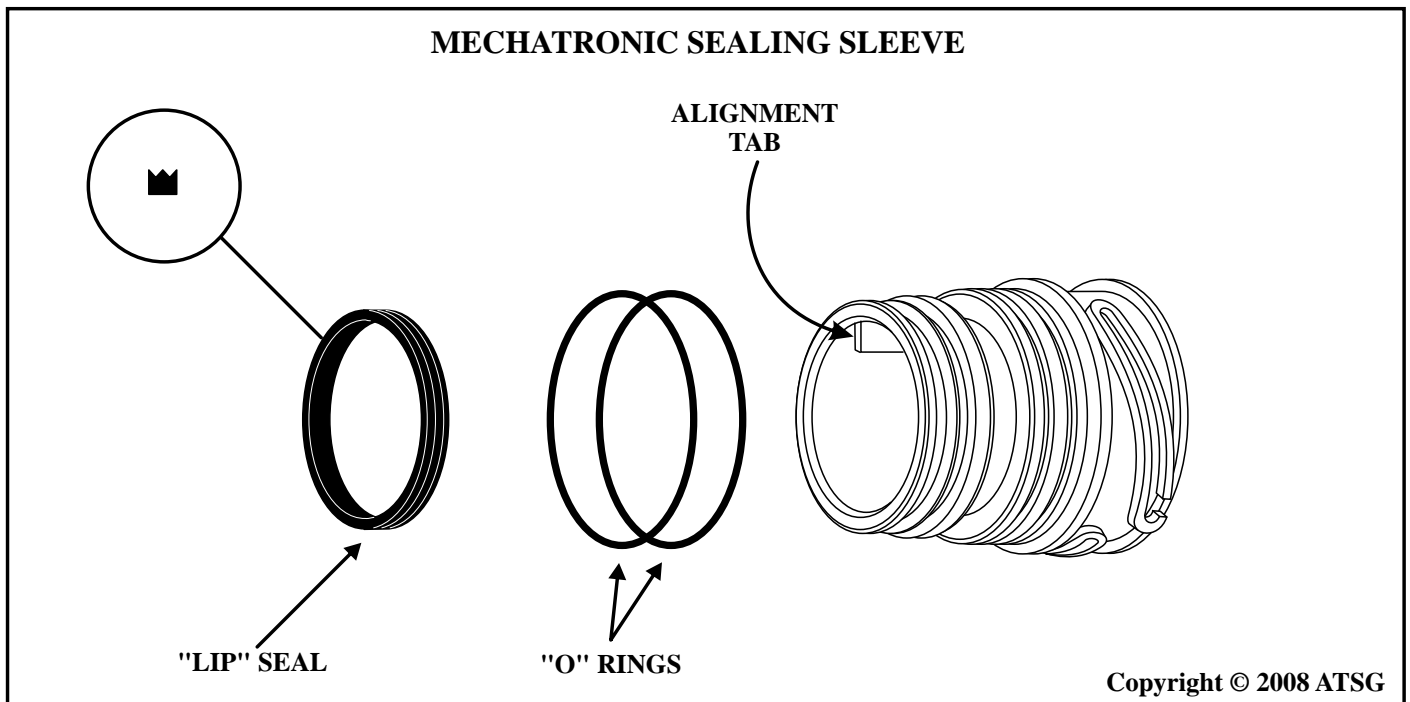
Figure 2

CAUSE: The Mechatronic Sealing Sleeve o-rings (Refer to Figure 2) is leaking and running down along the pan rail giving the appearance that the pan gasket is leaking.

CORRECTION: Replace the Mechatronic Sealing Sleeve.

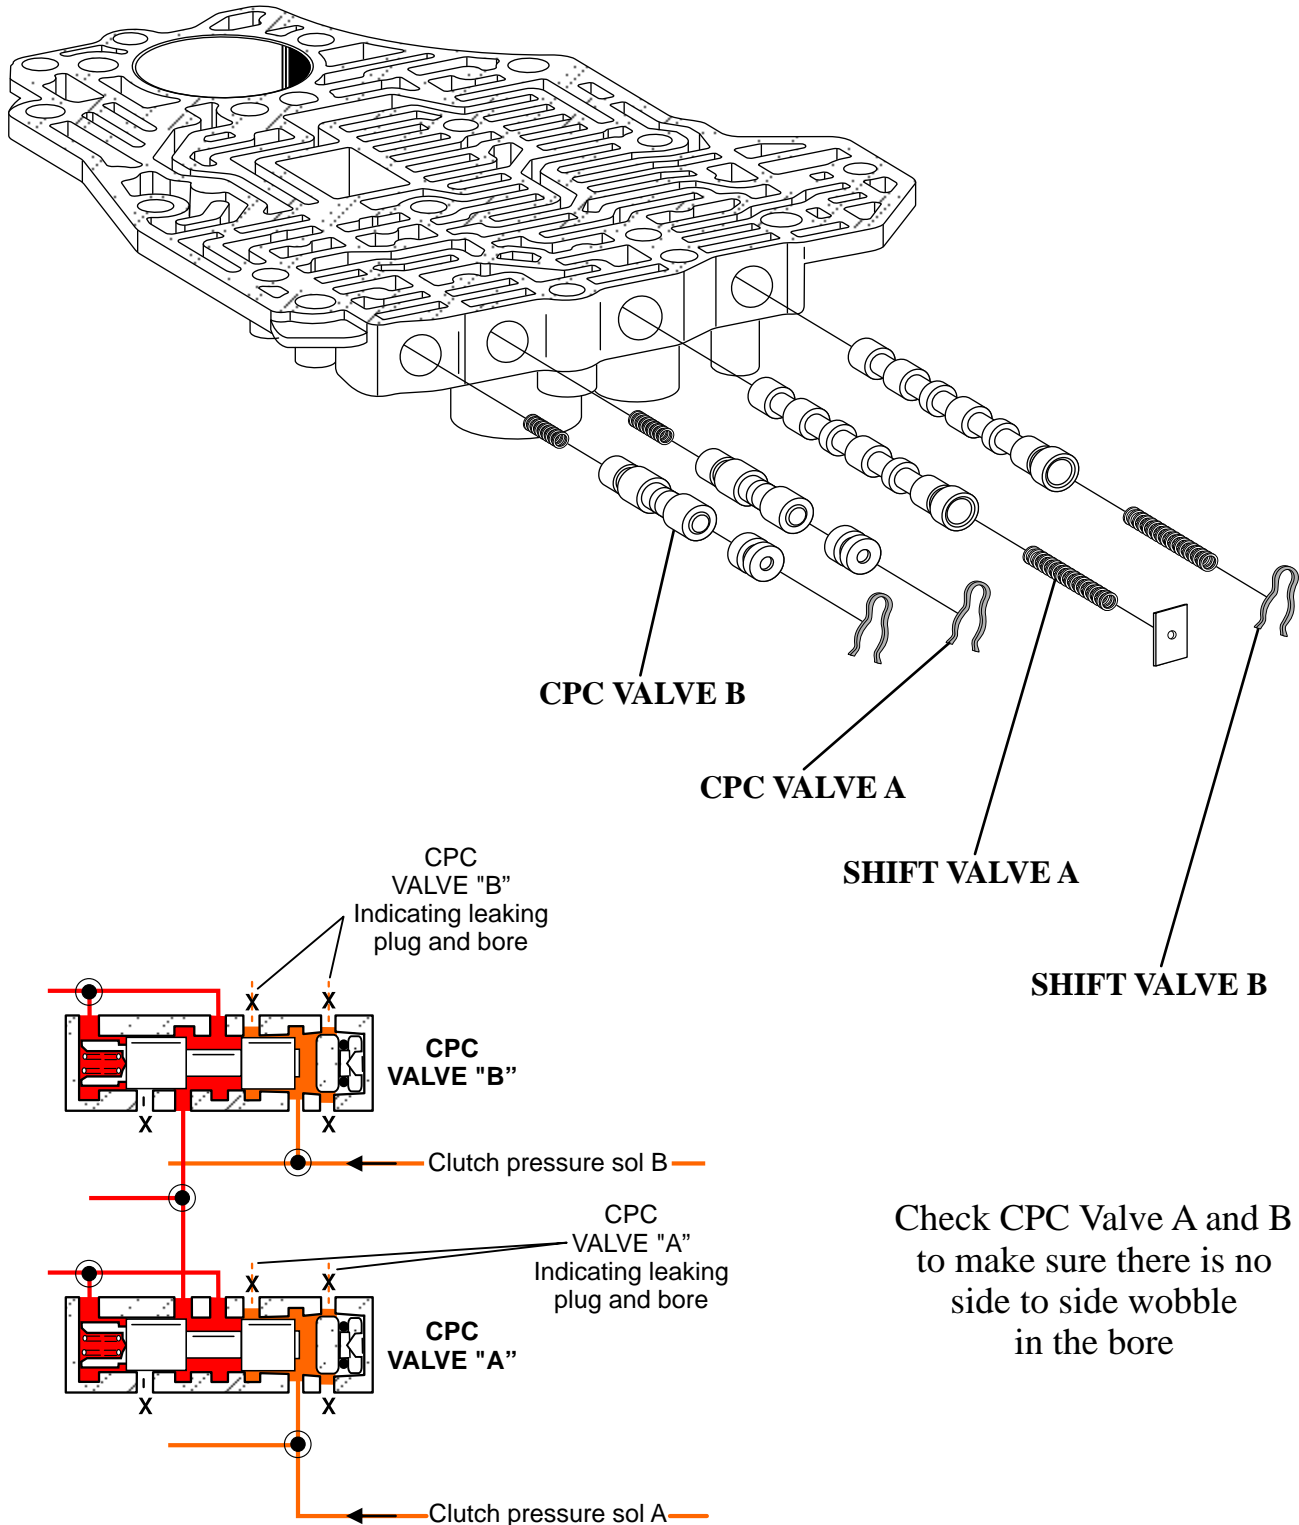
Figure 3
Automatic Transmission Service Group

CAUSE: One cause may be a loss of clutch apply pressure at the Clutch Pressure Control (CPC) valves in the accumulator valve body. Clutch apply pressure loss can be caused by faulty Clutch Pressure Control Solenoids, a faulty Clutch Pressure Switch, or a problem with the CPC valves in the valve body. The CPC valves are used to regulate clutch apply oil during each gear shift transition. The CPC valves are regulated by pressure from the Clutch Pressure Control Solenoids. The Solenoids are activated and modulated by the ECM and use the Clutch Pressure Switches as an input for clutch apply control. The valves may stick in the bore during cold operation. If this happens, they cannot regulate clutch control pressure adequately, causing a flared or sliding shift. The bore plugs that retain the CPC valves may become loose in the bore or the bore where the CPC valves travel may become worn causing a loss of clutch control pressure. This also can cause a flared or sliding shift.

CORRECTION: When overhauling the transmission, it is necessary to pay close attention to the CPC valves, the bore plugs, and the CPC valve bores in the accumulator body. There are several things that need to be done during the overhaul procedure to reduce the potential of having a repeat failure, or continued problem.

The bores in the accumulator valve body where the CPC valves travel must be closely inspected for wear. If the bores are worn the accumulator valve body will need to be replaced.

Remove the CPC valve springs from the body (*leave the valves in and replace the bore plugs*). Place the accumulator body in a freezer for at least two hours. After the body has had a chance to get good and cold, turn the body from side to side and check if the valves drag. The valves should float freely back and forth, if there is any drag, clean the bores with some very slightly abrasive cloth, (*be careful not to scratch the bore*) or replace the accumulator body as necessary.

Make certain the bore plugs fit snugly in the bore. Use a tubing cutter around the outside of each plug to raise a ridge that will help the bore plugs fit much tighter and help reduce the possibility of leaking.

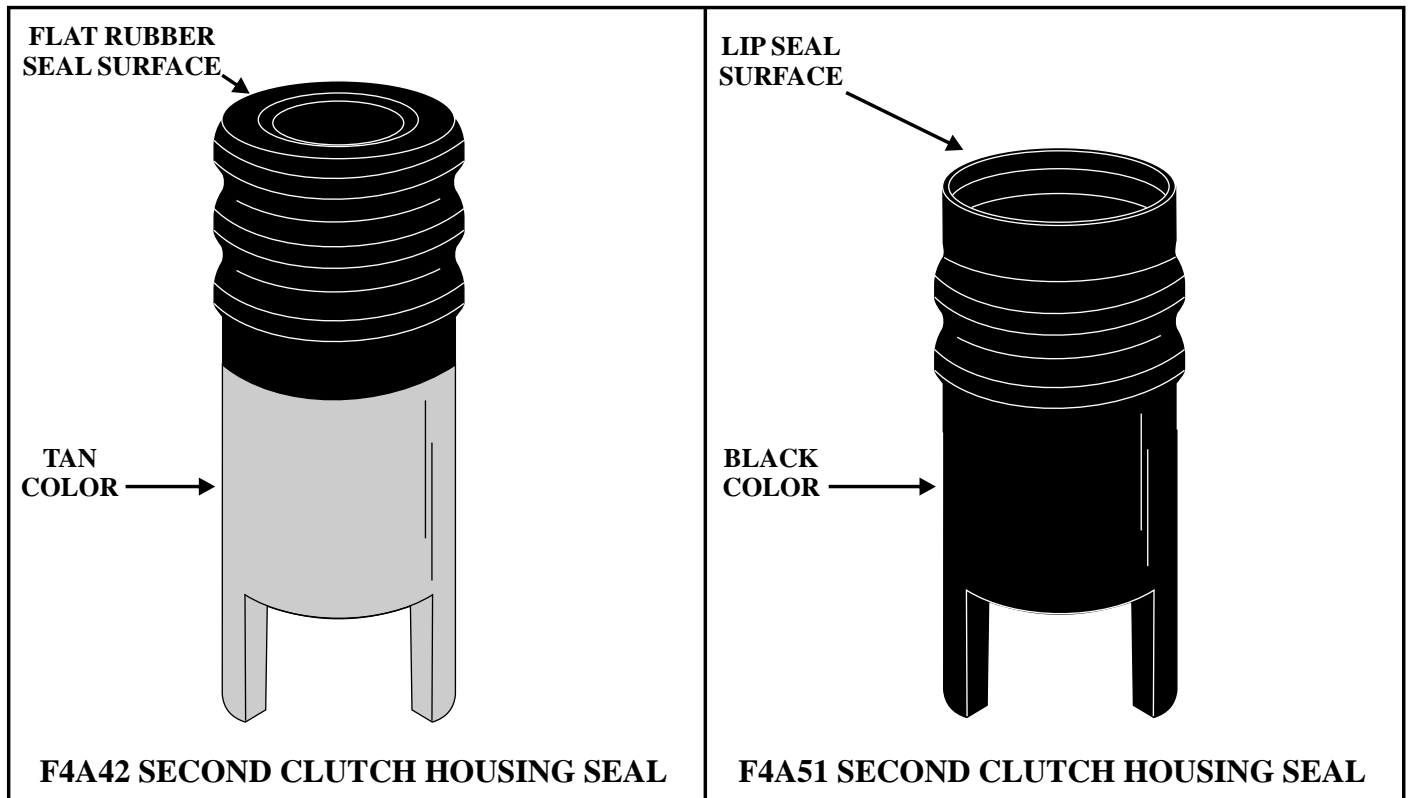
Figure 1

CAUSE: The use of a second clutch housing seal that is the incorrect length or the second clutch housing seal has failed and is leaking.

CORRECTION: The Tan seal has a flat rubber end that sits against the second clutch housing. The Black seal has a lip that sits against the second clutch housing, (Refer to Figure 1). This lip seal has been known to fail prematurely, use a quality seal.

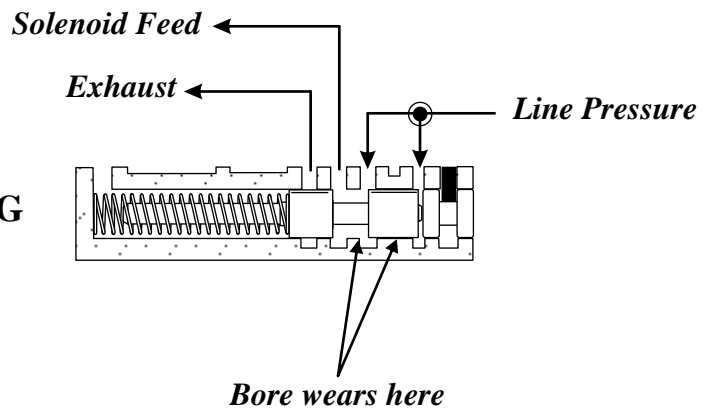
Note: Bore wear in the Solenoid Modulating Valve may cause low Solenoid Feed Pressure causing poor shift quality and premature Transmission Failure.

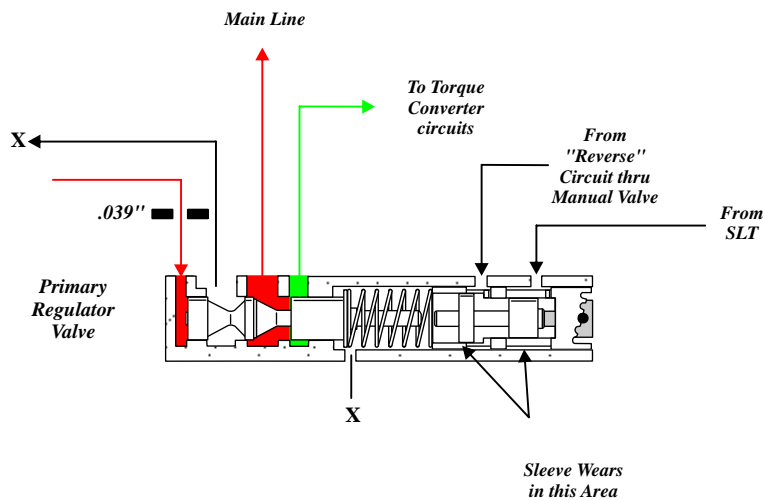
Figure 1

Wear in the Boost Sleeve may cause pressure loss in Reverse and or insufficient line pressure rise

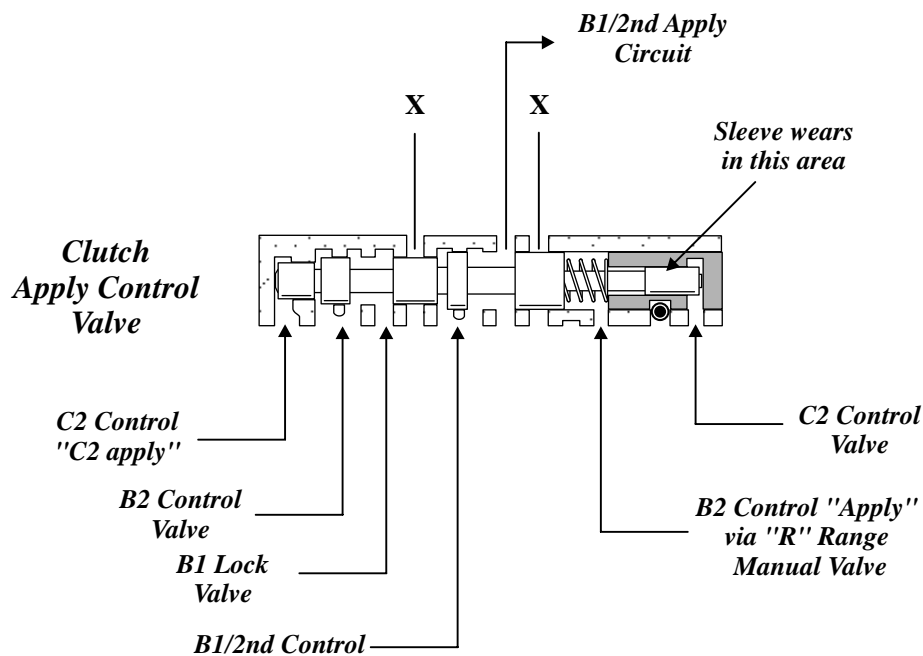
Figure 2

Wear in the Clutch Apply Control Valve Sleeve may cause problems with the sequencing of Clutch apply and Clutch release, which may lead to a flared or bind on a up or downshift.

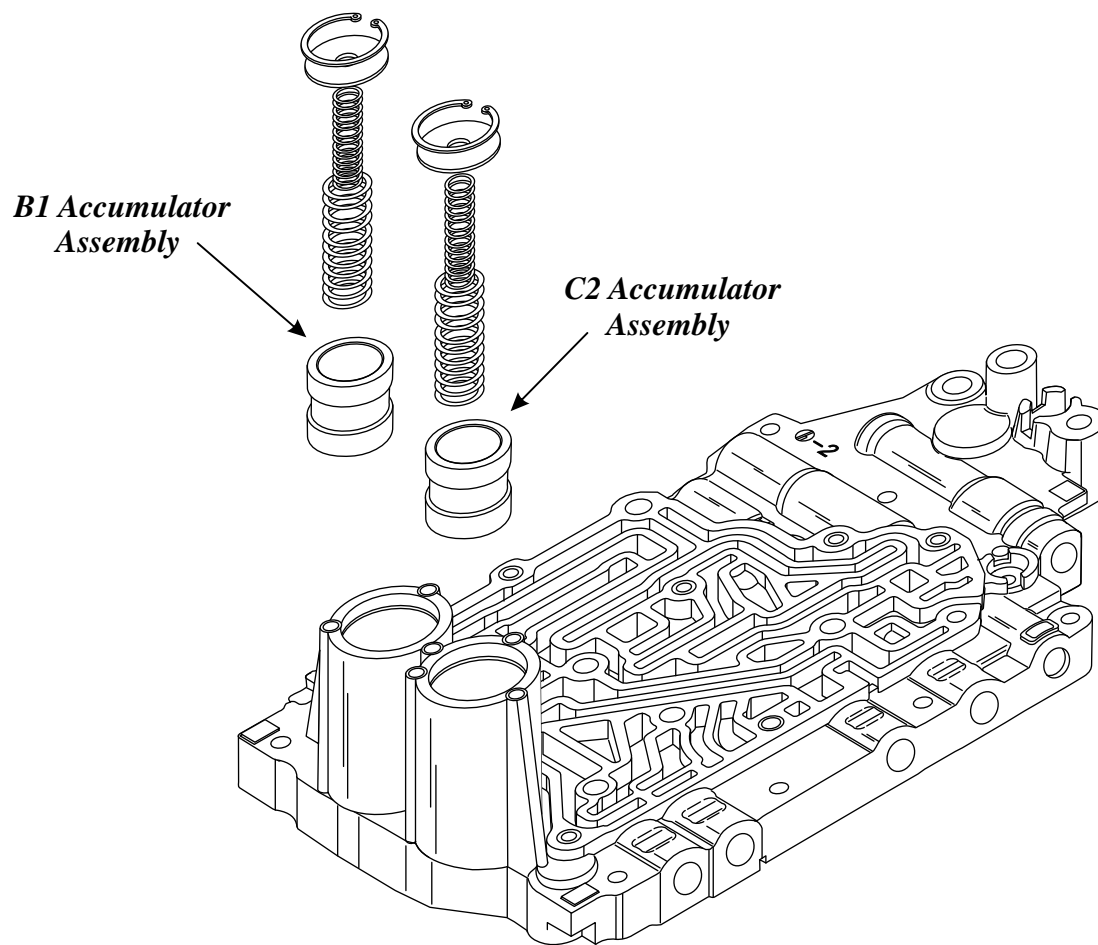
***NOTE: Inspect the Accumulator Pistons and bores in the Upper Valve Body
for wear, replace as necessary.***

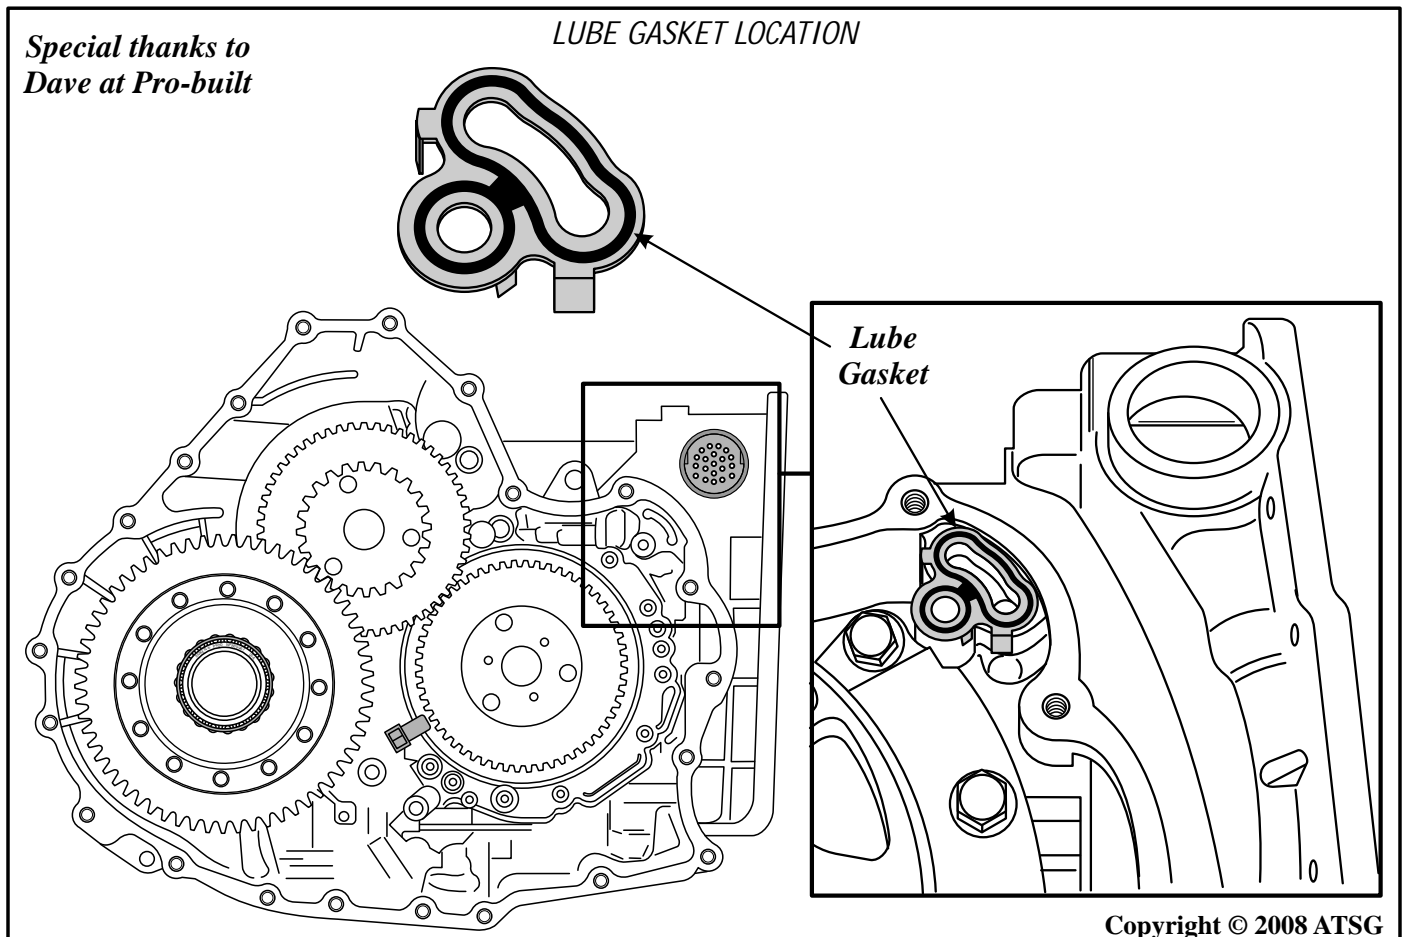
Figure 1

CAUSE: The cause may be, *not* installing the "beaded" gasket between the case and the converter housing, or installing the *wrong* "beaded" gasket, as shown in Figure 1. Jatco changed this gasket during the 2003 model year because of a change in the case pocket depth. This gasket is in the Volkswagen aftermarket kits only, as Volkswagen is the only manufacturer that uses the cooler mounted externally on the transaxle case, as shown in Figure 3. There are tubes that run from the back side of the converter housing, internally over to the cooler.

CORRECTION: Now there will be two different thickness gaskets included in your kits, and this will require you to measure the thickness of the original gasket metal core, before discarding, as shown in Figure 2. The 1st design gasket (1999-Some 2003) has a metal core thickness of .203mm (.008"). The 2nd design gasket (Some 2003-Up) has a metal core thickness of .610mm (.024"). Install the correct "beaded" gasket between the case and the converter housing, as shown in Figure 1.

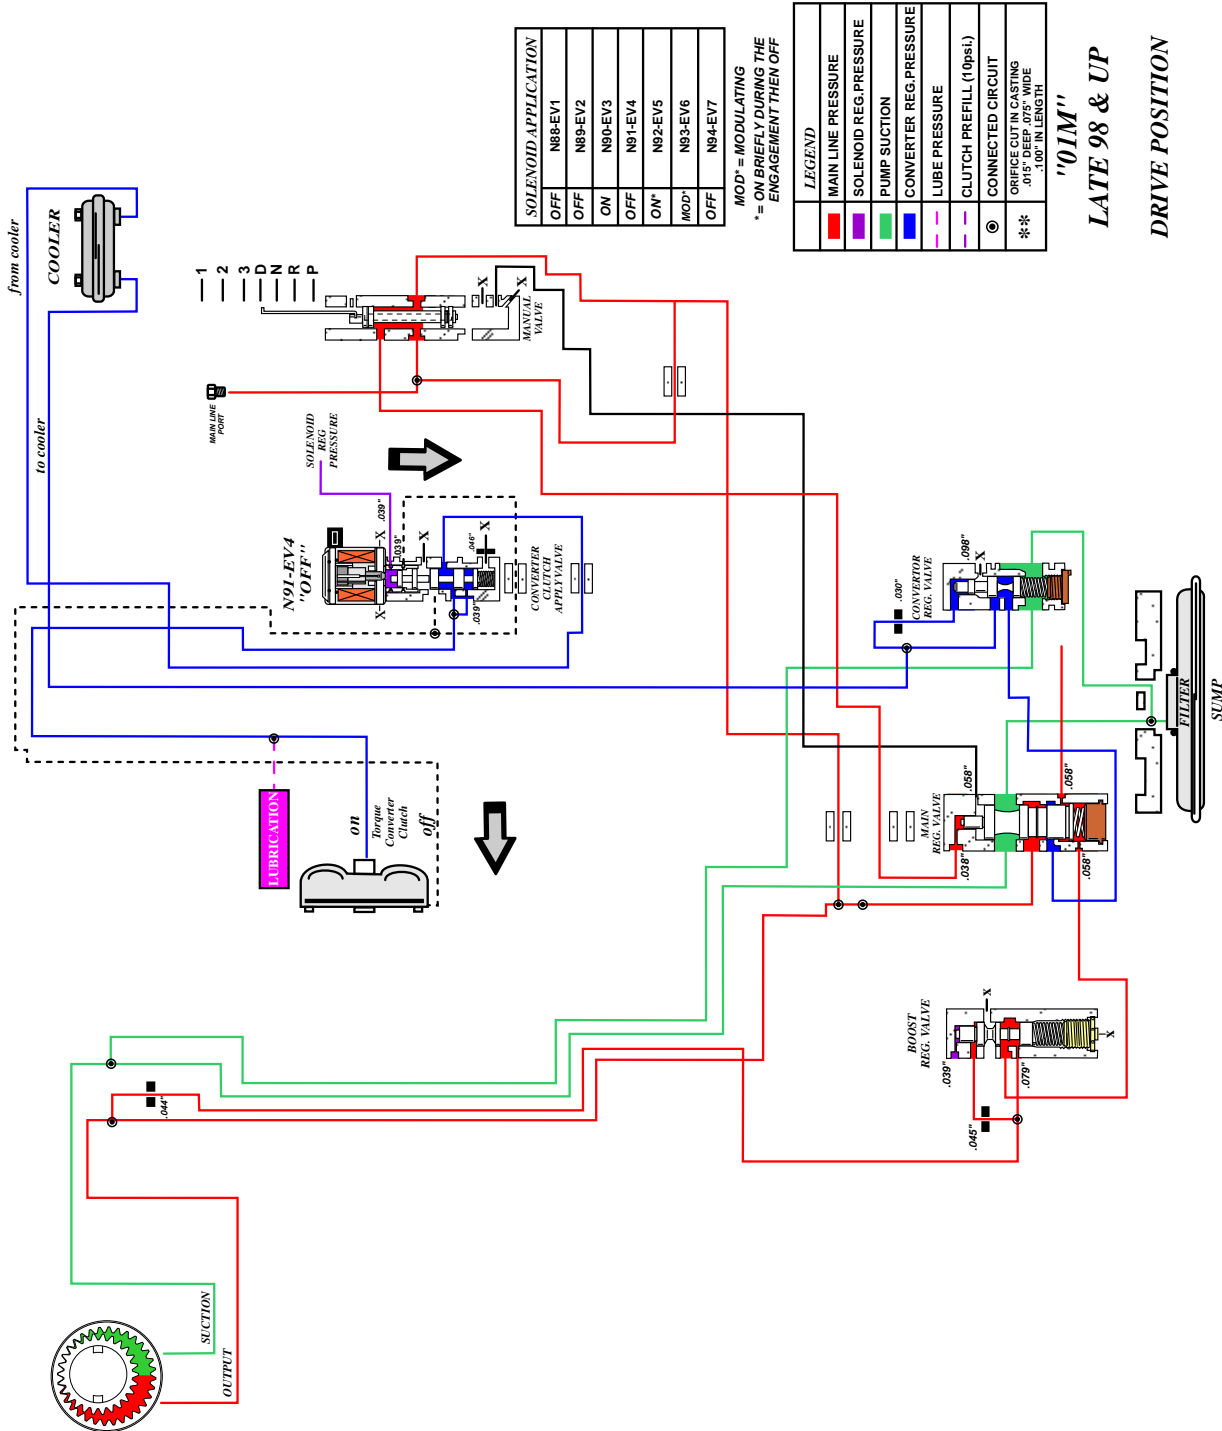
Figure 2
Automatic Transmission Service Group

The Torque Converter Clutch may be partially applied when EV4 is partially restricted

CORRECTION: Replace EV4 solenoid, and check the TCC Control valve as well as the small valve and sleeve for wear, repair or replace as necessary. **Note: Valve bore repair and replacements are available from Sonnax.**

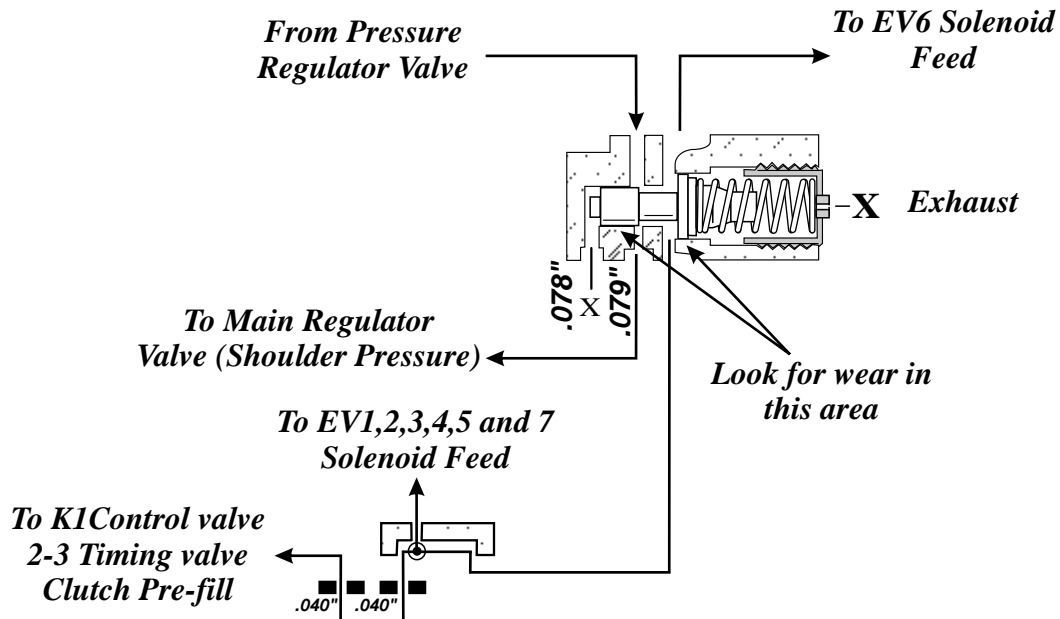
Check the bore of the Solenoid Regulator Valve for wear. Pressure bleeding past the valve lands will be exhausted at the plug shown above
