FORD AXOD

PREMATURE PLANETARY FAILURE

SEVERAL MODIFICATIONS CAN BE MADE IN AN EFFORT TO HELP IMPROVE LUBE OIL FLOW TO THE PLANETARY SYSTEM AND THEY ARE AS FOLLOWS:

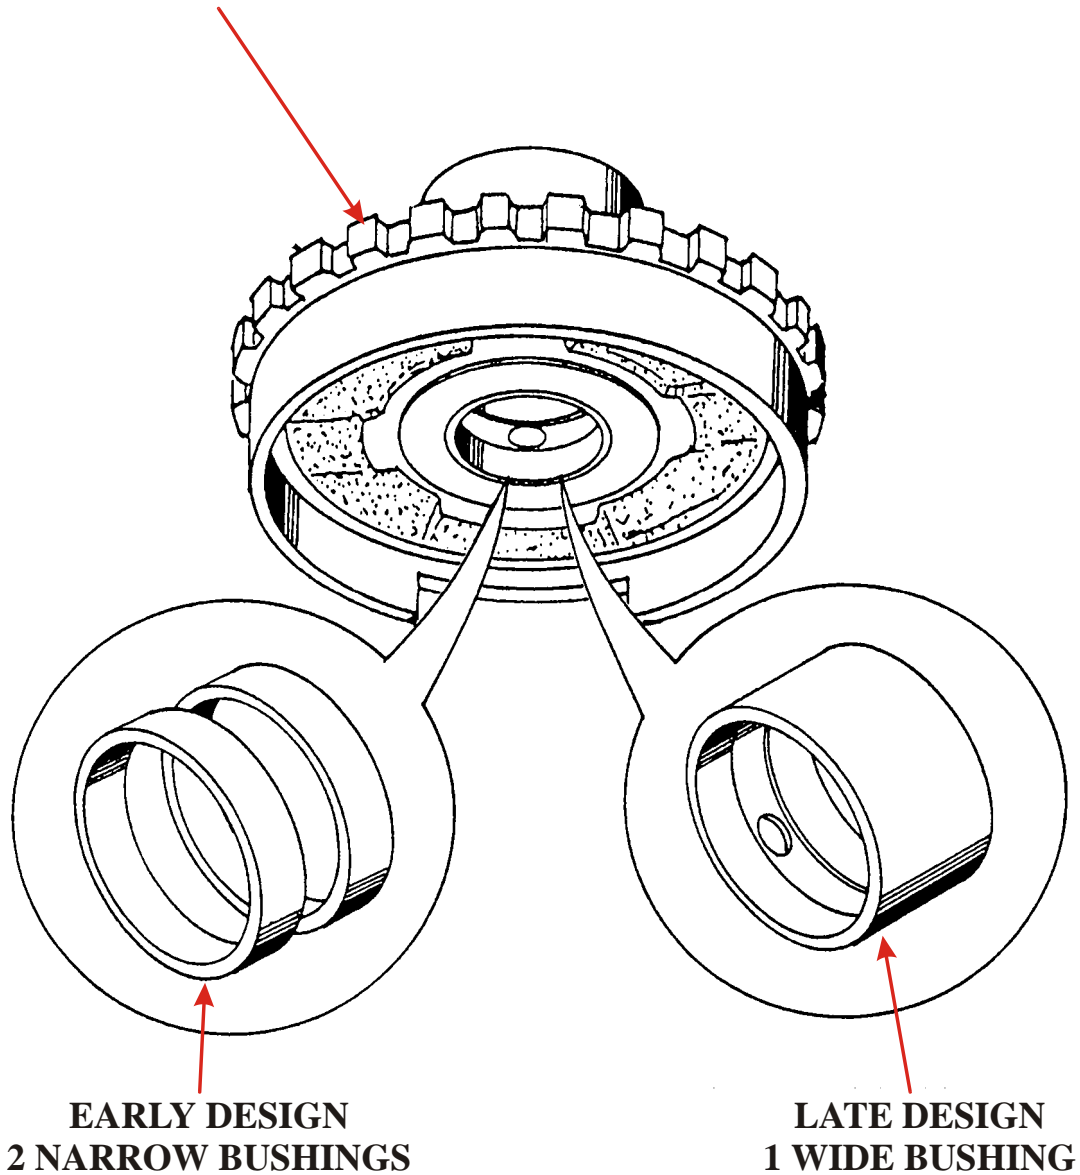
Figure 3

3. Inspect the bushings in the rear planetary support, as these bushings can move out of position and block the lube hole located in the support between them. The 1988 and later rear planetary support has a new second design, wider, one piece bushing with a groove and lube hole in the center. This will provide more surface area to prevent the bushing from moving. Refer to Figure 3.

The later rear planetary support, with the 2nd design bushing, will retro fit back to ALL previous models and is highly recommended. The new design rear planetary support is available under OEM part number E6DZ-7A130-A.

**THE LATER REAR PLANETARY SUPPORT, WITH THE 2ND DESIGN BUSHING
WILL RETRO FIT BACK TO ALL MODLES AN IS HIGHLY RECOMMENDED**
