EAGLE 4HP-18 SECOND GEAR STARTS (CLUTCH STACK)

COMPLAINT: Transmission starts in 2nd gear and binds up in manual low after overhaul.

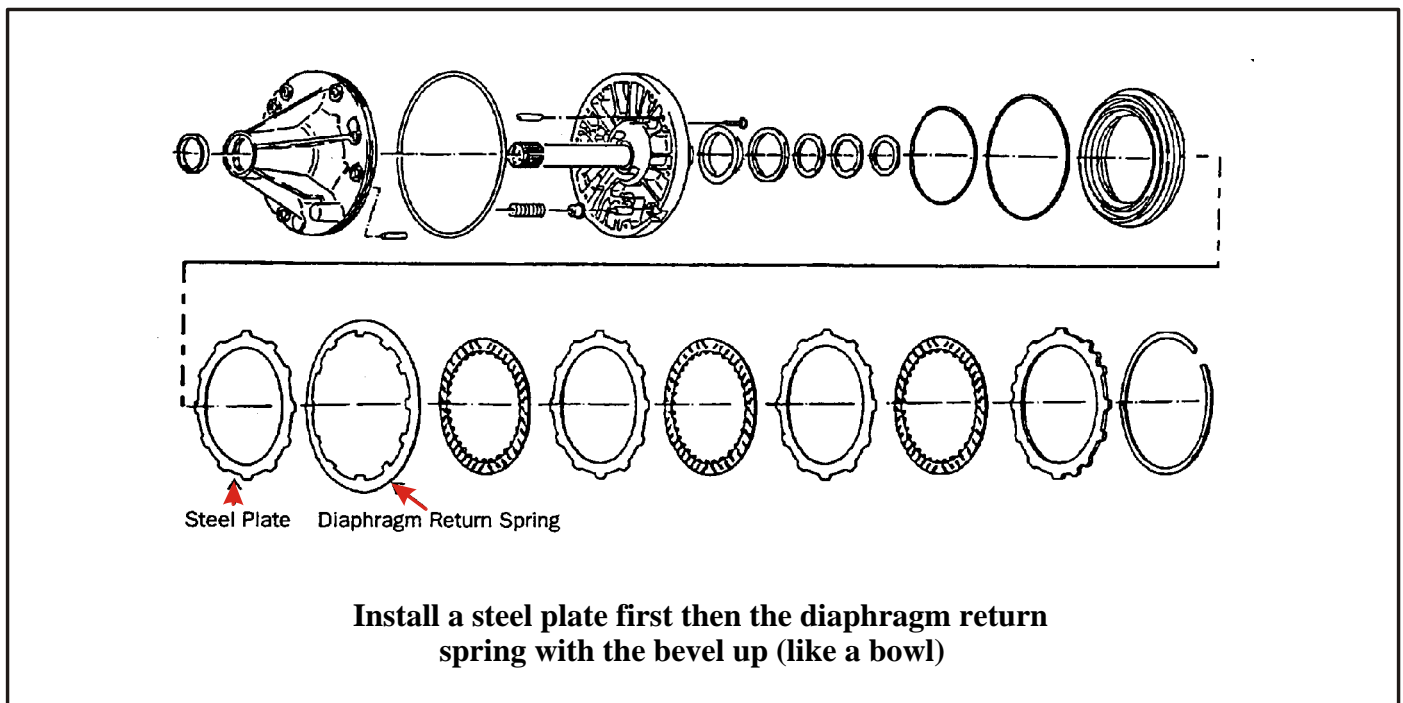
Figure 1

CAUSE: The diaphragm return spring in the C clutch (Intermediate Clutch), may be mis-positioned causing the C clutch to remain applied mechanically.

CORRECTION: Assemble the C clutch pack with a steel plate going first onto the pump where the C clutch piston is located (See Figure 1). Then the diaphragm return spring which sits down onto the steel plate with the bevel up (like a bowl) as shown in figure 2. Once the diaphragm return spring is installed, the rest of the clutch pack can be installed starting with a lined plate.
