Technical Service Information

THM 4L80-E NO 3RD, MANUAL OR AUTO, TRANS SHIFTS 1-2-4

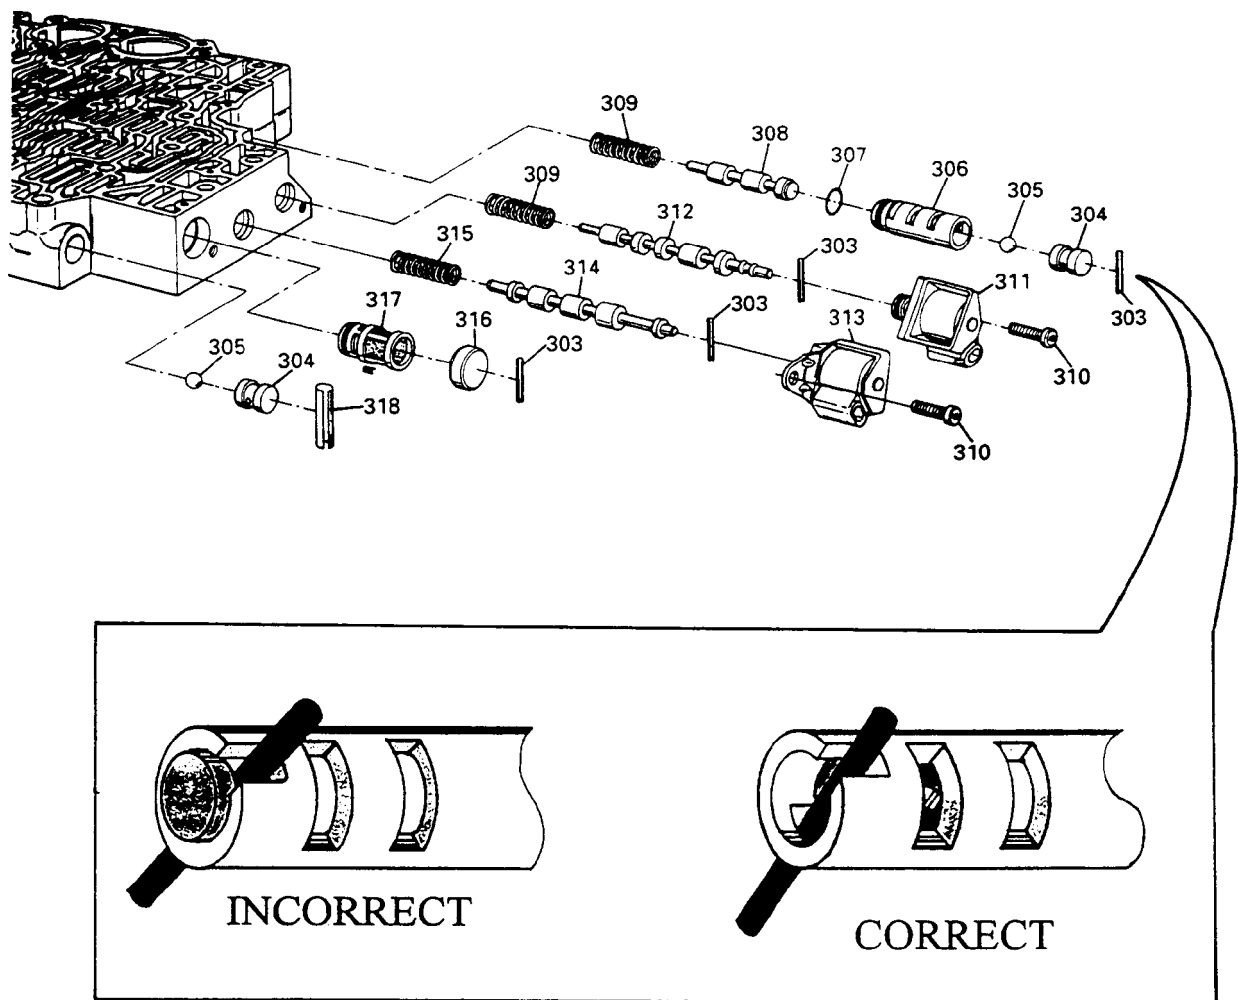
COMPLAINT: After rebuild, the transmission has no 3rd gear manual or automatic, and will upshift 1-2-4. The vehicle will still have reverse.

CAUSE: The cause may be, the roll pin that retains the 3rd/Reverse checkball bushing and bore plug in the valve body, has been mislocated through the hole in the bore plug, as shown in Figure 1.

CORRECTION: Position the roll pin in front of the bore plug, as shown Figure 1. The roll pin will be visible when looking at the end of the bore, after the valve train has been installed, if you have assembled it correctly (See Figure 1).
