TRANSMISSION SEMINAR 1992

1992 SEMINAR INFORMATION

THM 4L80-E COMPONENT LOCATIONS AND CONNECTIONS

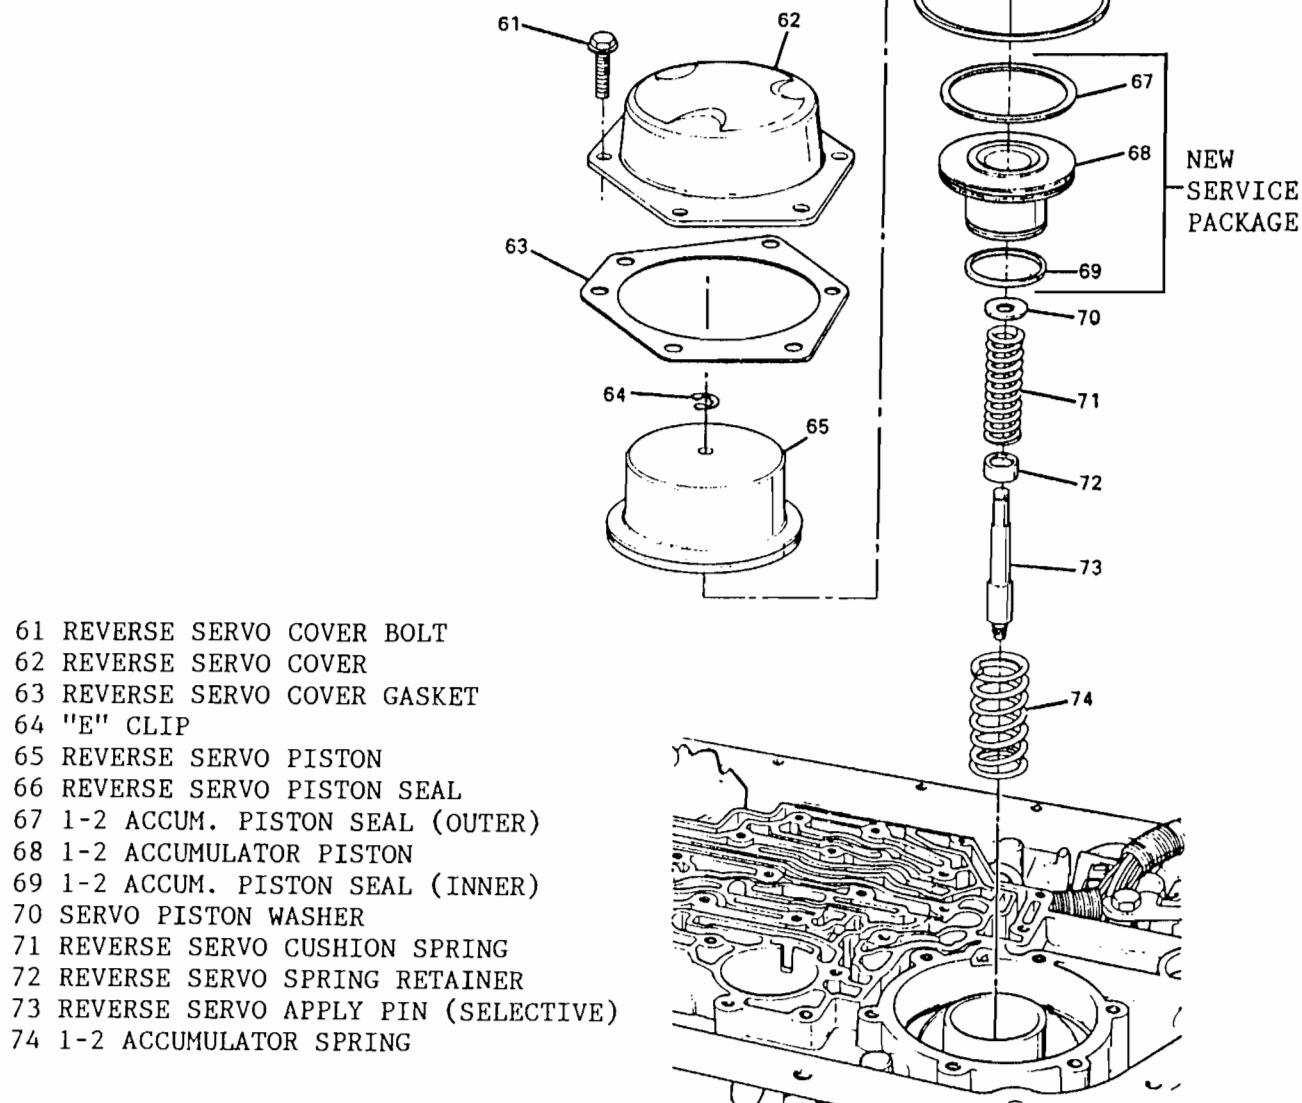
CAUSE: The cause may be, fluid leaking past the 1-2 accumulator piston seals. The 1-2 accumulator piston is located inside of the reverse servo piston (See Figure 1).

CORRECTION: Install a new design 1-2 accumulator piston and ring assembly to eliminate this condition. The new service package is available under OEM part number 8680929. Refer to Figure 1 for assembly.

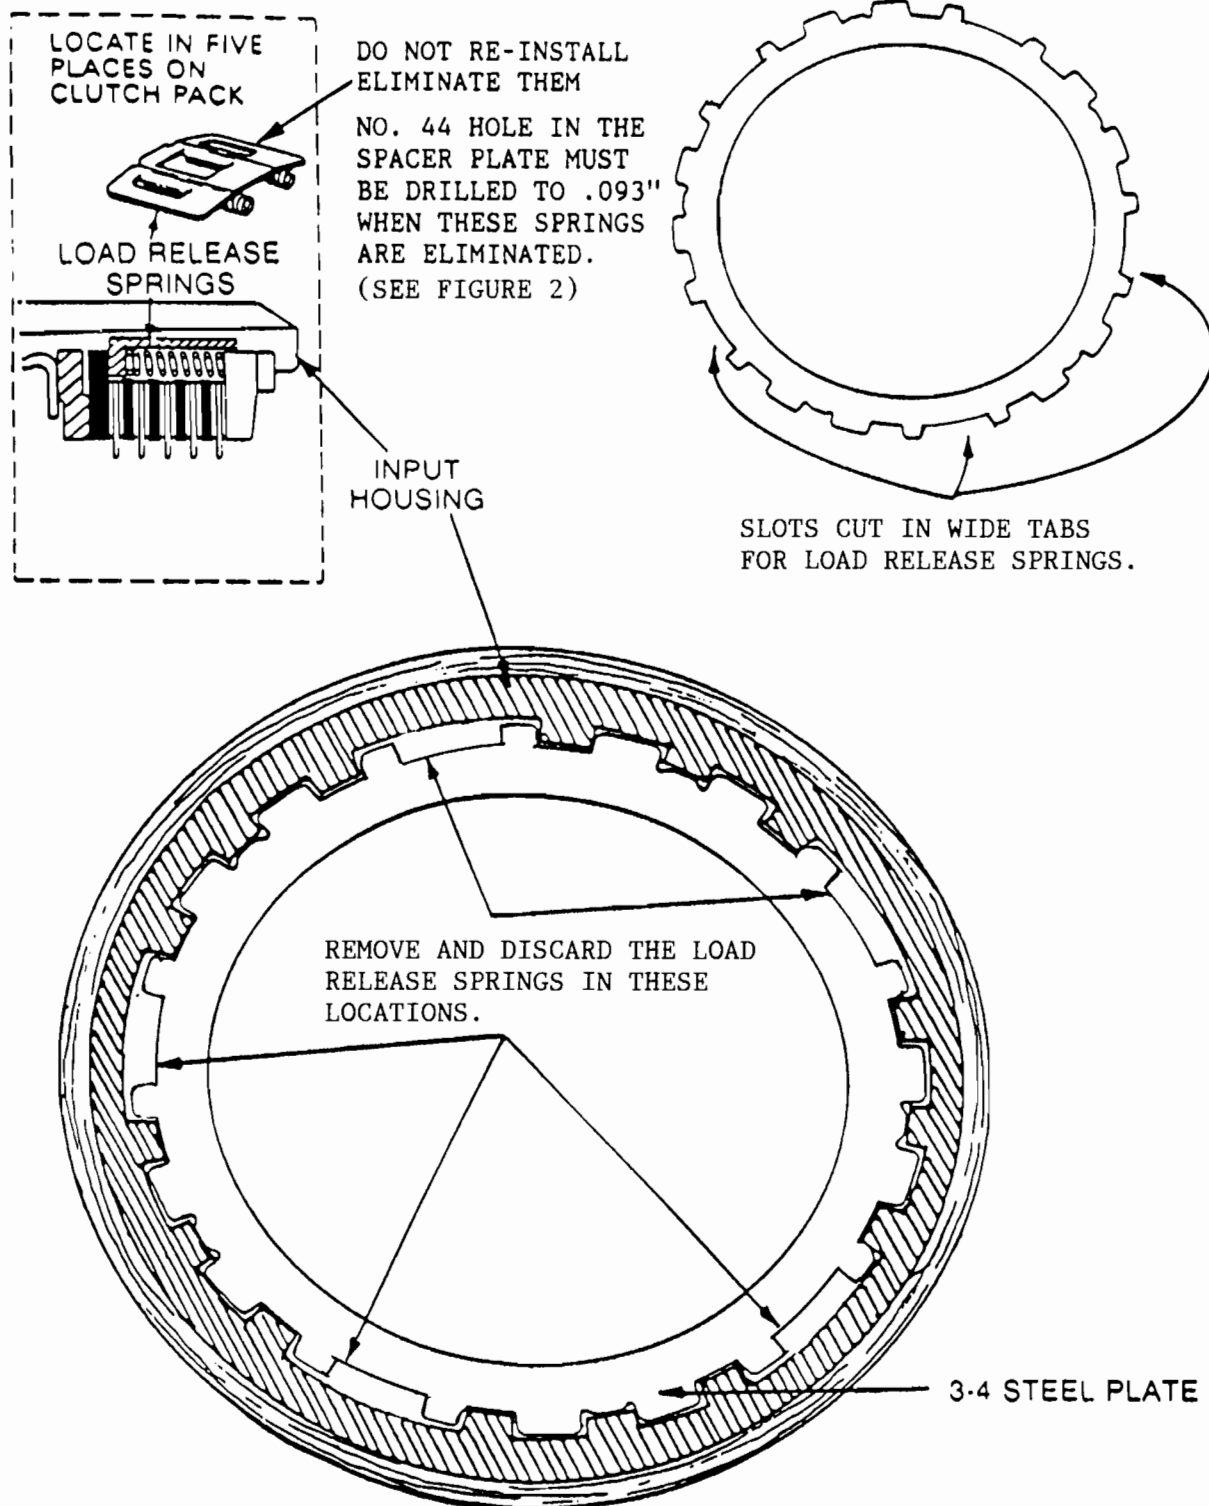
Figure 1

COMPLAINT: Premature 3-4 clutch failure on 1988 to 1992 model 700-R4 transmissions, and can occur as early as 200 miles on the unit.

CAUSE: The cause may be too much spring pressure for available 3-4 clutch oil pressure to overcome.

NOTE: WITH THE 3-4 LOAD RELEASE SPRINGS REMOVED, IT ALLOWS YOU TO INSTALL THE STEEL PLATES IMPROPERLY. PROPER INSTALLATION IS WITH THE STEEL PLATES INSTALLED SO THAT THE LOAD RELEASE SPRINGS WOULD FIT, IF WE WERE GOING TO USE THEM.

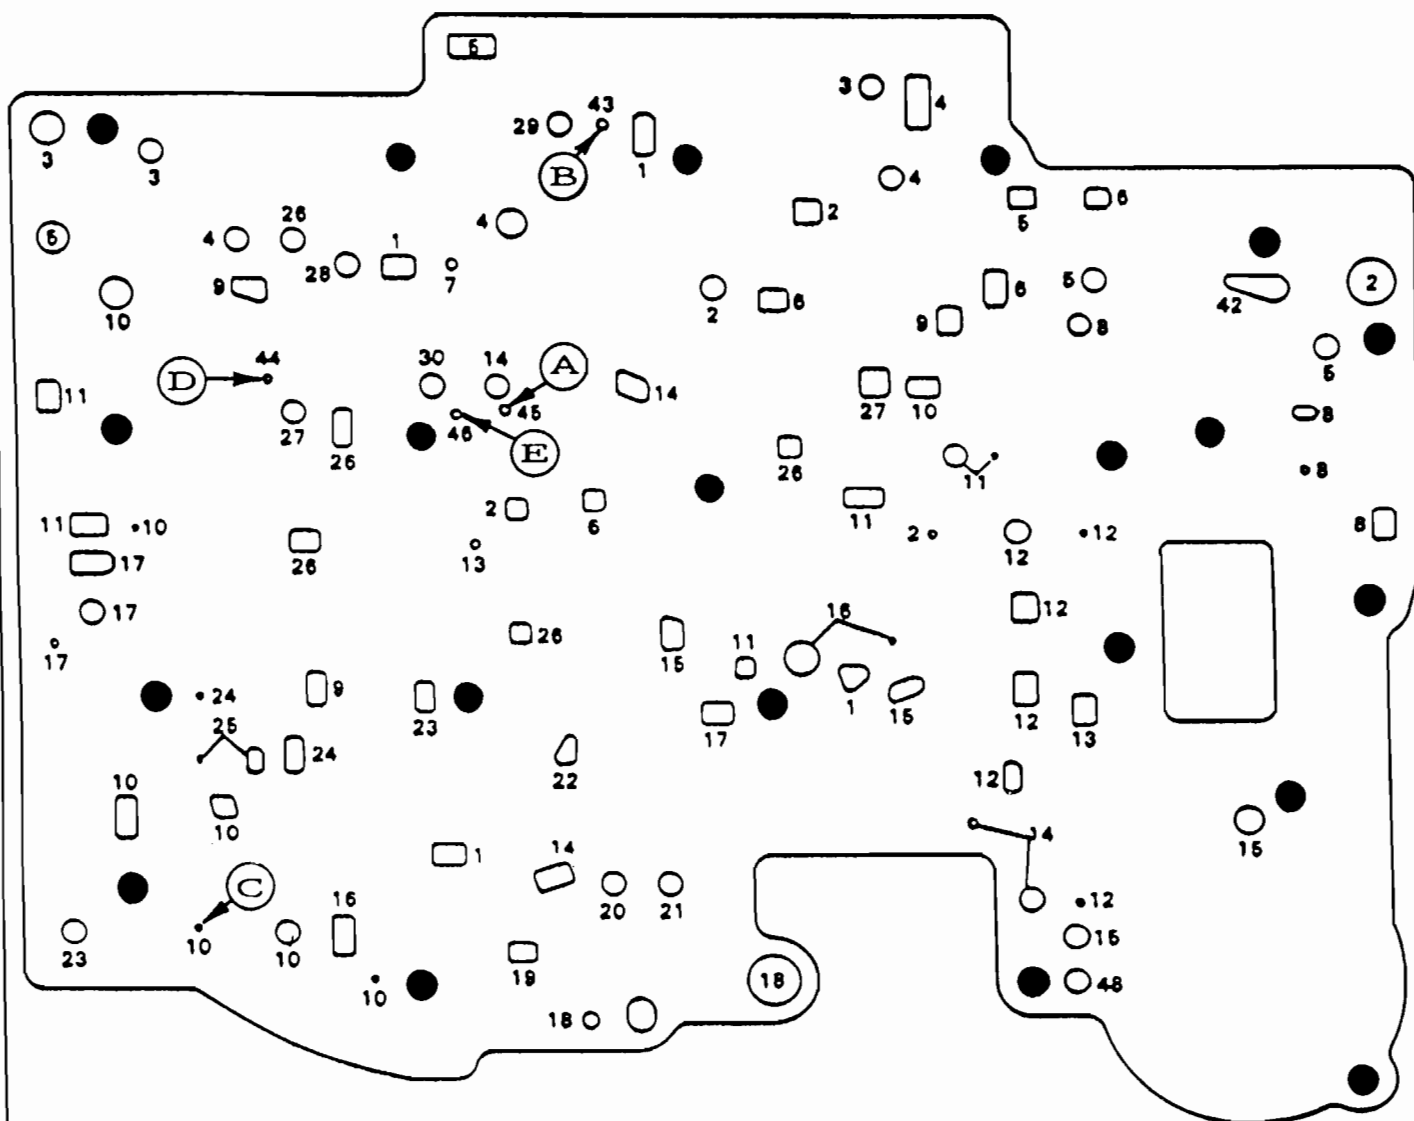
Figure 3

- (1) Shifts 1-3 in drive, after initial upshift pattern. First set of upshifts are normal, and will be again, after setting awhile.
- (2) Delayed (5 Seconds) 4-2, or 3-2 kickdown.
- (3) Delayed (5 Seconds) manual downshift from D3 to D2. (Stays in 3rd)
- (4) Binds in reverse, after upshifting to 3rd gear. Normal operation after setting for a while.
- (5) Binds in manual Lo, after upshifting to 3rd gear. Normal operation after setting for a while.
- (6) Results in burnt 3-4 clutch plates. They are usually wiped out on the road test, as this is the exhaust hole for the 3-4 clutch.

HOLE "A", DRILL TO .110"
HOLE "B", DRILL TO .086"
HOLE "C", DRILL TO .055"
HOLE "D", DRILL TO .093" (DRILL EVEN IF THERE IS NO HOLE IN THIS LOCATION)
HOLE "E", MAKE SURE THIS HOLE IS NOT COVERED WITH YOUR GASKETS.

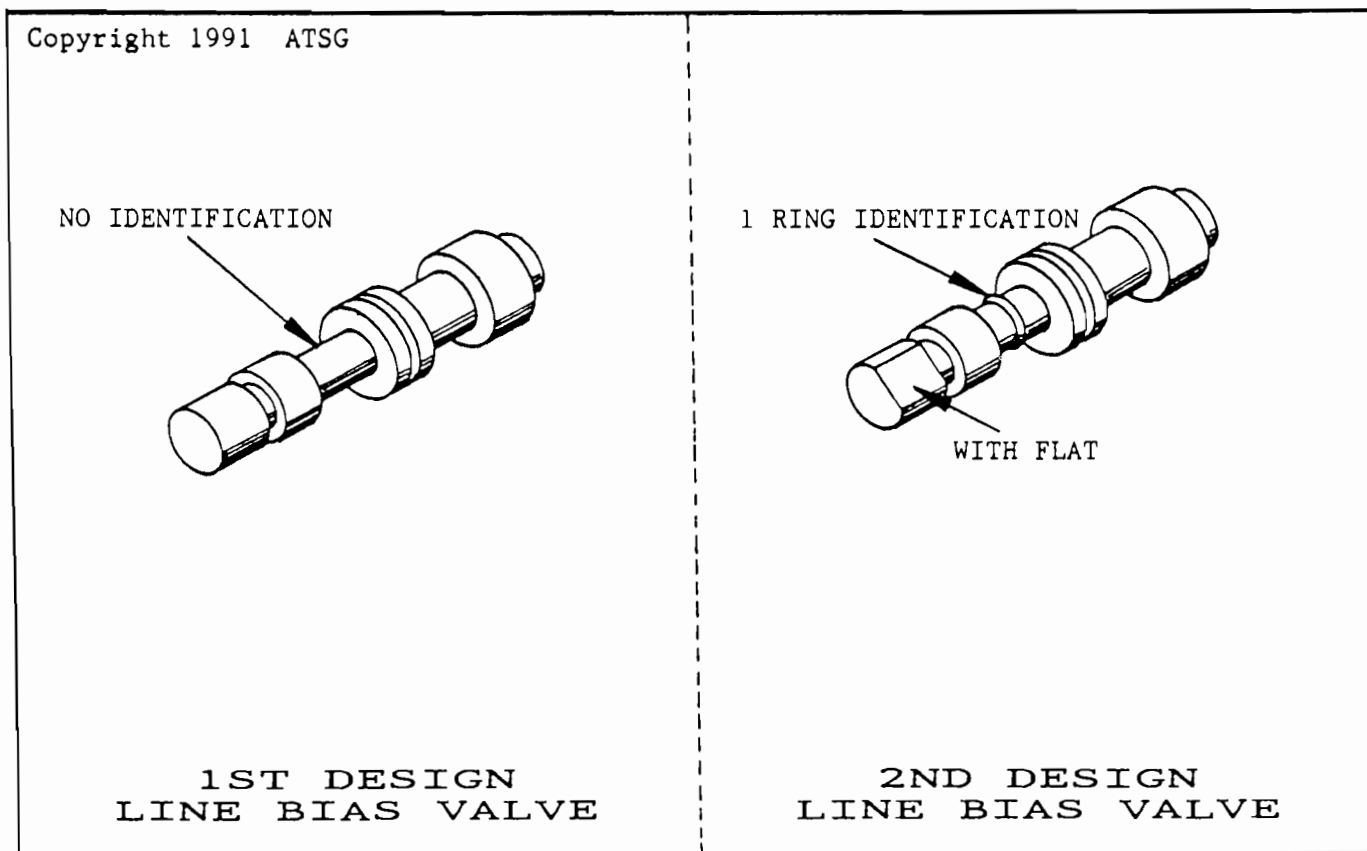
Figure 4

CAUSE: The cause may be a mis-matched line bias valve, and spacer plate. Beginning in 1987, a 2nd design line bias valve was introduced that has a "Flat" on the small land (See Figure 4). This change required that the detent hole in the spacer plate be eliminated (See Figure 5). If the 2nd design line bias valve (With Flat) is installed with the 1st design spacer plate (With Detent Hole), all T.V. oil will be exhausted at 3/4 to full throttle positions.

CORRECTION: Install matching line bias valve and spacer plate.
Line bias valve WITHOUT flat, requires spacer plate WITH detent hole. (Refer to Figures 4 and 5).
Line bias valve WITH flat, requires spacer plate WITHOUT detent hole. (Refer to Figures 4 and 5).

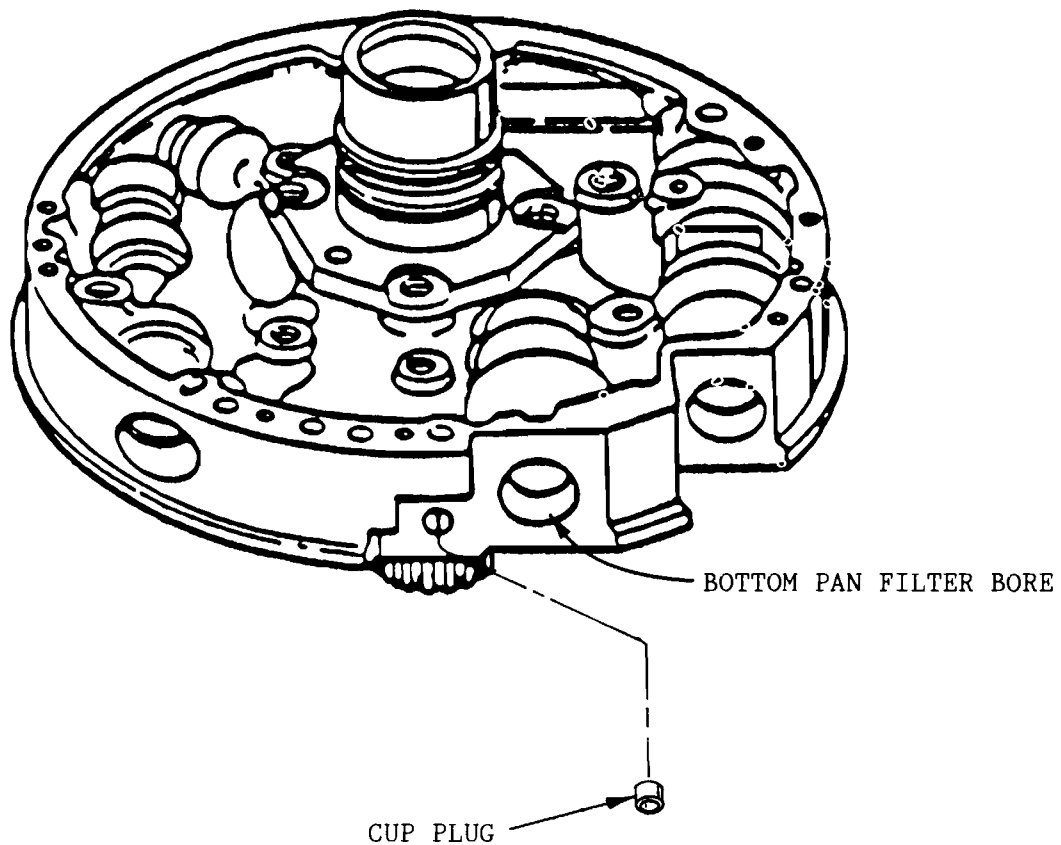
Figure 11

CUP PLUG MUST BE INSTALLED IN THIS LOCATION,
WHEN USED WITH 82-86 MODEL TRANSMISSIONS.

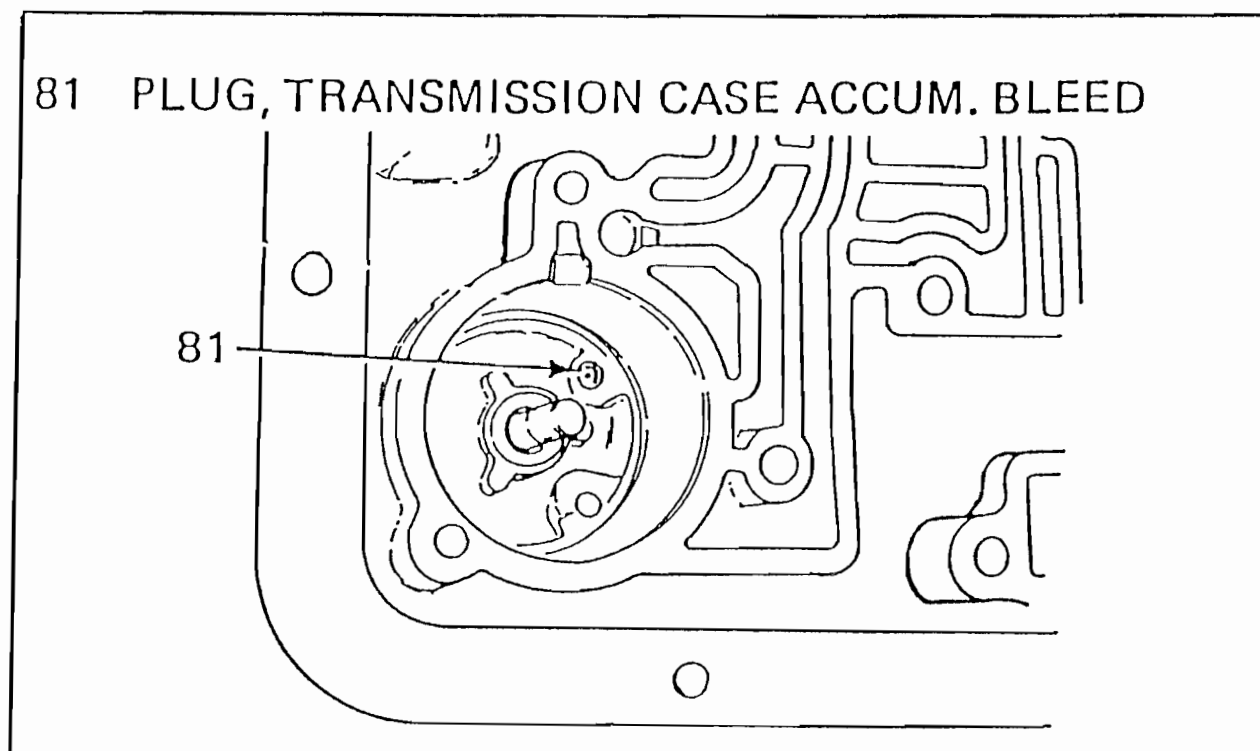
Figure 11a

CAUSE: The cause could be the bleed orifice cup plug missing from the case in the bottom of the 3-4 accumulator bore (see Figure 11a.)

CORRECTION: Install bleed orifice cup plug, OEM Part Number 8628864.

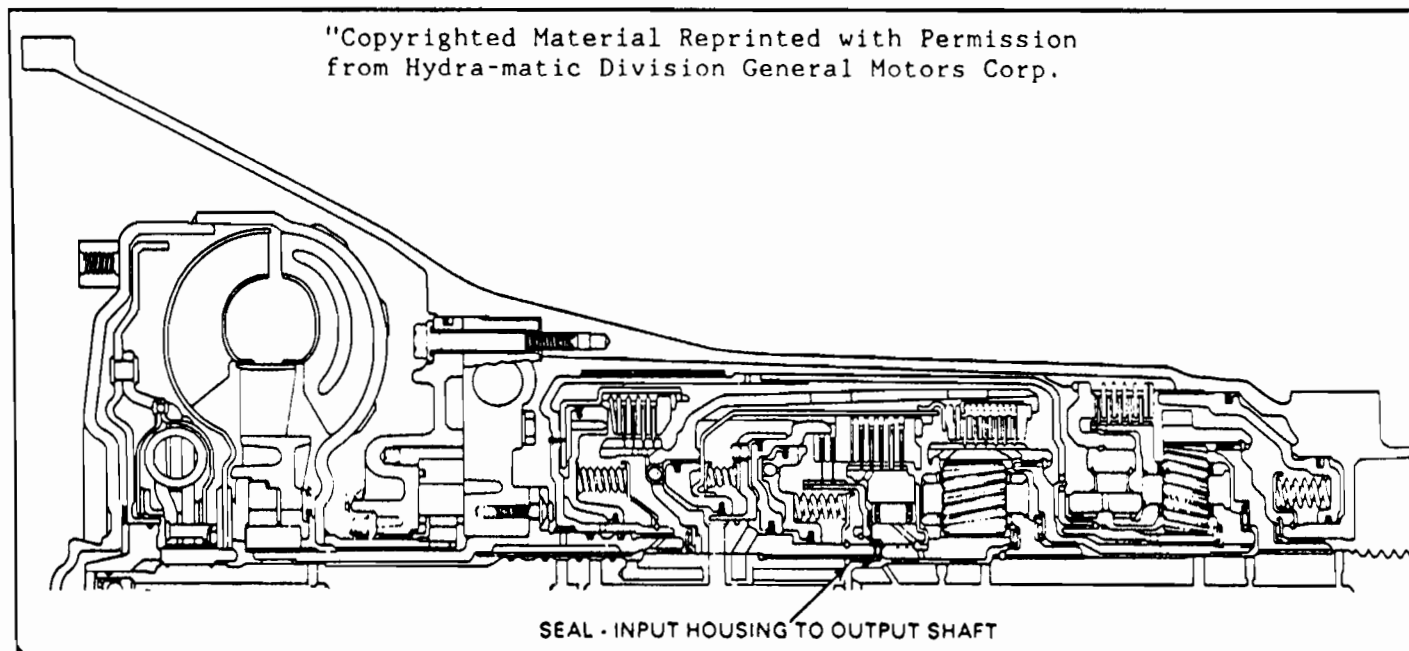
Figure 12

- (1) INPUT HOUSING LUBE SEAL - Now made of a soft rubber material instead of the previous hard plastic, is Red Oxide in color, and helps retain lube oil even in mis-alignment conditions because of soft material.
(Refer to Figures 12 and 13).
- (2) OUTPUT SHAFT - Revised lube hole location. New design can be identified by lube hole in the chamfer at the front of the output shaft. Previous design has the lube hole located on the pilot at the front of output shaft (See Figure 13). The new design output shaft now aims lube oil directly at the Input Housing/Sun Gear Bearing, greatly increasing the durability of the bearing (See Figure 12).

- (1) THE NEW DESIGN SEAL (SOFT RUBBER) "WILL NOT" WORK WITH THE PREVIOUS DESIGN OUTPUT SHAFT. The lube hole in the pilot of the output shaft will tear the new style seal, and/or block the hole completely.
- (2) The previous design seal (Hard Plastic) "WILL" work with "ALL" shafts including the new design output shaft.
- (3) The new design output shaft and seal will retro fit back to any 700-R4 transmission ever built.

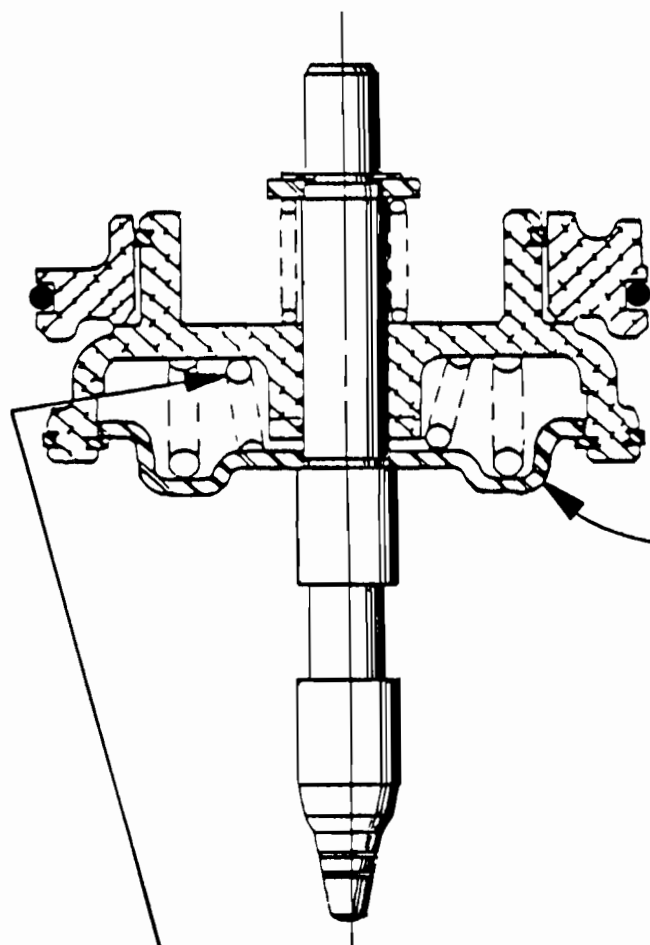
CAUSE: The cause may be, timing of the release of the 3-4 clutch and re-apply of the 2-4 band. A new conical 2-4 servo cushion assist spring has been released to alleviate this condition, along with enlarging the 3rd clutch exhaust hole in the spacer plate.

INSTALL CONICAL SPRING 8681195 WITH SMALL DIAMETER TOWARD THE RETAINER AS SHOWN.

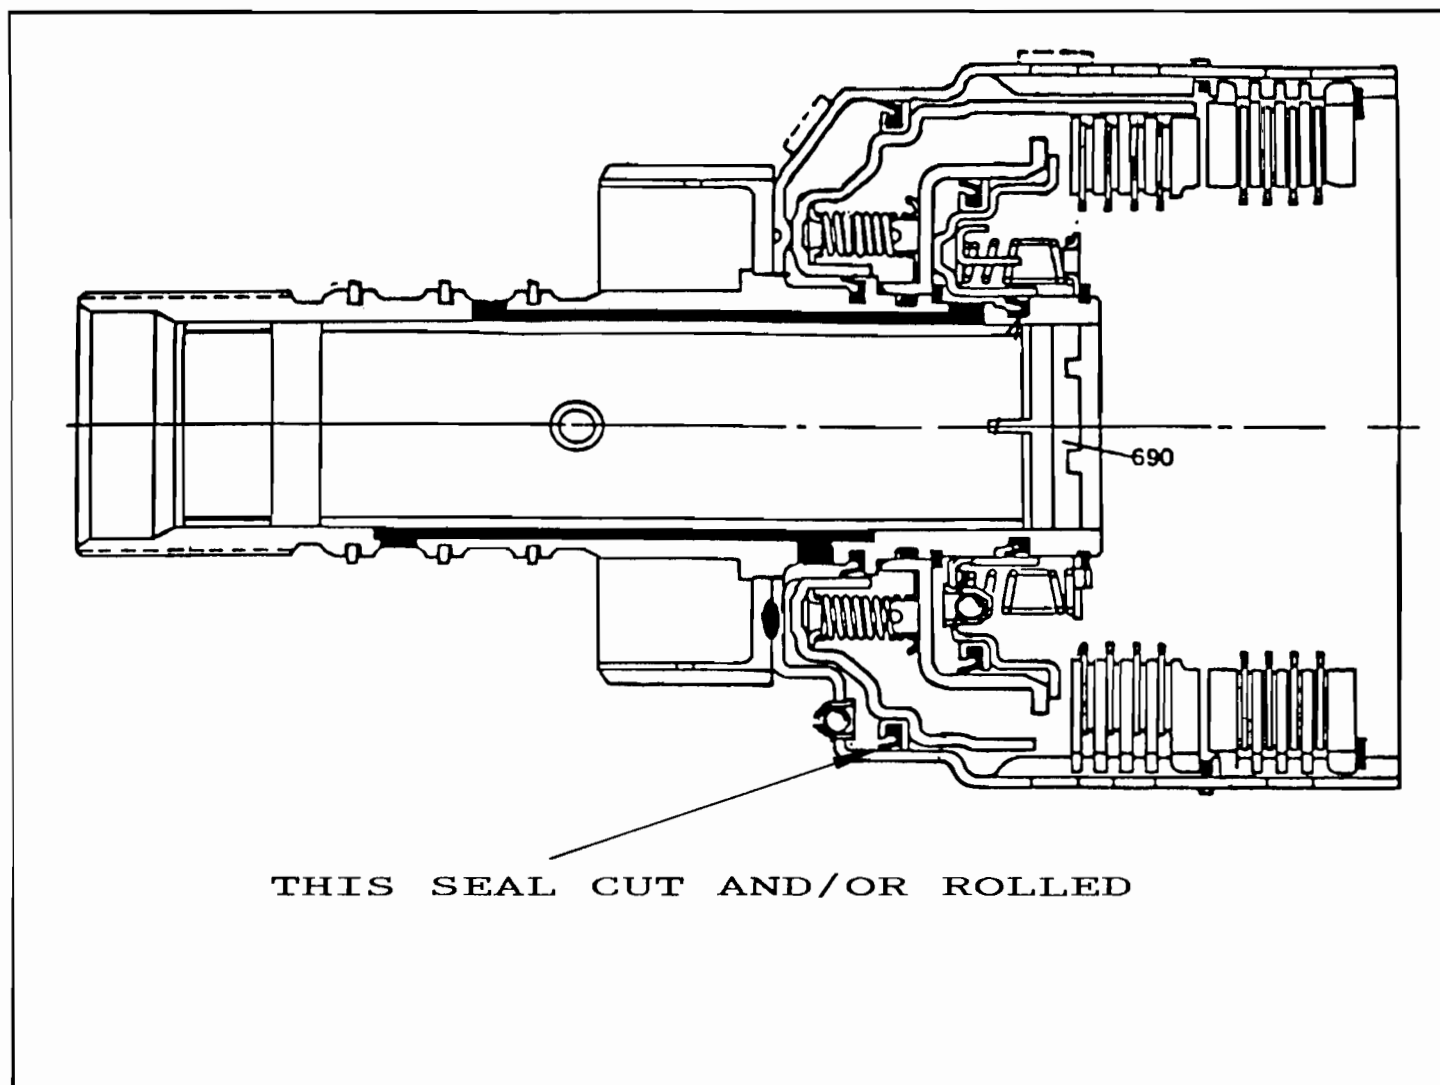
Figure 16

COMPLAINT: Some THM 4T60 (440-T4) and 4T60-E Transaxles may exhibit a no move condition while the transaxle fluid is cold, and after warm the transaxle will perform fine.

CAUSE: The cause may be, a cut and/or rolled input clutch piston outer lip seal (See Figure 16).

CORRECTION: Replace the input clutch piston outer lip seal, and inspect the seal groove for any damage. Replace the input clutch piston as necessary.

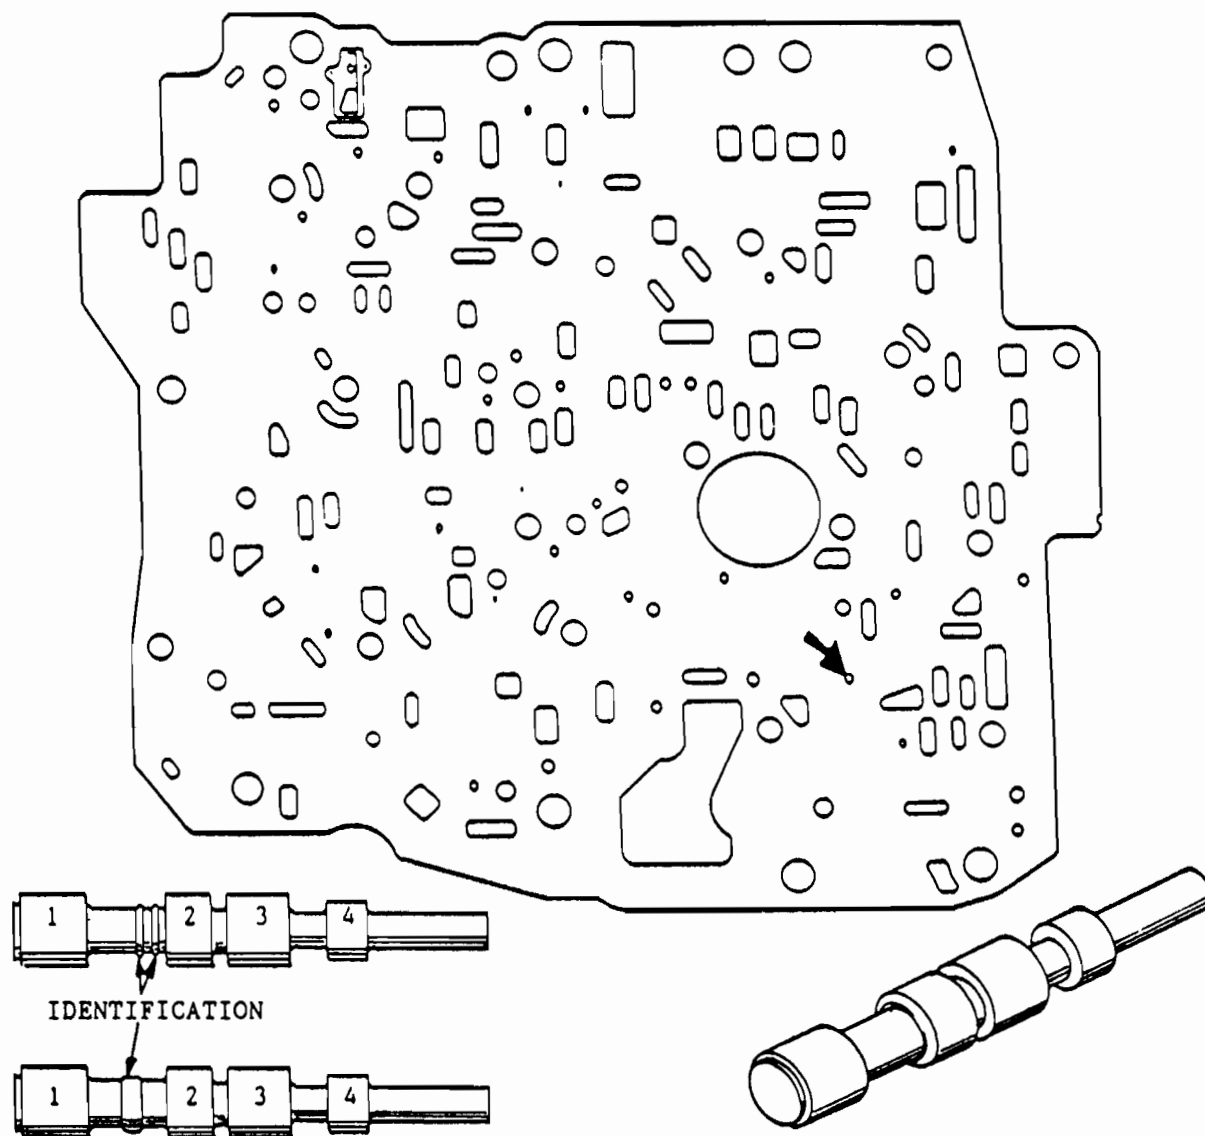
CAUSE: The cause may be, a loss of T.V. pressure due to a mis-matched spacer plate and T.C.C. Regulator Valve.

CORRECTION: Install spacer plate and T.C.C. regulator valve that are compatible with one another. Refer to Figures 21 and 22.

THIS TYPE OF CONVERTER CLUTCH REGULATOR VALVE REQUIRES
SPACER PLATE WITH HOLE SHOWN BY ARROW ABOVE.

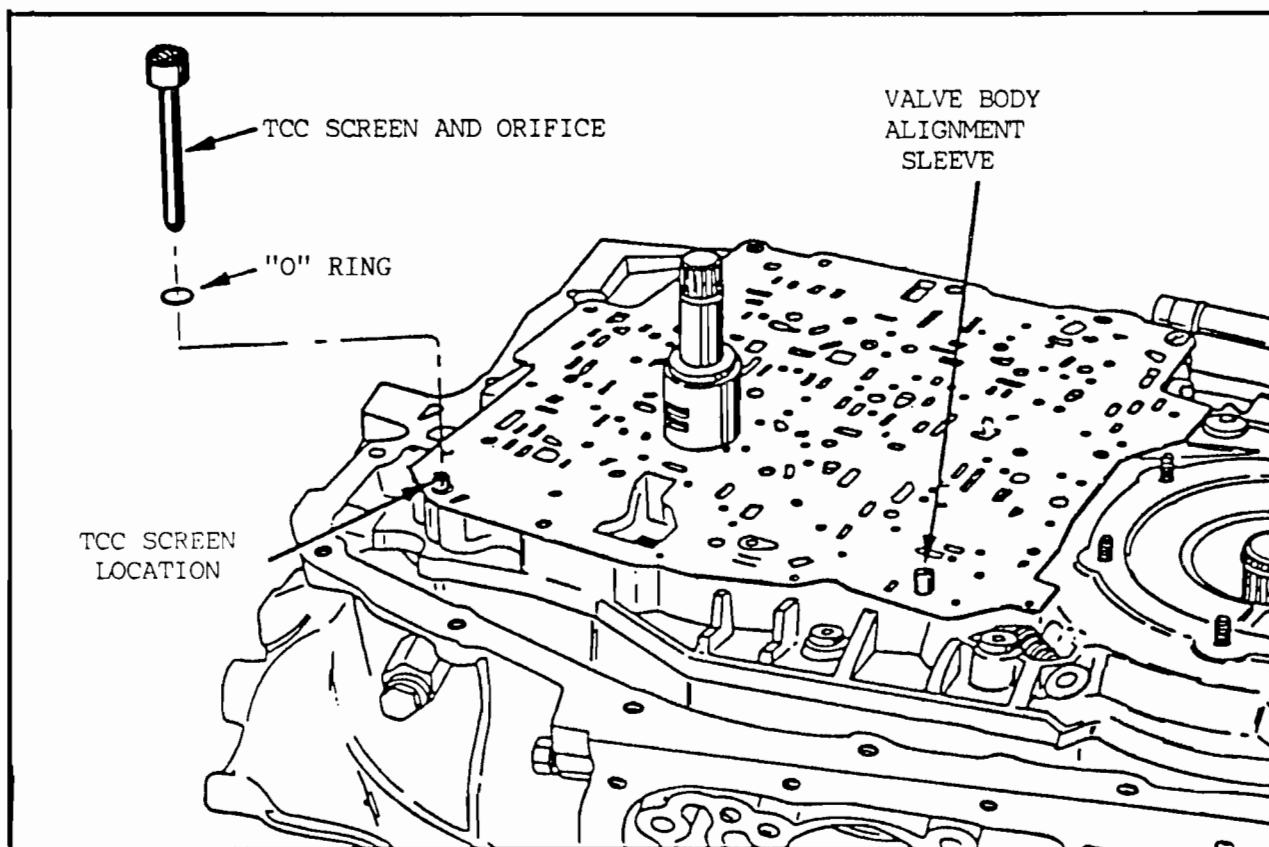
Figure 23

CAUSE: The cause may be one of the following:

- (1) The TCC screen and orifice assembly missing from its location in the spacer plate (See Figure 23).
- (2) The TCC screen and orifice assembly "Melted" and usually found in the TCC solenoid, blocking the exhaust passage. Usually an aftermarket product, not OEM.
- (3) The TCC solenoid blocked with foreign material.
- (4) TCC solenoid for Canadian application, which is self grounded, installed on a computer controlled transaxle (See Figure 24).
NOTE: Will not lock-up with wire harness disconnected.

CORRECTION: (1) Install the TCC screen and orifice assembly, with the "O" ring, in its proper location in spacer plate (See Figure 23).
OEM part numbers are found below.

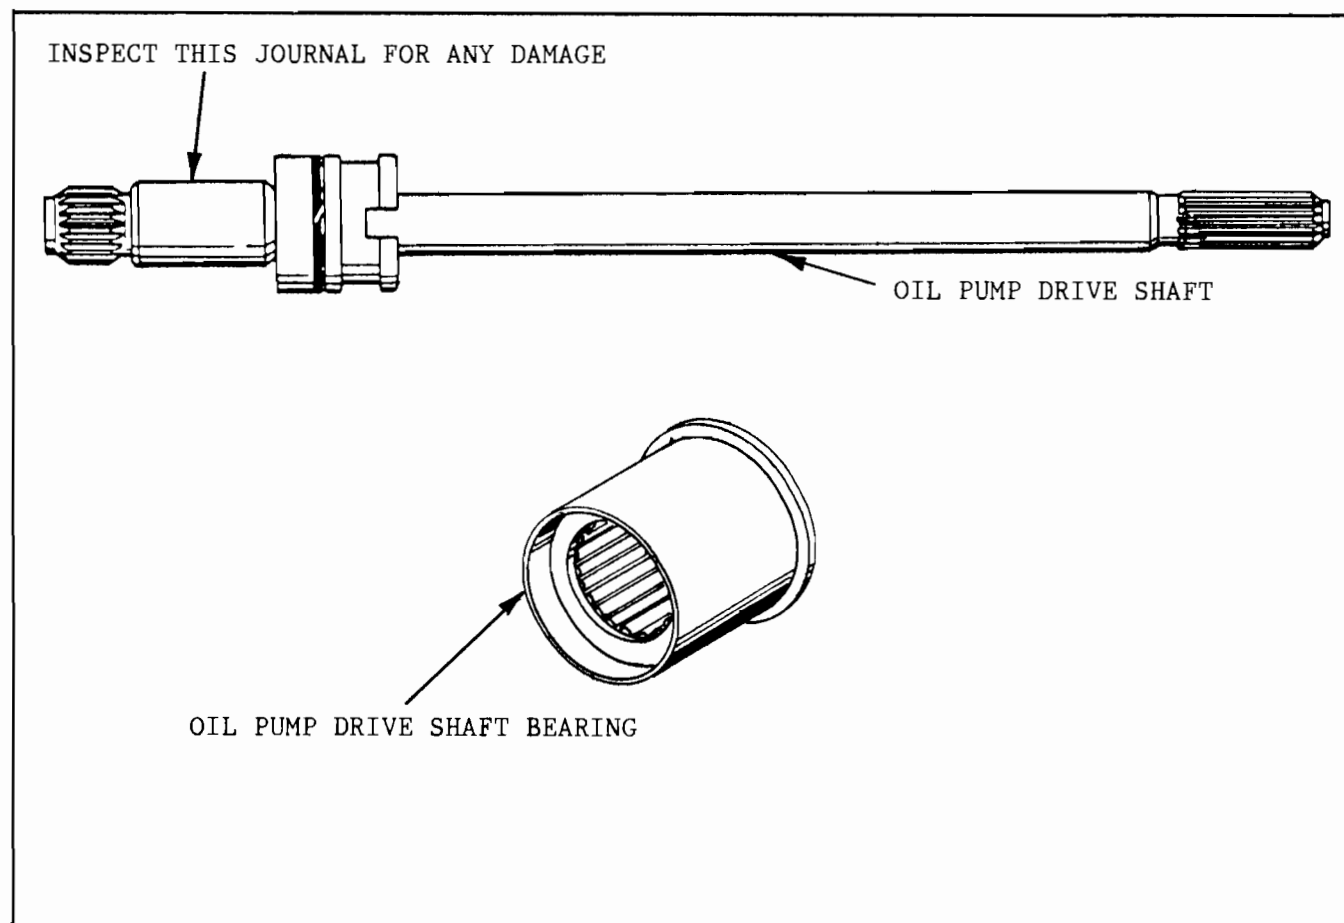
Figure 28

CAUSE: The cause may be a defective oil pump drive shaft and/or the bearing in the valve body that the pump shaft rides in. Inspect the bearing journal on the oil pump drive shaft (See Figure 28). A defective oil pump drive shaft bearing is not easily detected without destroying the bearing, may as well replace it.

CORRECTION: Replace the oil pump drive shaft as necessary, and our recommendation is to replace the bearing on every rebuild.
