# Technical Service Information

## **THM 4T80-E TROUBLE CODE P039 OR OBD II CODE P0741**

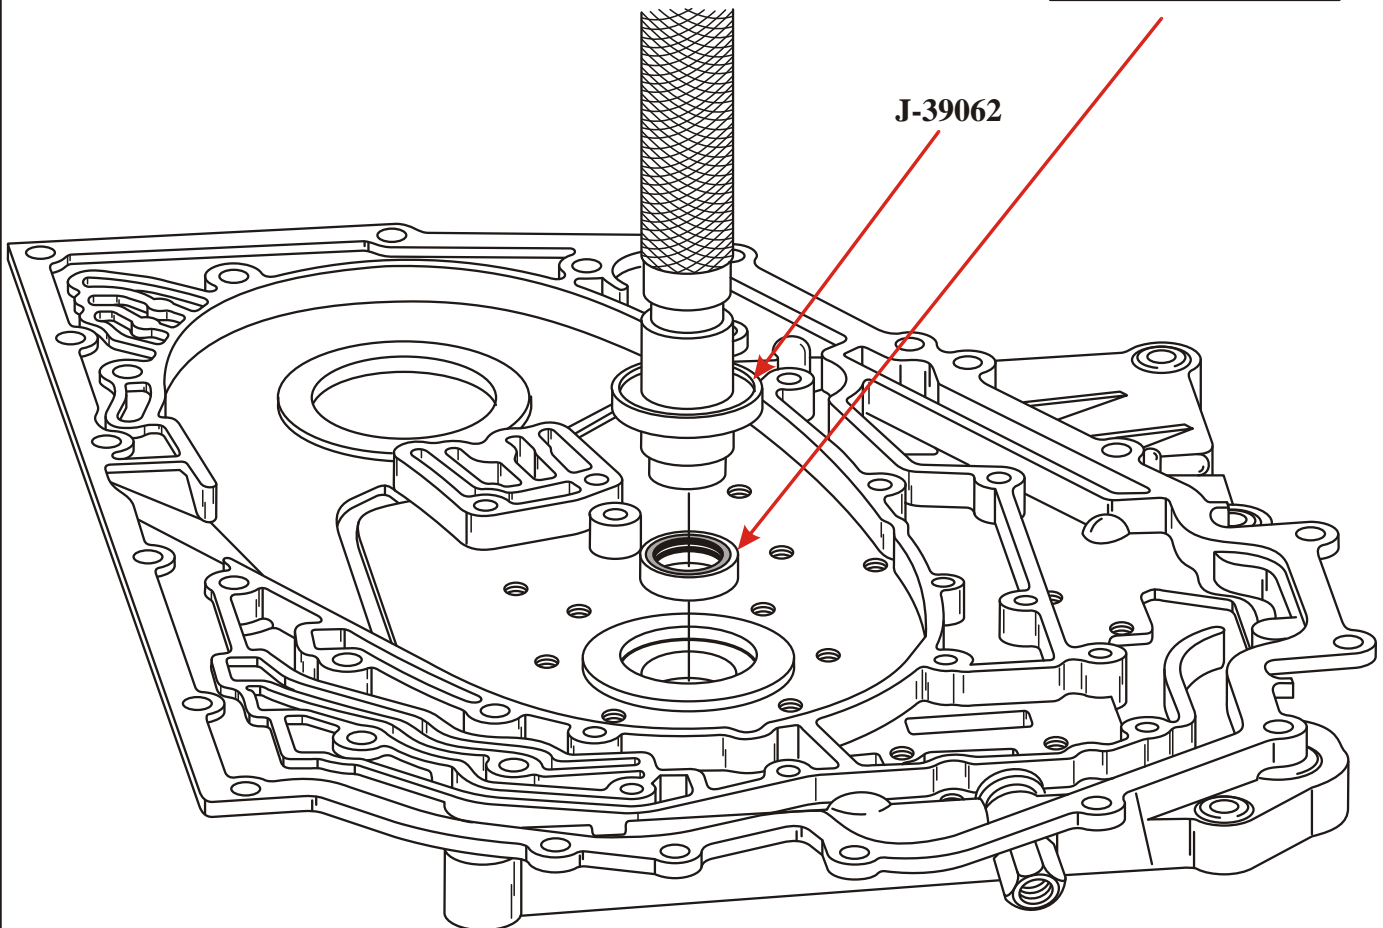
Figure 1

**COMPLAINT:** Vehicle illuminates the "Check Engine" lamp and stores Diagnostic Trouble Code P039 on 1993-1995 models, or OBD II Code P0741 on 1996-Up models. The converter clutch may or may not be operational.

**CAUSE:** The cause may be, one or both of the metal clad seals located in the channel plate not installed during the rebuilding process. Some overhaul kits do not include the turbine shaft seal in the kit.

## TURBINE SHAFT SEAL ASSEMBLY

*Cut-Away View of  
Double Lip Seal and  
Sleeve Assembly  
OEM Part Number  
24201991*

**CORRECTION:** After removing both seals from the channel plate, install the Turbine Shaft Seal into the channel plate first, using the seal driver shown in Figure 1. The Turbine Shaft Seal is a double lip metal clad seal that is incorporated into a steel sleeve, and should be installed in the direction shown in Figure 1, as it is off-set in the sleeve.  
Next install the Drive Sprocket Seal into the channel plate, using the seal driver shown in Figure 2. Install the Drive Sprocket Seal with lip facing direction shown in Figure 2.  
If your overhaul kit did not include one or both of these seals, use the OEM part numbers listed under "Service Information" to obtain them.

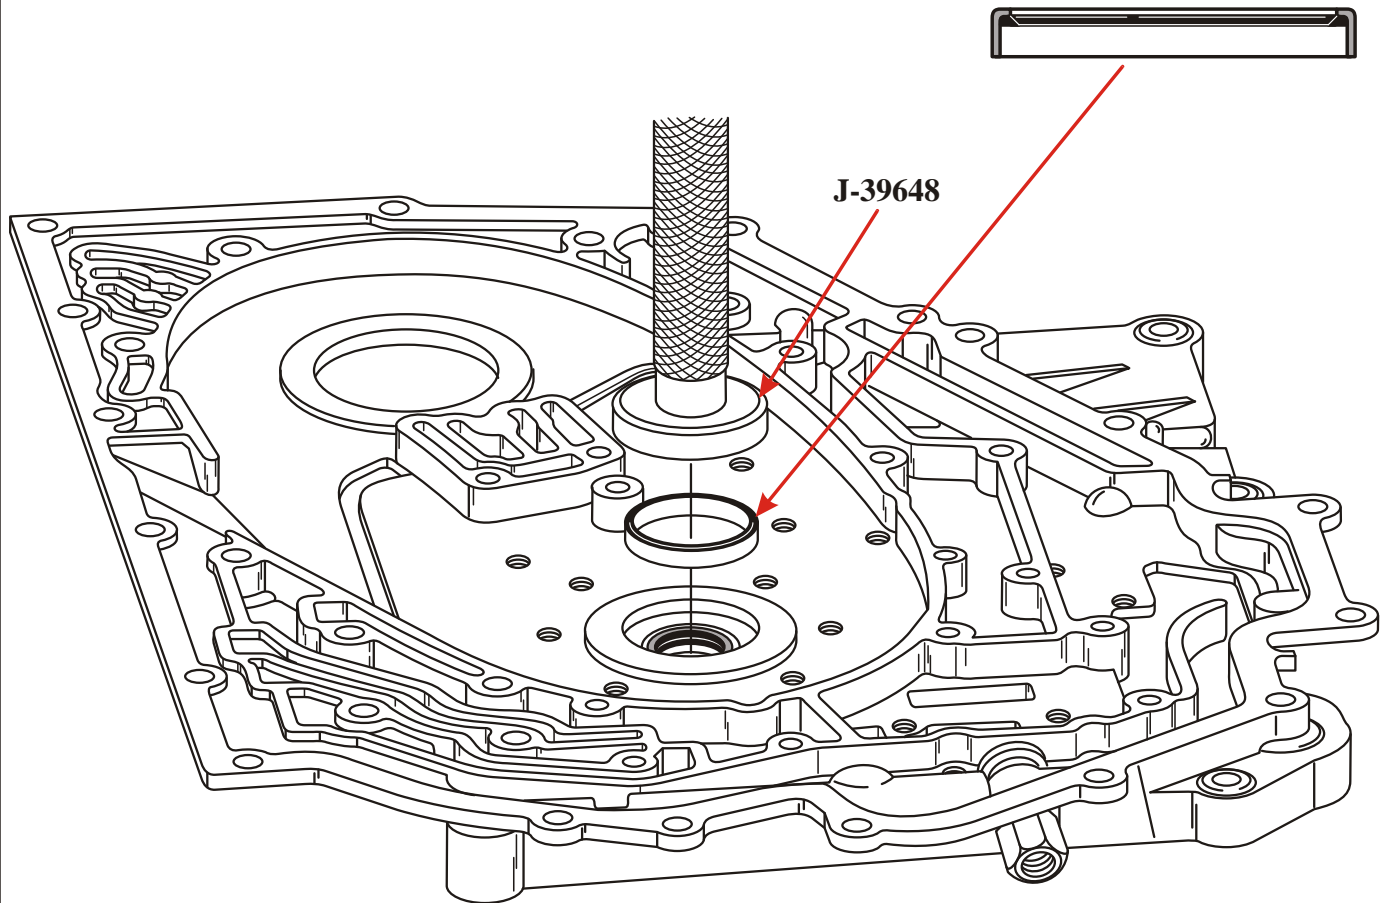
Figure 2

## DRIVE SPROCKET SEAL ASSEMBLY

*Cut-Away View of  
Drive Sprocket Seal  
OEM Part Number  
24201992*
