# Technical Service Information

## SATURN TAAT

### FALLS OUT OF DRIVE AT A STOP

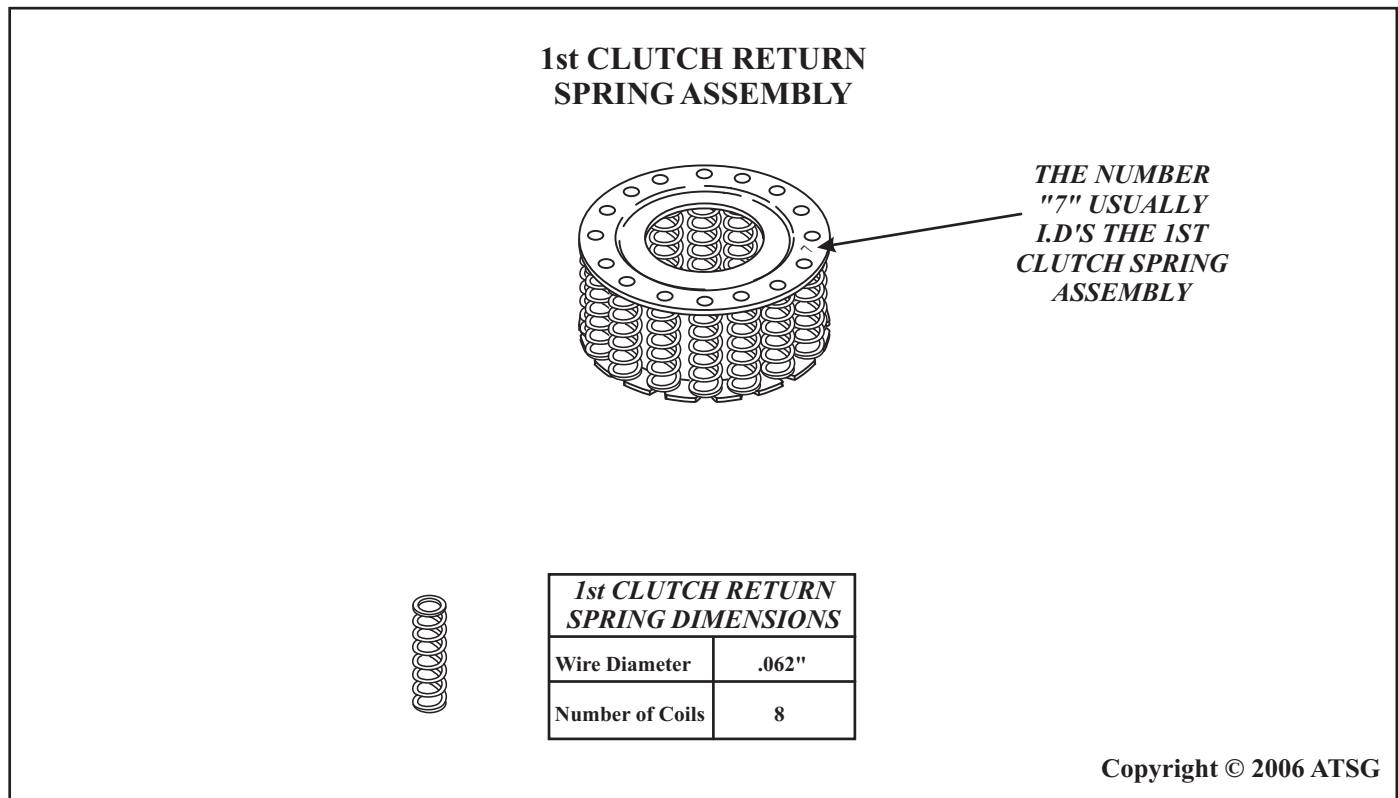
**COMPLAINT:** After overhaul, Saturn vehicles equipped with the MP6 or MP7 transaxle, may exhibit a complaint of falling out of "Drive" at a stop, or a slipping condition on take off.

**CAUSE:** The cause may be, that during overhaul, the 2nd, 3rd or 4th Clutch return spring assembly was mistakenly used in place of the 1st Clutch spring assembly. When this happens, the 1st Clutch can not fully engage until line pressure is increased. Refer to Figure 1 and 2 to compare the 1st Clutch return spring assembly to the 2nd, 3rd and 4th. Notice that the coil diameter of the springs, on 2nd, 3rd and 4th are approximately .010" larger and the number of coils are one more than the 1st which makes them stronger.

**CORRECTION:** Refer to Figure 1 to identify the 1st Clutch return spring assembly, and ensure it is in the correct location.

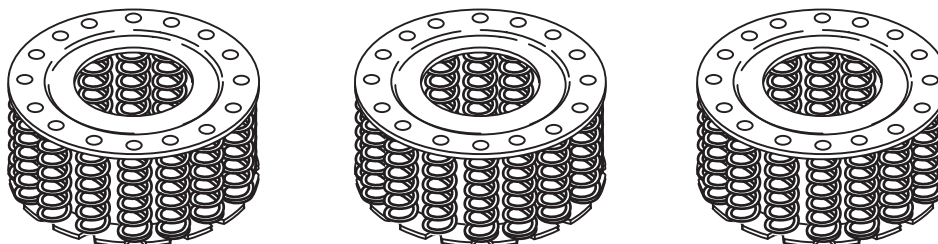
Figure 2

## 2nd, 3rd and 4th CLUTCH RETURN SPRING ASSEMBLIES

<i>2nd, 3rd and 4th CLUTCH RETURN SPRING DIMENSIONS</i>	
Wire Diameter	.072"
Number of Coils	9
