Technical Service Information

THM 4L60 (700-R4) NO 4TH GEAR

COMPLAINT: No 4th gear before and/or after overhaul.

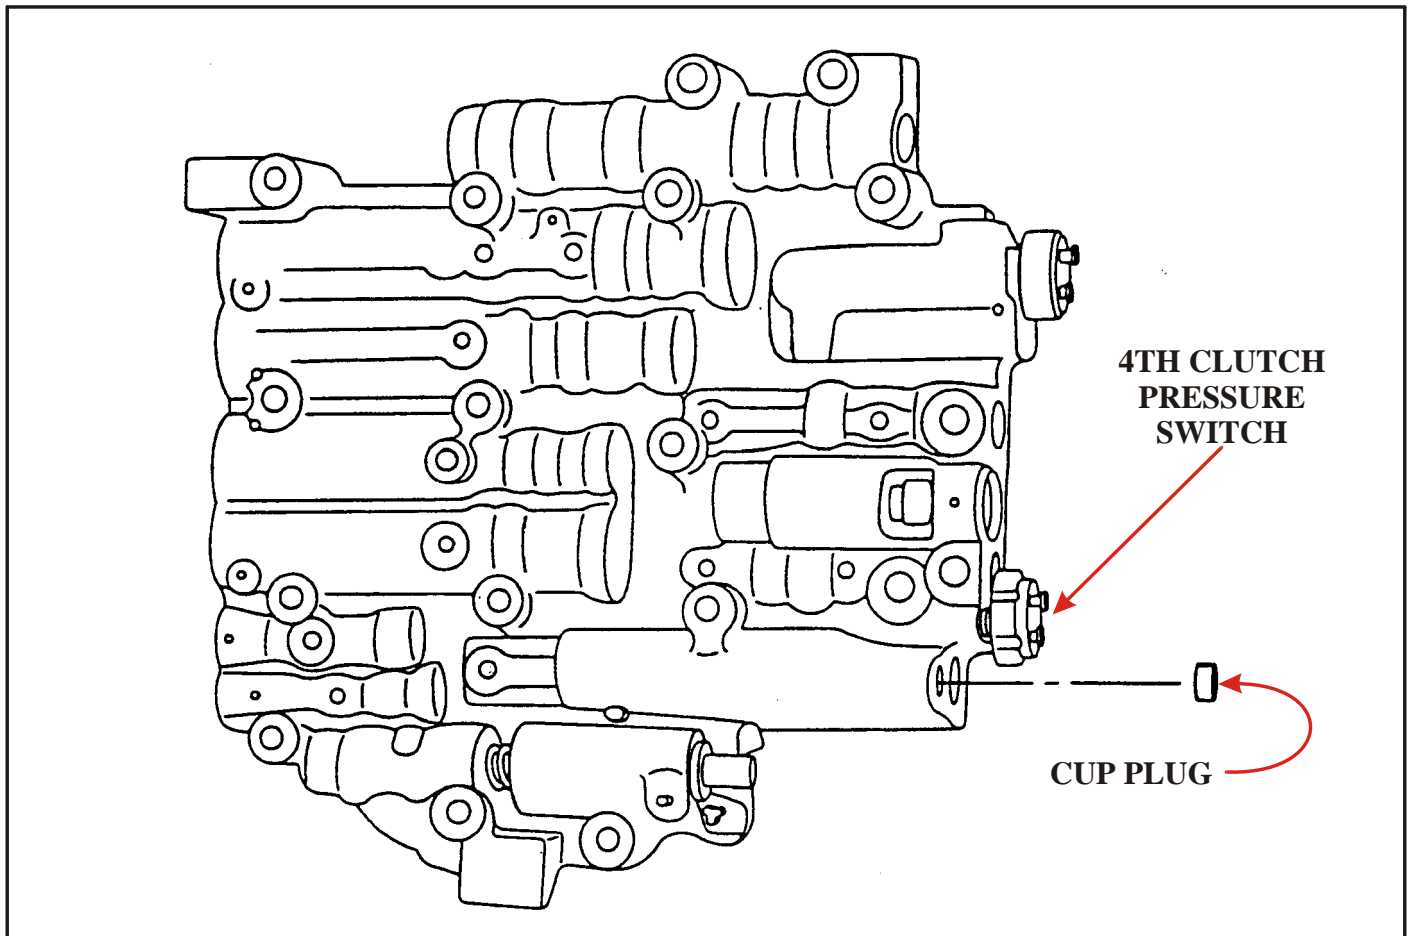
Figure 1

CAUSE: The cup plug missing from the servo feed passage in the valve body shown in figure 1.

The 4th clutch pressure switch is leaking causing a loss of 4th signal oil to the 3-4 relay valve (See Figure 1).

CORRECTION: Install a cup plug in the bore as shown in figure 1.

Screw the 4th clutch pressure switch into the end of your blow gun and pressurize the switch. if are comes out of the front of the switch, replace the switch with one that does not leak (See Figure 1).

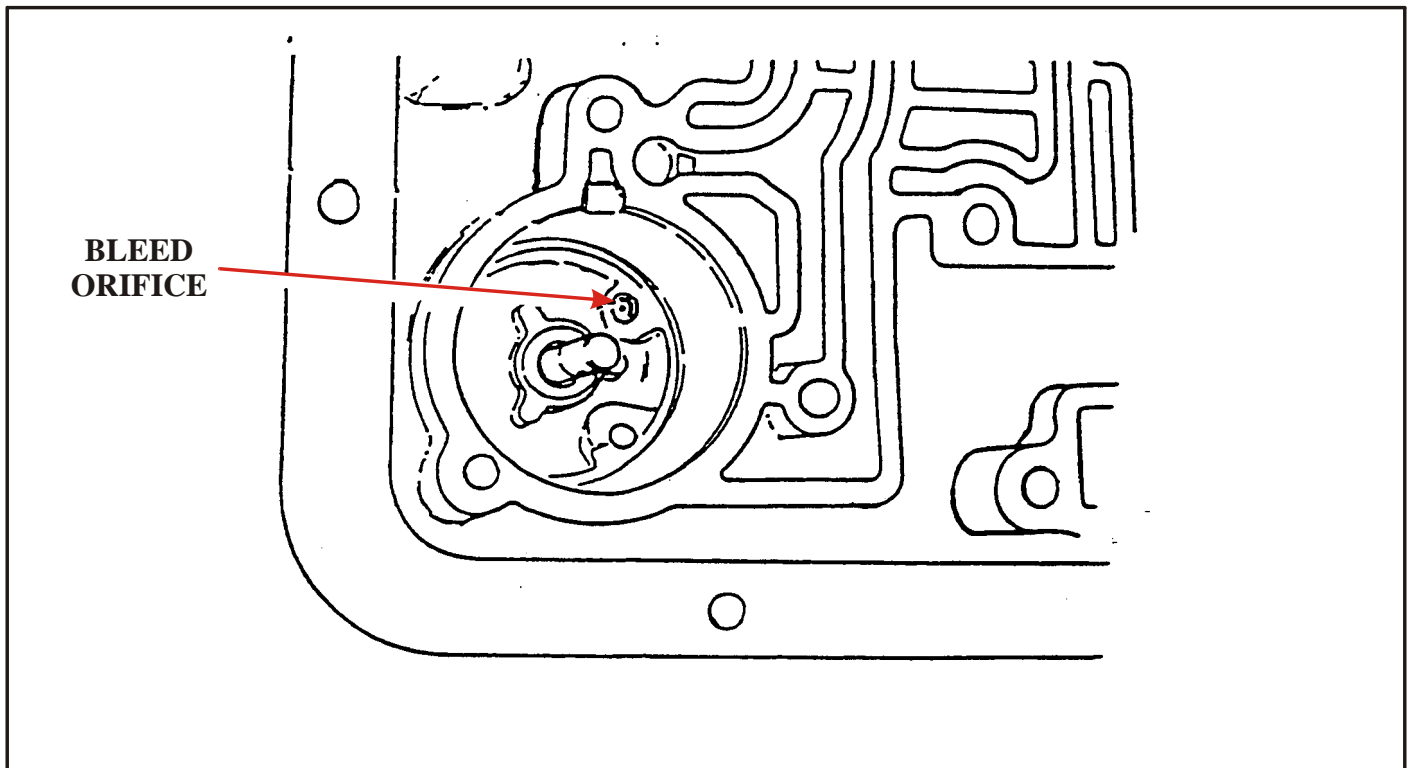
Figure 2

The bleed orifice cup plug is missing from the case in the bottom of the 3-4 accumulator bore (See Figure 2).

Replace the missing bleed orifice, part # 8628864 (See Figure 2). Install the 3-4 relay valve correctly as shown in figure 3.

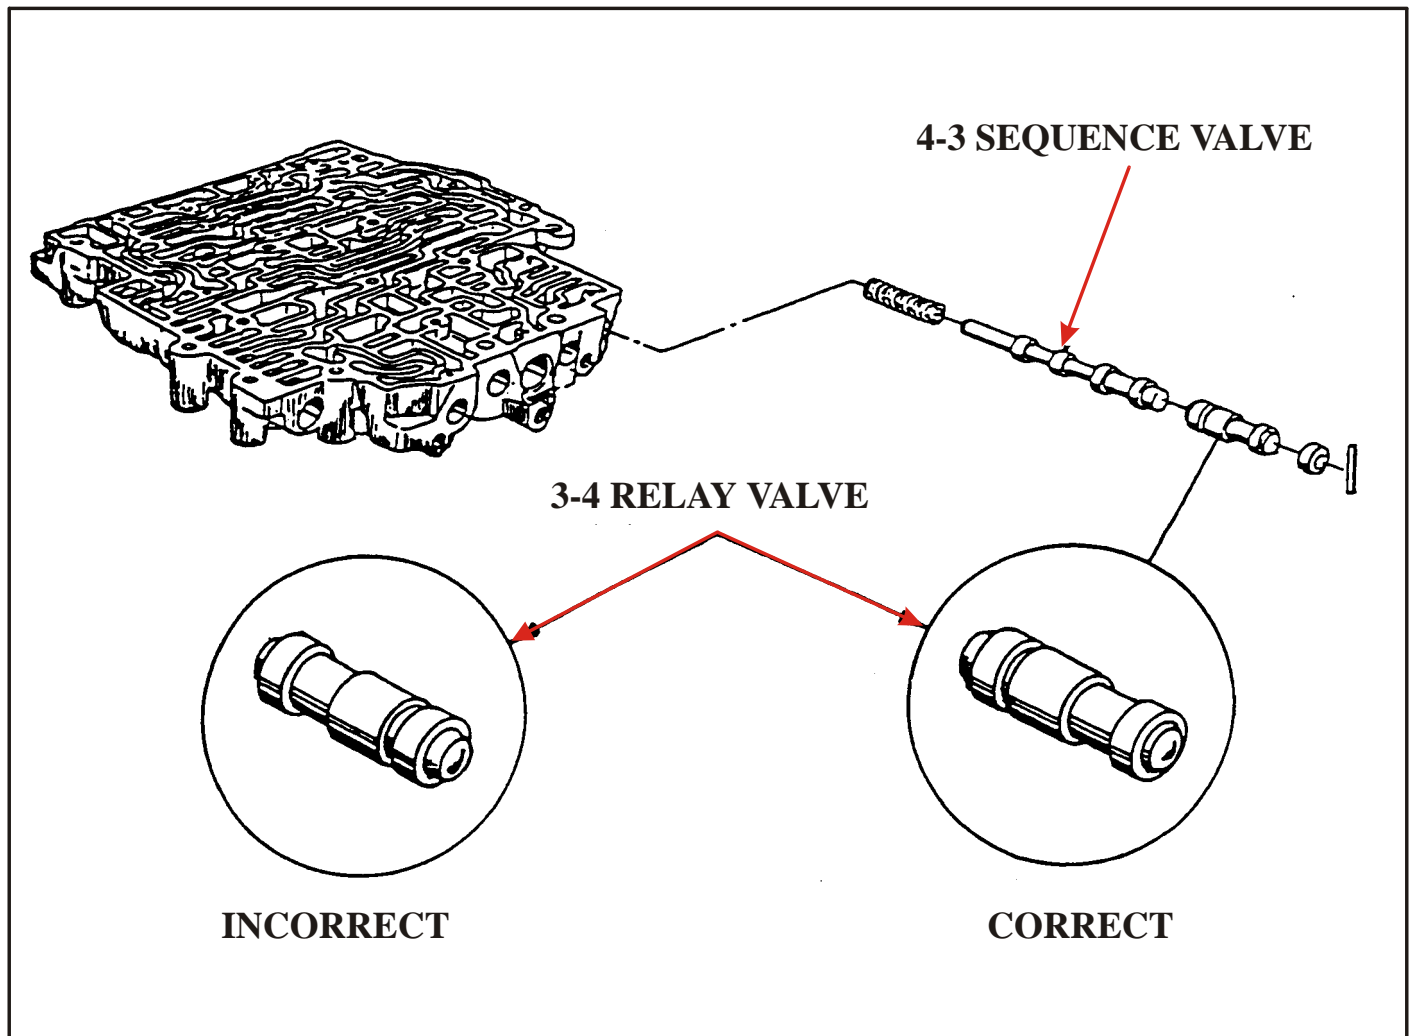
Figure 3

The 3-4 relay valve may be installed backwards (See Figure 3).

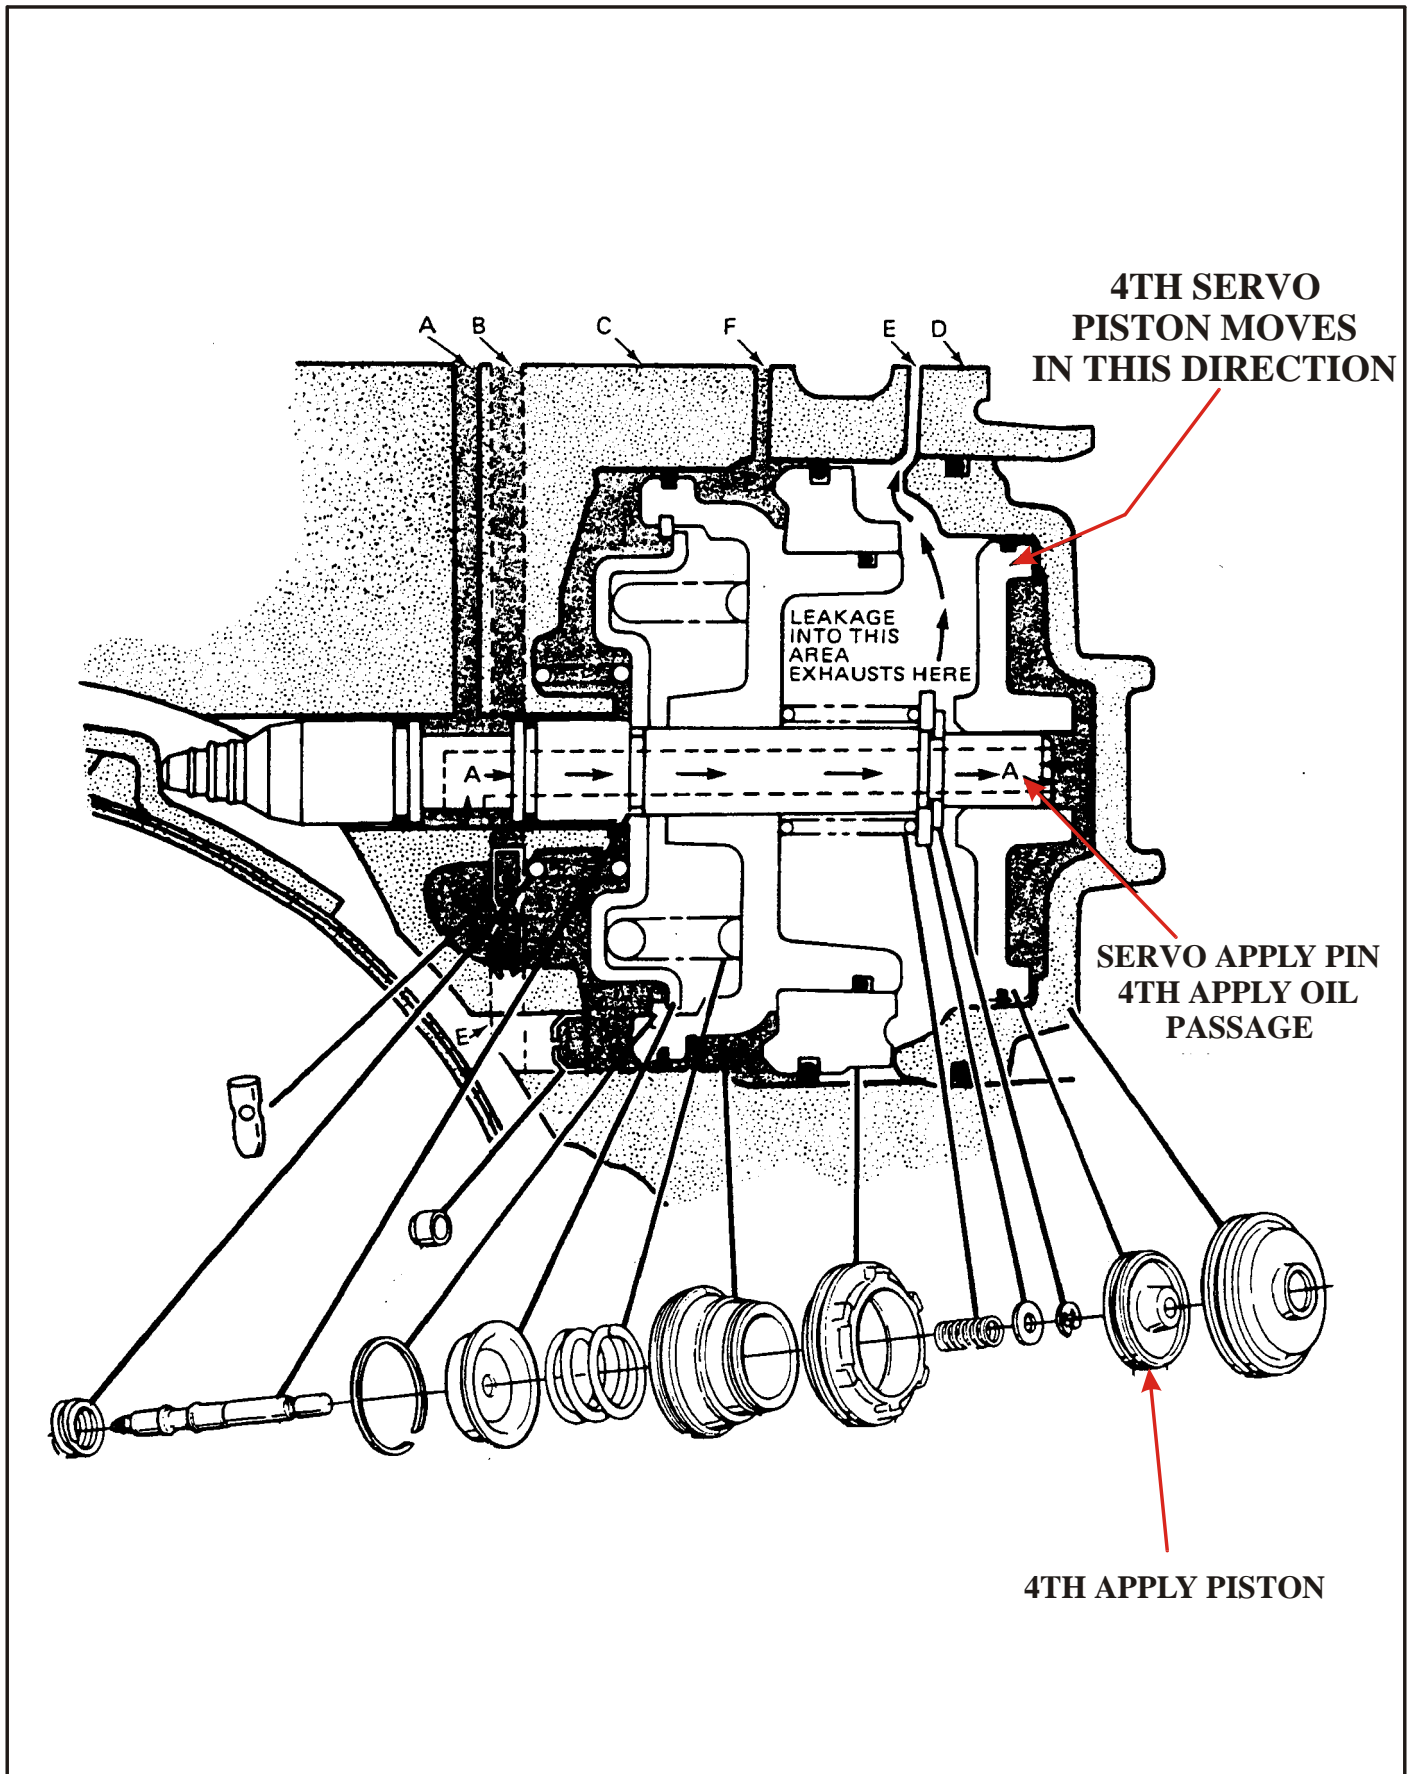
Figure 4

The 4th apply piston seal in the servo may be missing or torn causing 4th apply oil to leak into the exhaust (See Figure 4).

The 4th oil apply passage in the servo apply pin may be blocked with foreign material (See Figure 4).

Repair or replace the sealing ring on the 4th apply piston in the servo (See Figure 4). Remove the foreign material that is blocking the 4th apply passage in the servo pin (See Figure 4).

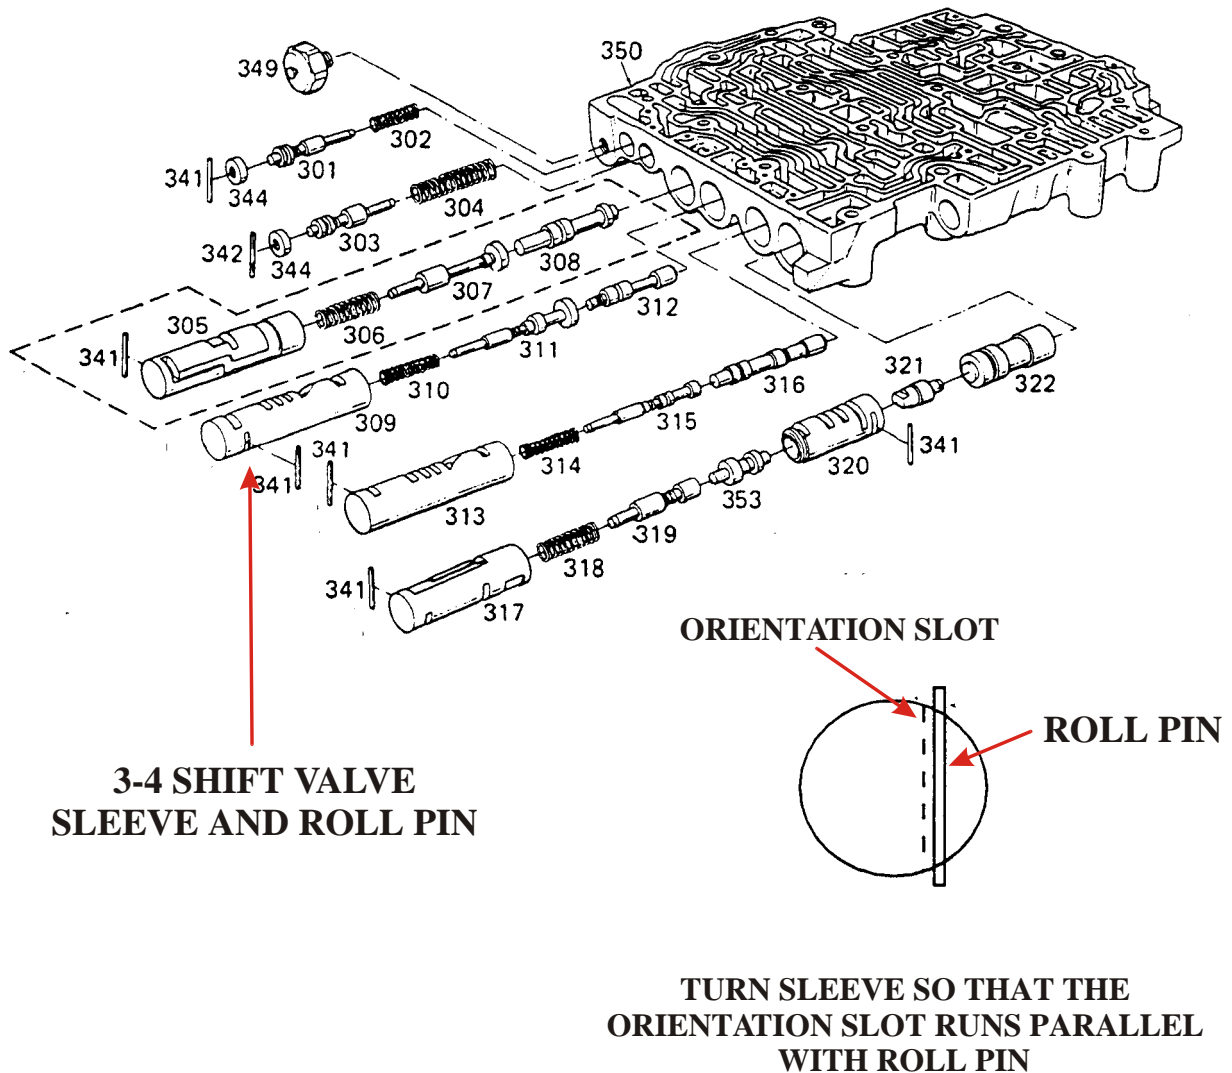
Figure 5

The 3-4 shift valve sleeve may be rotated to far against the roll pin (See Figure 5).

Rotate the 3-4 shift valve sleeve so that it does not rest up against one-end of the roll pin (See Figure 5).

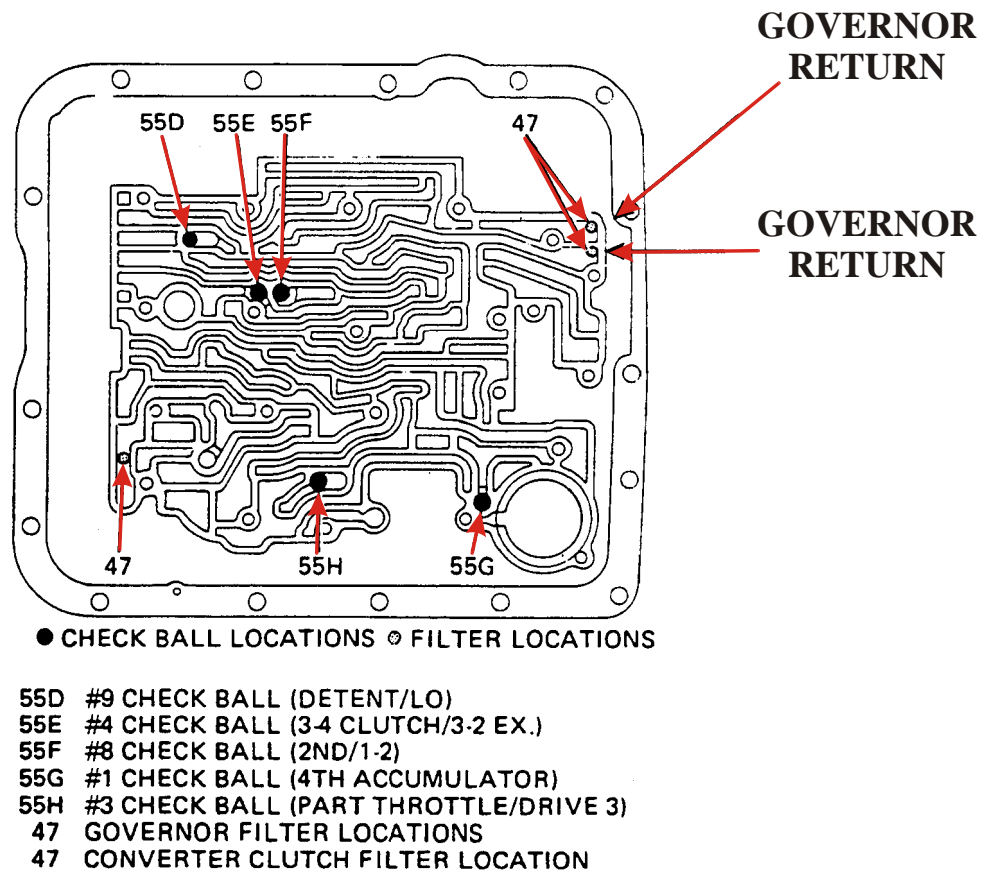
Figure 6

The governor may be defective, or the governor bore is worn, or the screen in the governor feed circuit may be restricted (See Figure 6).

Replace the governor, resleeve the bore if necessary, and remove the filter from the feed circuit if it has been installed (See Figure 6).
