Technical Service Information

SATURN NO CONVERTER CLUTCH APPLY

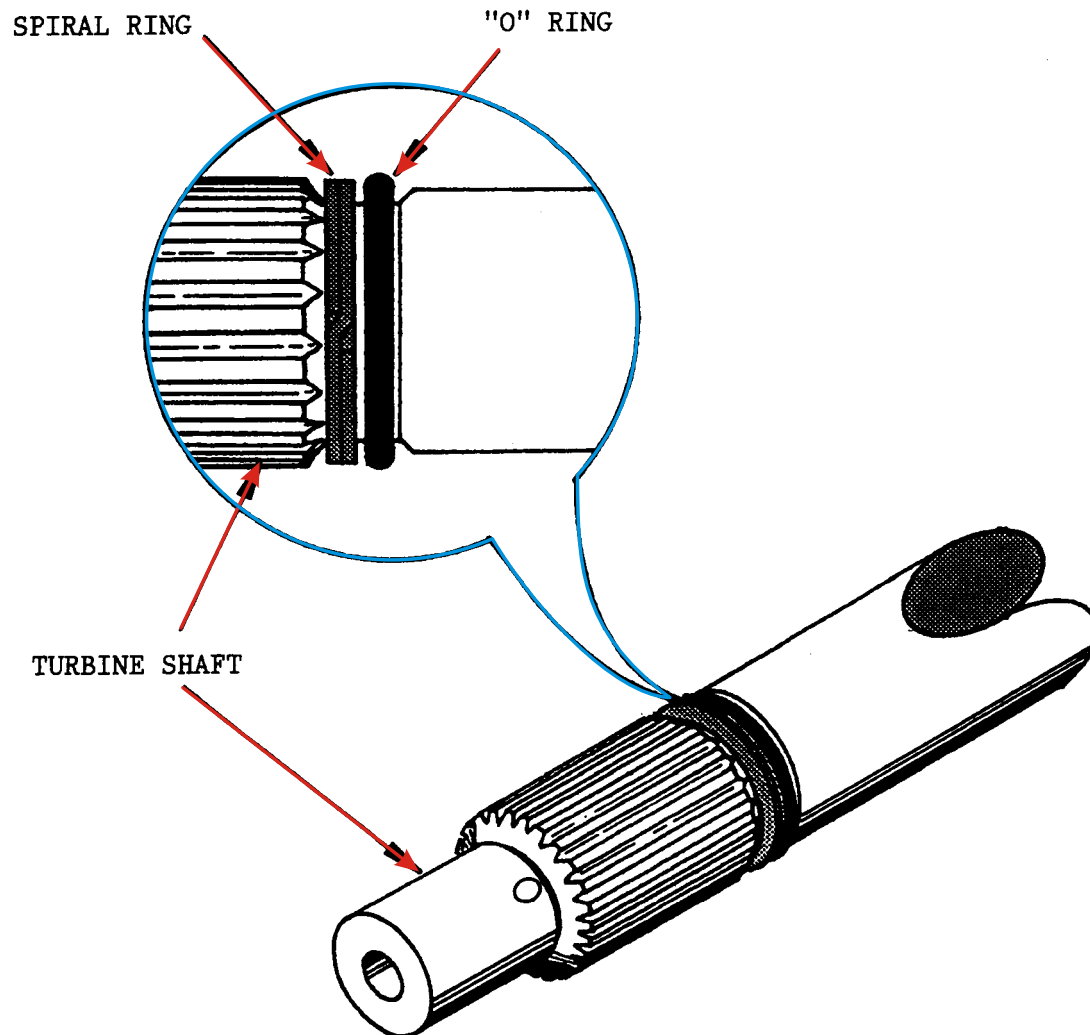
SATURN TURBINE SHAFT

CAUSE: The cause may be, the "O" ring on the turbine shaft missing. The "O" ring **MUST** be installed in the turbine shaft groove **BEHIND** the spiral ring, as shown in Figure 1, and **NOT** next to the turbine shaft splines.
If the "O" ring is installed next to the splines, the "O" ring will roll off and remain in the torque converter as the converter is removed from the transaxle.

THE "O" RING MUST BE INSTALLED IN THE TURBINE SHAFT GROOVE BEHIND THE SPIRAL RING, AS SHOWN ABOVE.

CORRECTION: Install a new, proper size, "O" ring into the turbine shaft groove. Make sure the "O" ring is placed **BEHIND** the spiral ring, as shown in Figure 1, and **NOT** next to the turbine shaft splines. It is not necessary to remove the spiral ring to install the "O" ring into the groove in the proper position.
