## THM 440-T4 MODULATOR AND MODULATOR VALVE CHANGE

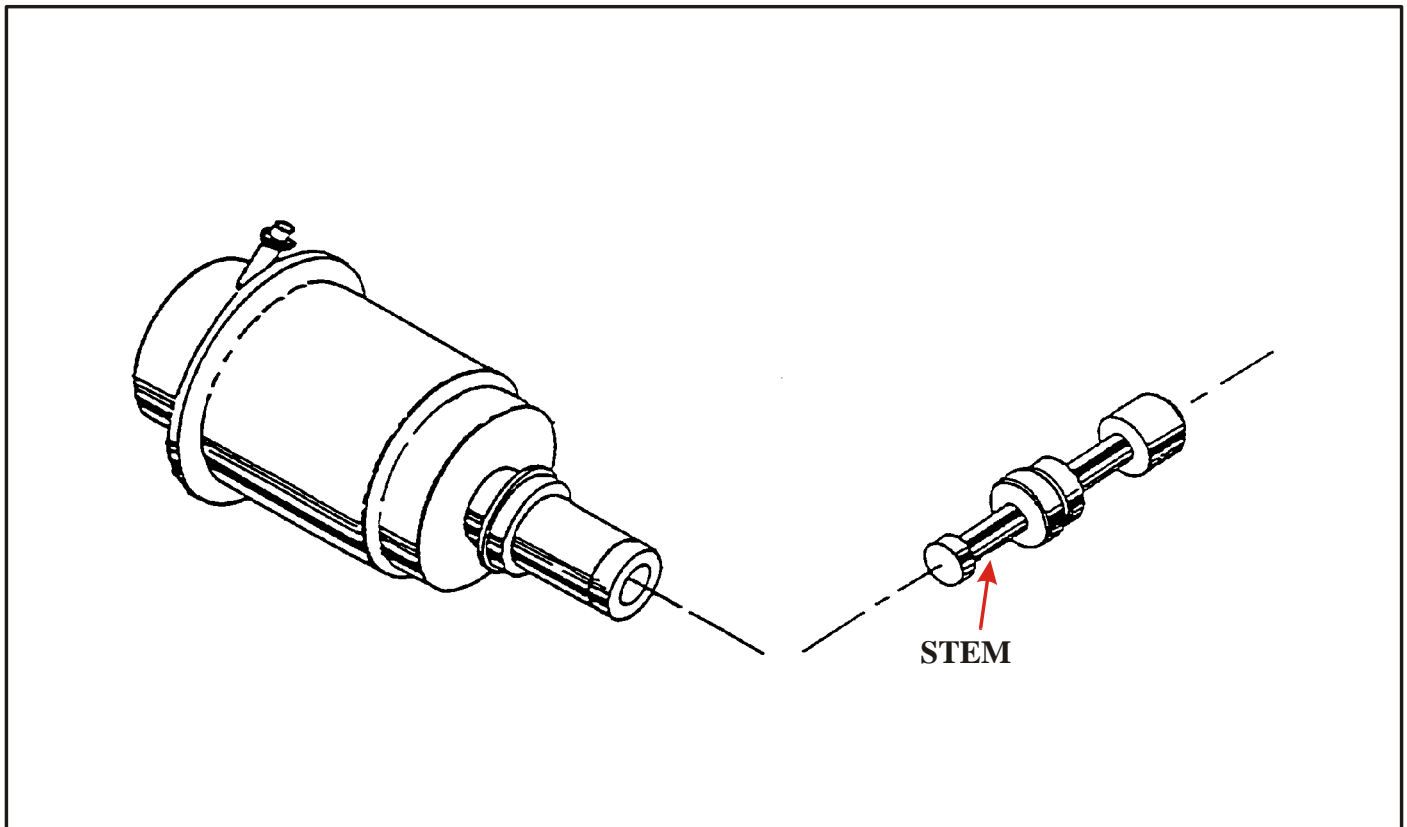
Refer to Figure 1 for the Previous vacuum modulator and modulator valve, and Figure 2 for the latest vacuum modulator and modulator valve.

A new vacuum modulator assembly, and a new modulator valve have been released for service in a package (OEM Part No. 8646956). for the harsh upshift condition. The dimensions of the new vacuum modulator and the new modulator valve have changed drastically. If the previous style vacuum modulator was to be installed with the latest modulator valve, damage to the trans-axle could occur as a result of low line pressure.
