Technical Service Information

KM 175 SLIPPING OR NO REVERSE

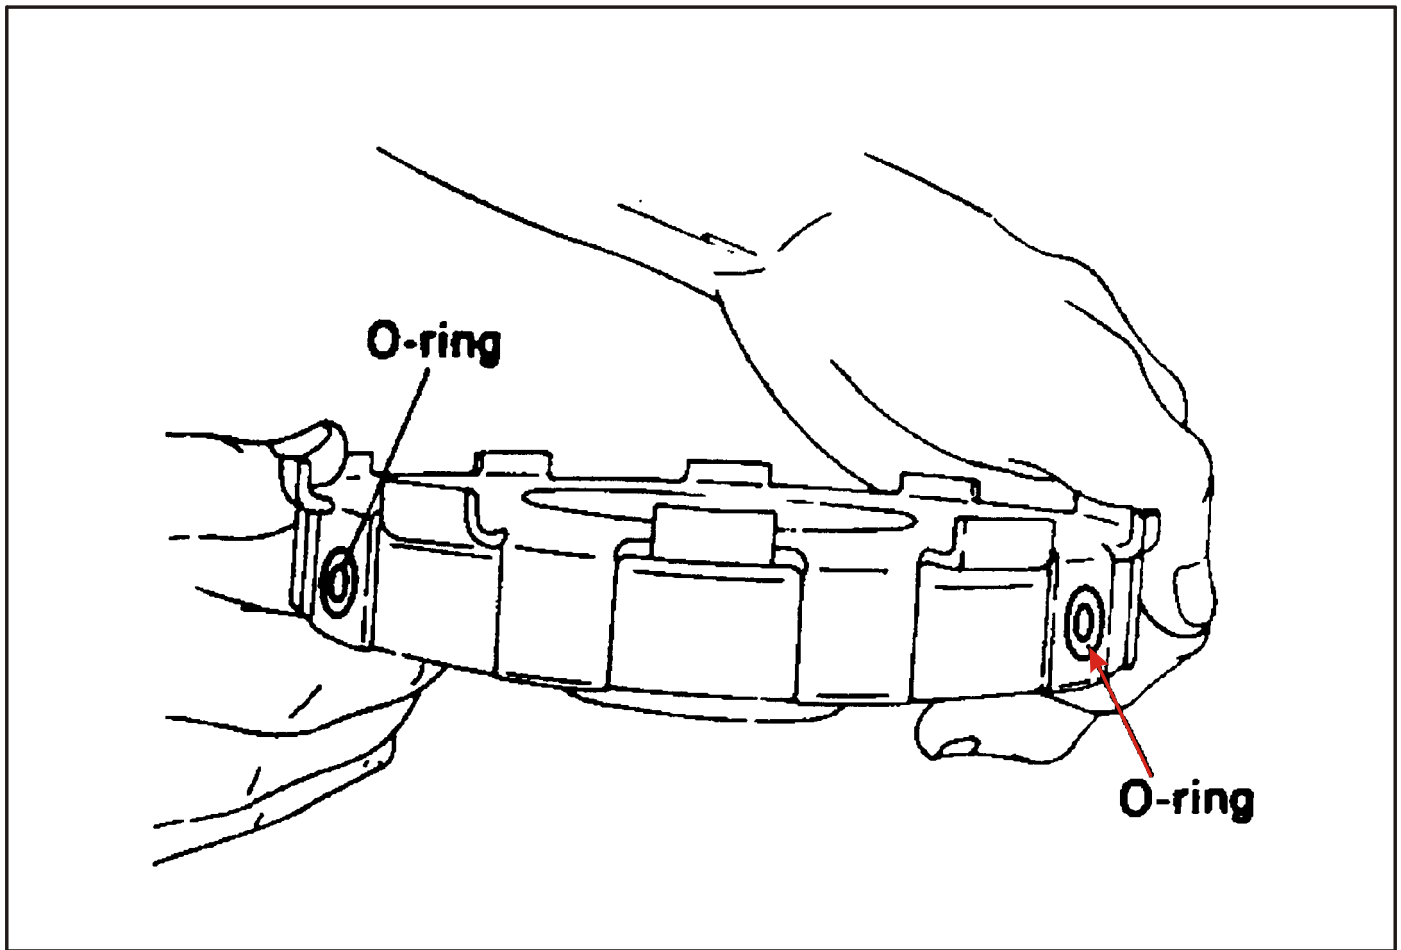
Figure 1

COMPLAINT: Slipping or no reverse when hot after overhaul.

CAUSE: Missing or undersized O-rings on the center support causing a loss of low and reverse oil.

CORRECTION: Install or replace O-rings with a thicker O-ring. A C4 inner linkage seal O-ring is thicker and fits nicely into the support. This will provide a better compressed seal when the support is placed into the case. See figure 1 below for the O-ring location on the center support.
