Technical Service Information

CHRYSLER A904/A999 NO UPSHIFT, AFTER REBUILD

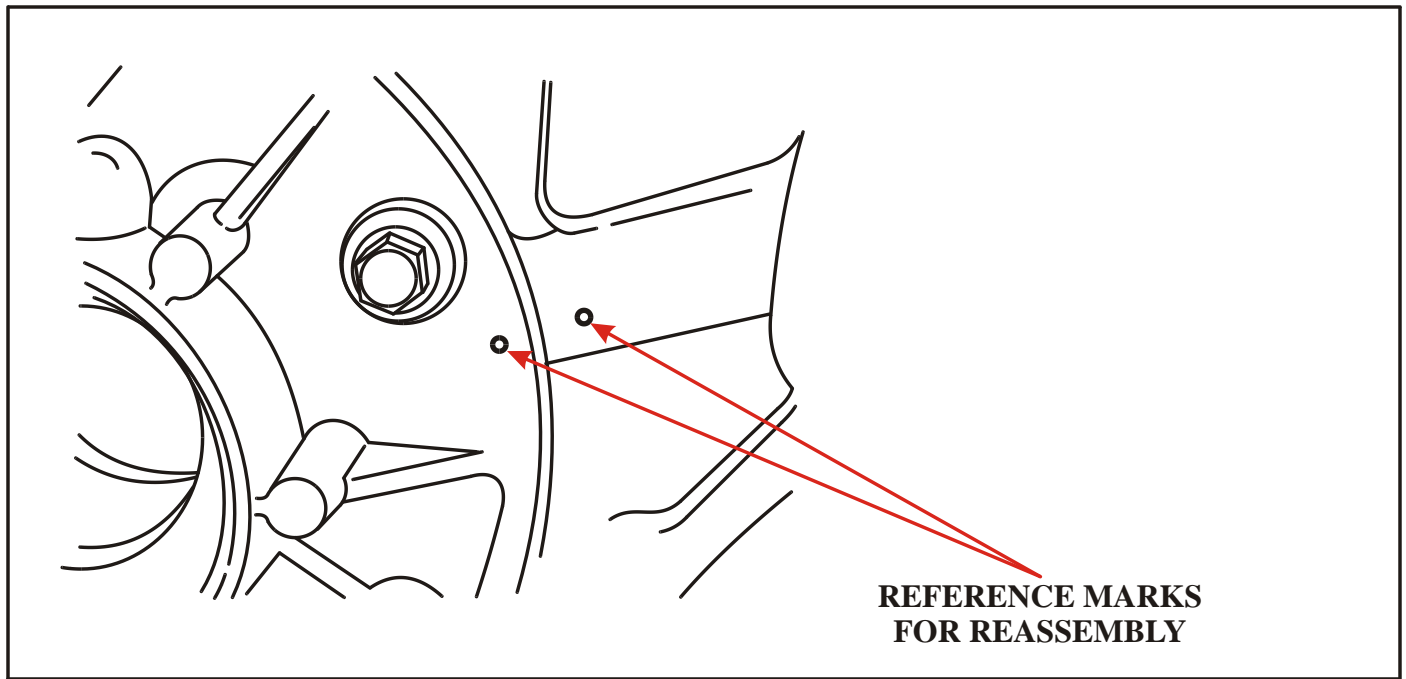
Figure 1

**GOVERNOR SUPPORT
FRONT VIEW**

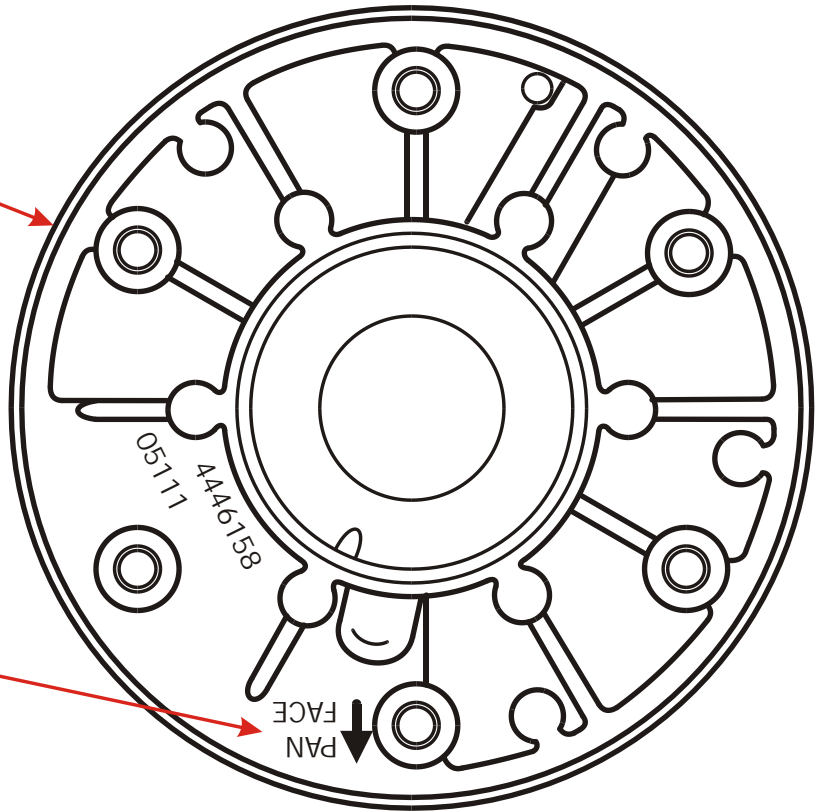
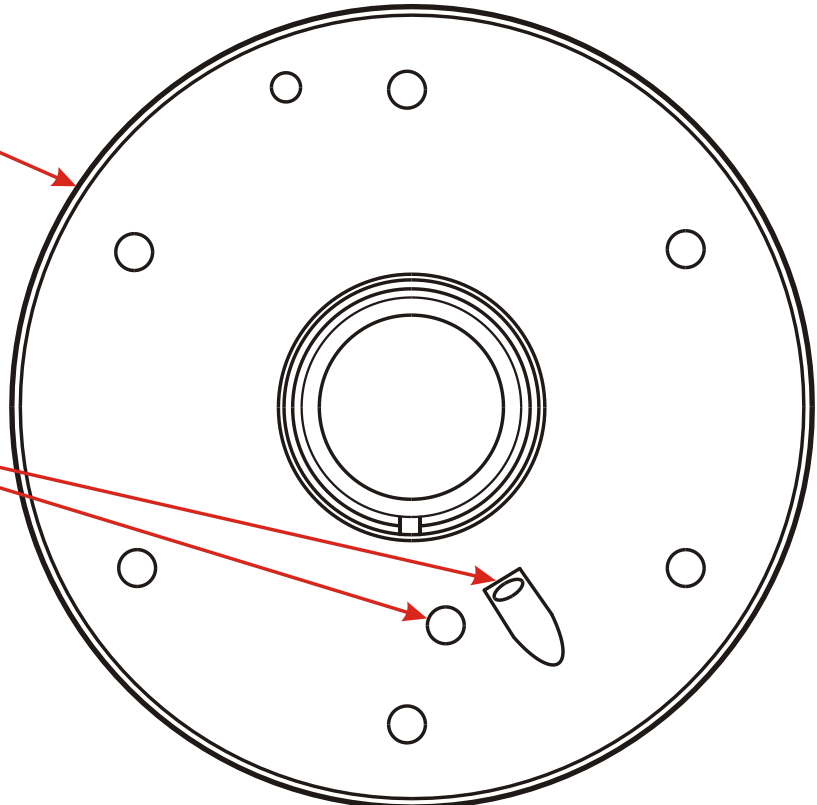
Figure 2

SOME SUPPORTS ARE
MARKED WITH ARROW

FEED PASSAGES

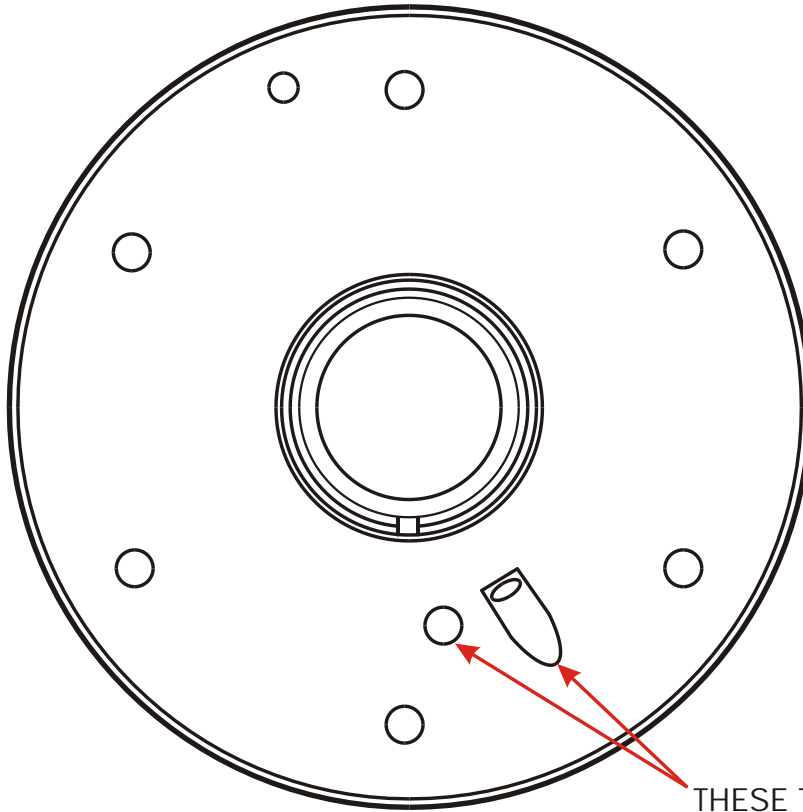
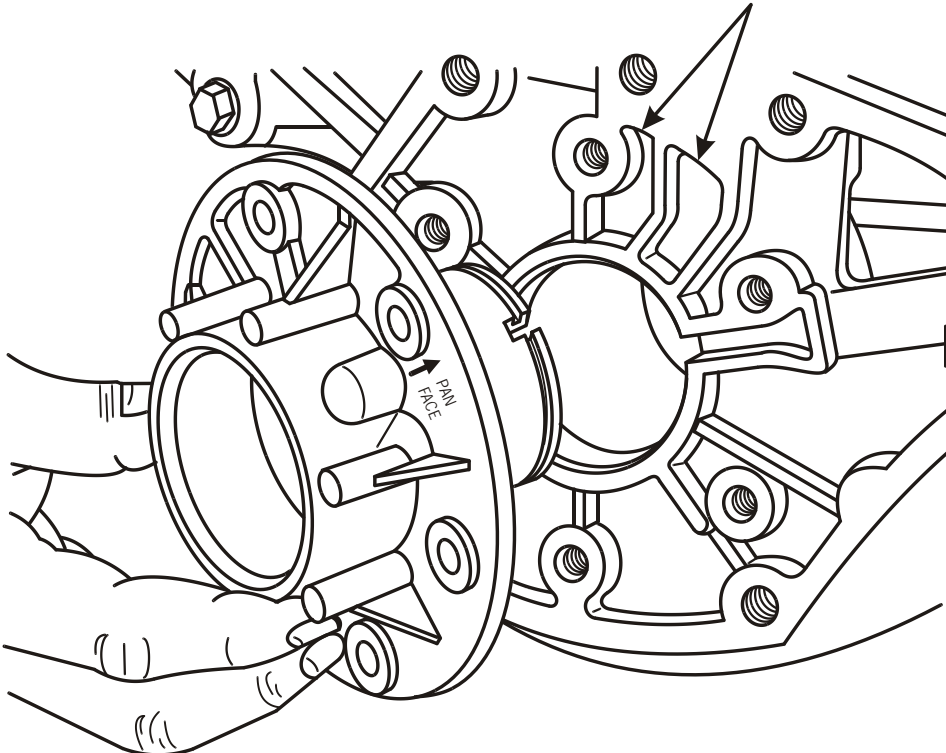
Figure 3

INSTALLING GOVERNOR SUPPORT

THESE TWO FEED PASSAGES
MUST BE ALIGNED WITH,
THESE TWO CASE PASSAGES

CORRECTION: The late model Chrysler A904/A999 transmissions have a Governor Support with the mounting holes evenly spaced, or concentric around the support, which will now allow you to install the Governor Support so that the governor feed passage is blocked. Some Governor Supports have an arrow with the words "PAN FACE" cast into the support as shown in Figure 2, and should be installed with the arrow towards the pan face. If your support is not so marked, make your own reference marks on the support and the case with a center punch as shown in Figure 1, before removing. If you have already removed the support, and your support is not marked with the arrow, the support must be installed into the case with the feed holes lined up with the corresponding case passages, as shown in Figure 3.
