# Technical Service Information

## **FORD 4EAT PROBE** **BIND UP IN REVERSE AND** **MANUAL LOW**

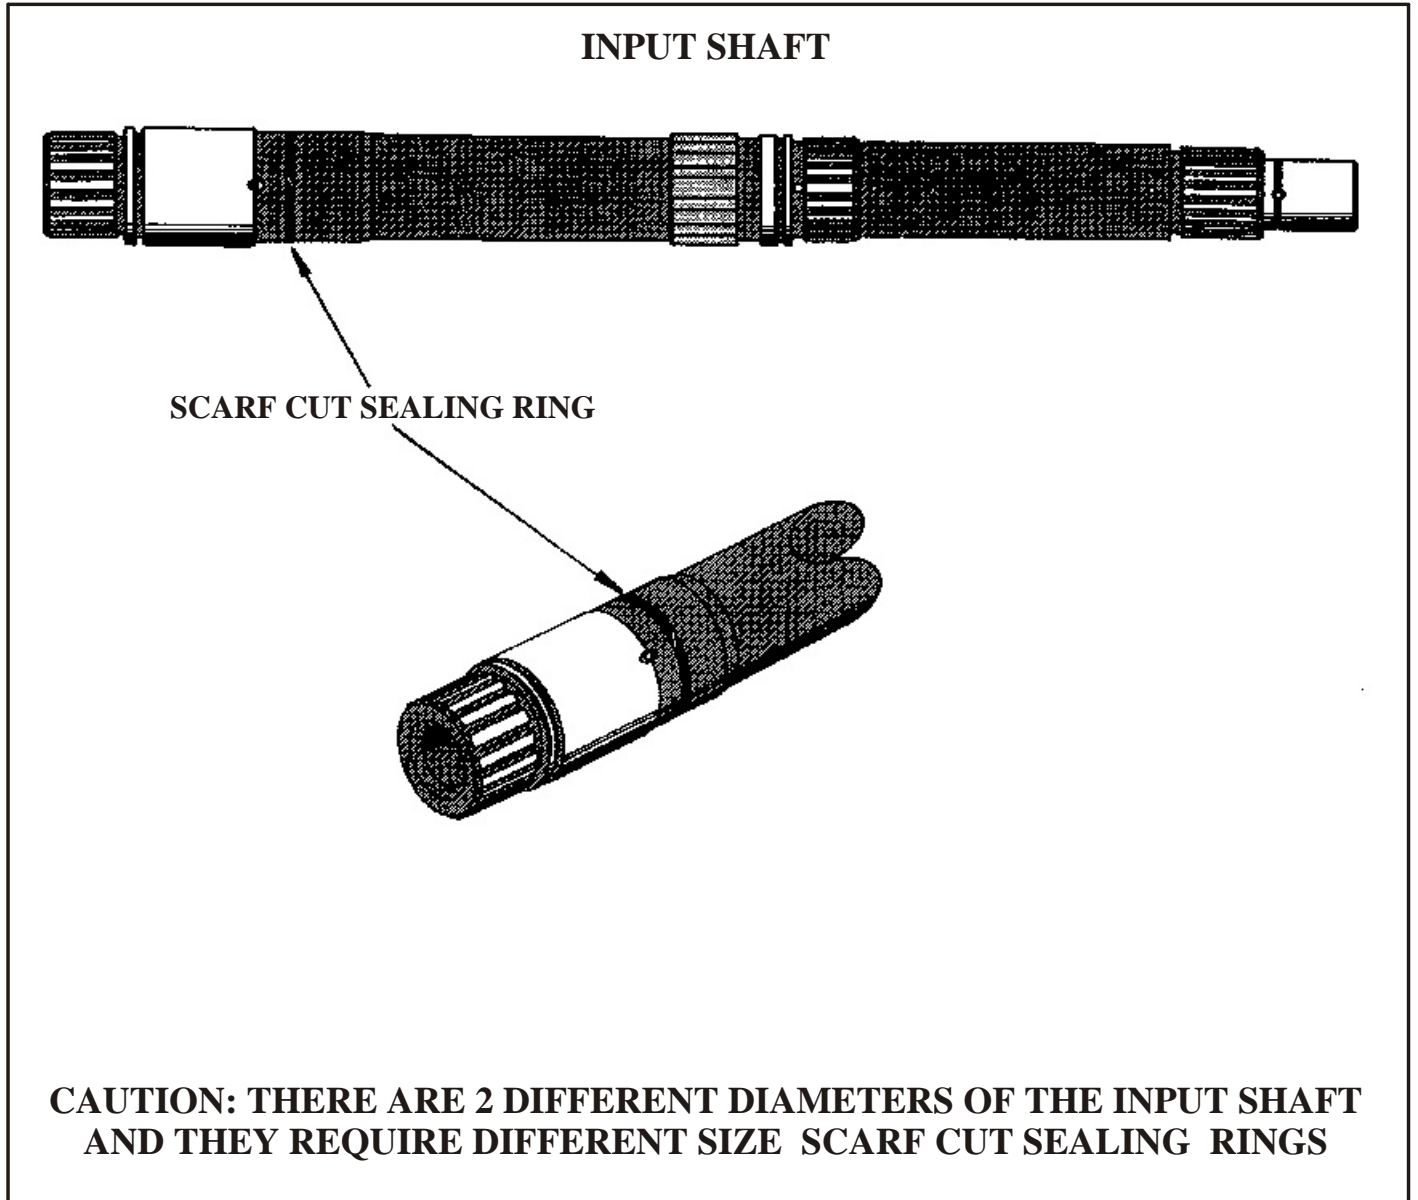
Figure 1

- COMPLAINT:** Bind-up when the selector lever is placed in Reverse or the Manual Low positions. Also may display premature 3-4 clutch failure.
- CAUSE:** The cause may be the scarf-cut Teflon sealing ring on the input shaft leaking, which would allow converter release oil into the 3-4 clutch passage and apply the 3-4 clutch pack (See Figure 1).
- CORRECTION:** Install a new Teflon scarf-cut sealing ring in the input shaft groove, as shown in Figure 1.  
**CAUTION: THERE ARE TWO DIFFERENT DIAMETERS OF THE G4A-EL INPUT SHAFT AND THEY REQUIRE DIFFERENT SIZE SEALING RINGS.**  
One shaft has 21 turbine splines, and the journal diameter behind the splines is .902" in diameter. One shaft has 25 turbine splines, and the journal diameter behind the splines is 1.092" in diameter. Be very careful to select the proper size scarf-cut sealing ring for the input shaft.
