Technical Service Information

FORD CD4E

NO REVERSE & MOVES IN MANUAL LOW ONLY

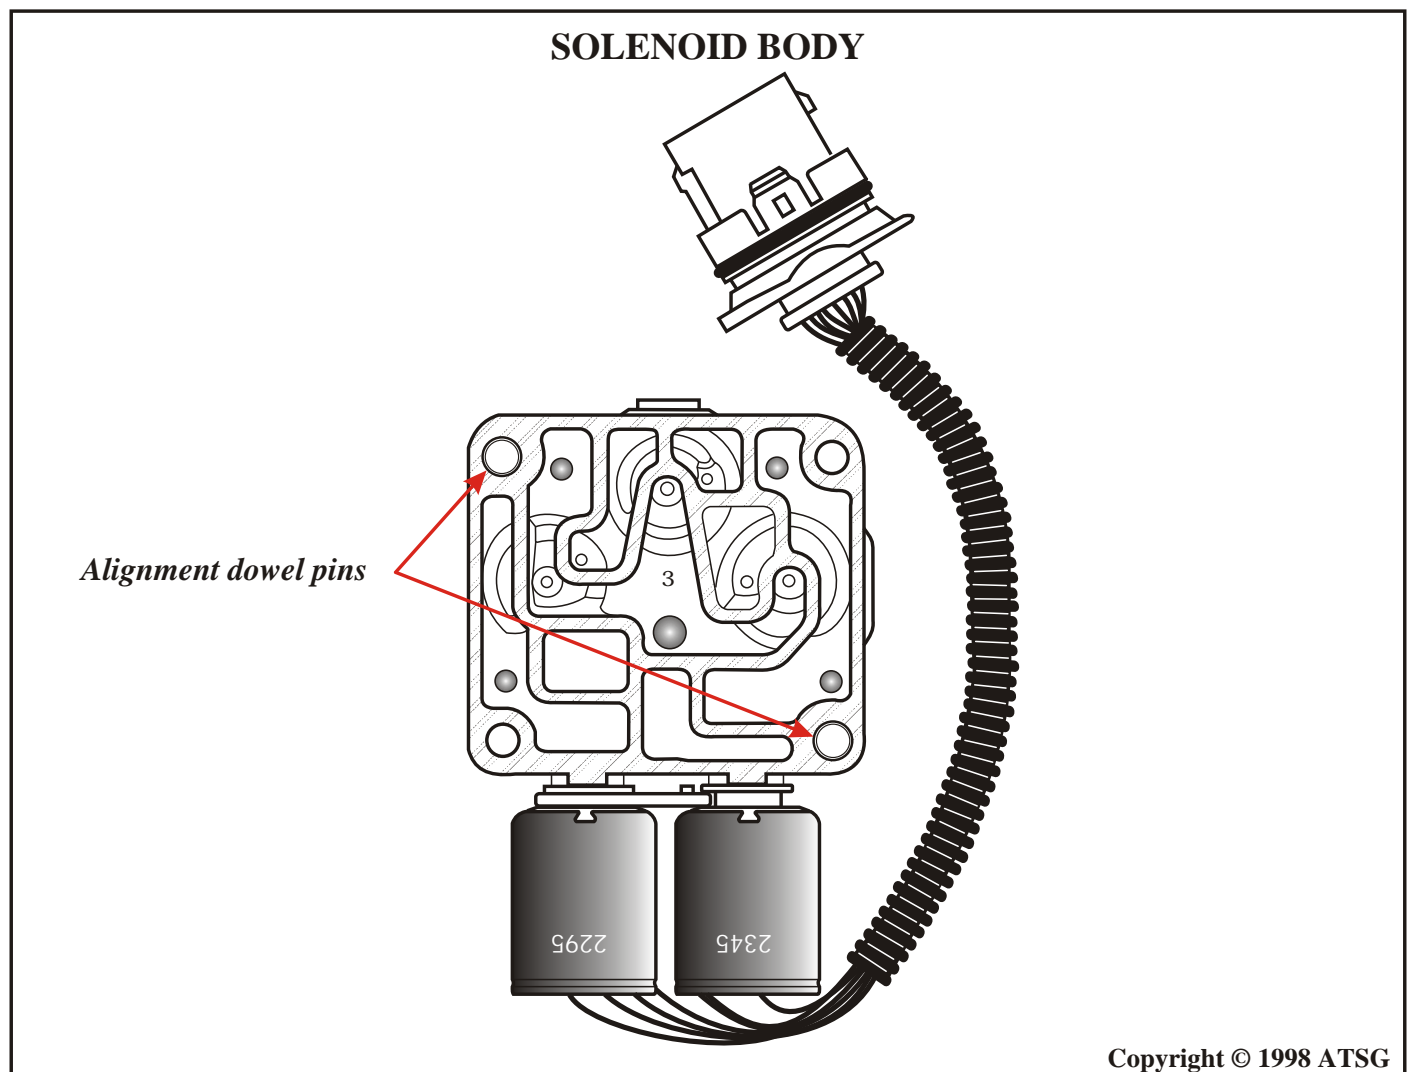
CORRECTION: The solenoid body has two alignment dowel pins in opposite corners (See Figure 1). This allows the possibility of the solenoid filter gasket to be installed in two different positions. Figure 2 shows the **INCORRECT** positioning of the filter gasket. Figure 3 shows the **CORRECT** filter gasket position.

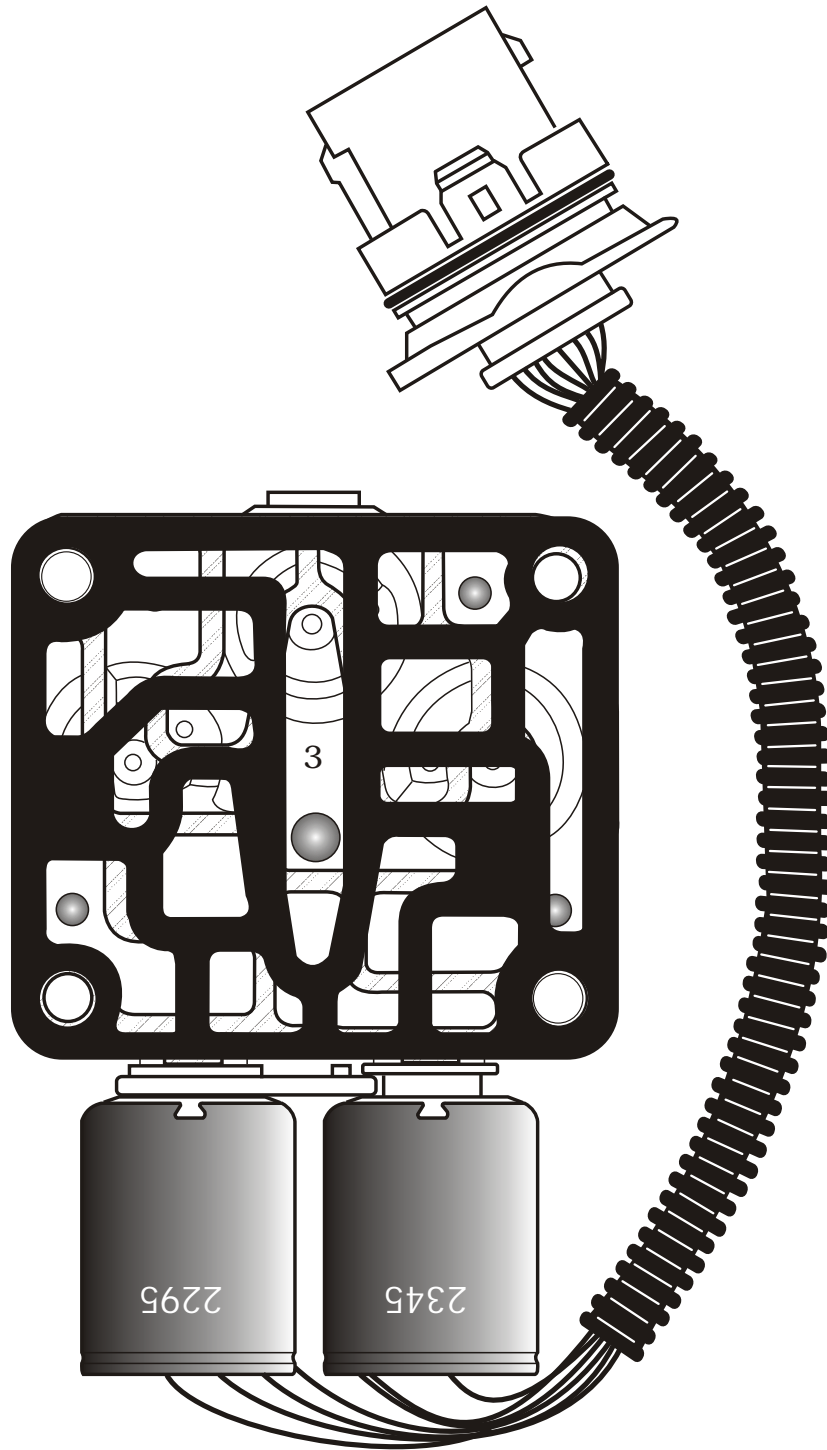
Figure 2

COMPLAINT: After rebuild or solenoid body replacement, the vehicle exhibits a no reverse condition and moves forward in the manual low range only. If the wheels are off the ground, forward movement may be detected in other forward ranges as well.

CAUSE: The cause may be, the solenoid body filter gasket has been installed incorrectly.

"INCORRECT" POSITIONING OF THE SOLENOID FILTER GASKET

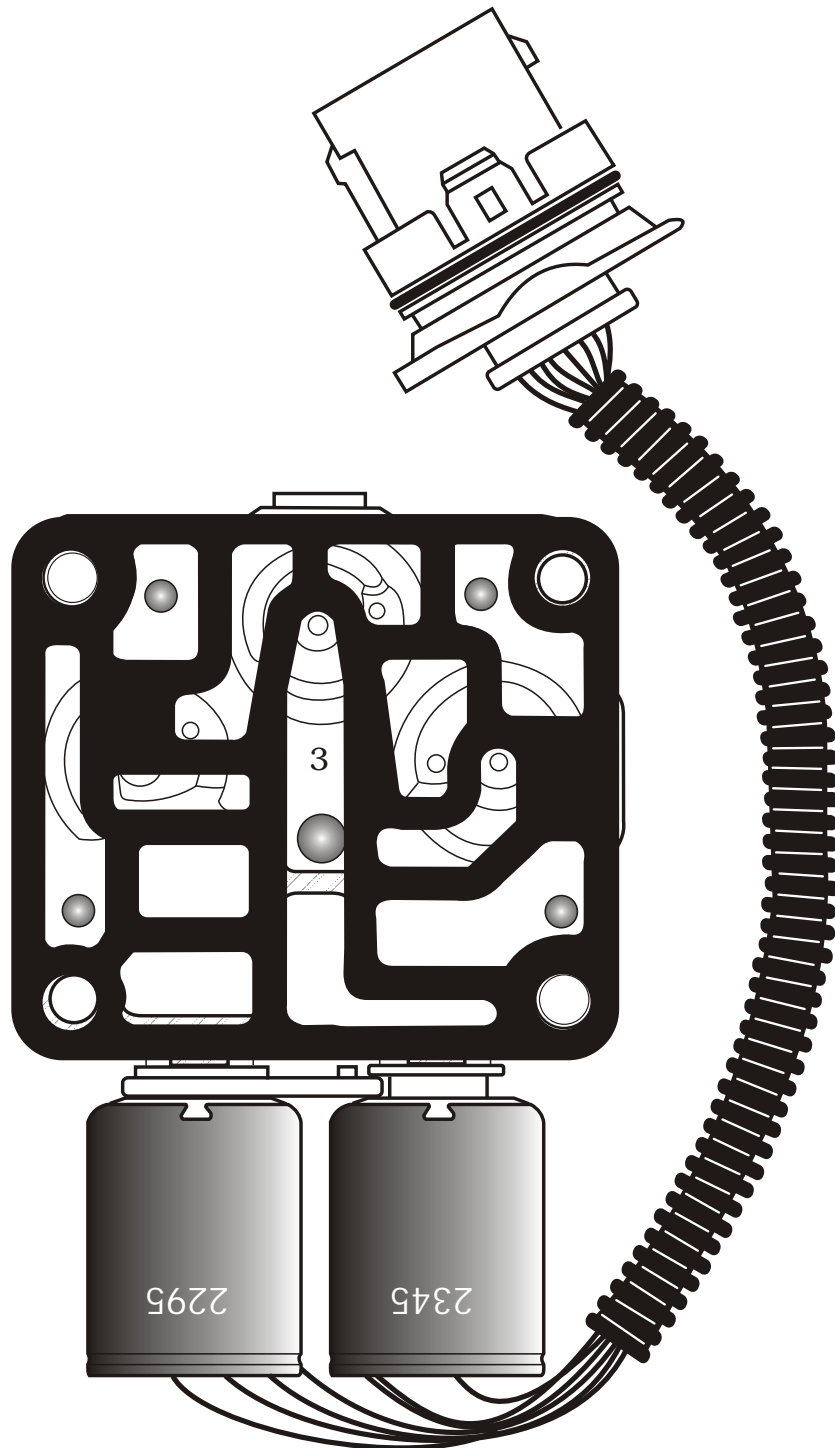
Figure 3

"CORRECT" POSITIONING OF THE SOLENOID FILTER GASKET
