NISSAN RE4R01A AND RE4F04A SHIFT CYCLING 4-3-4

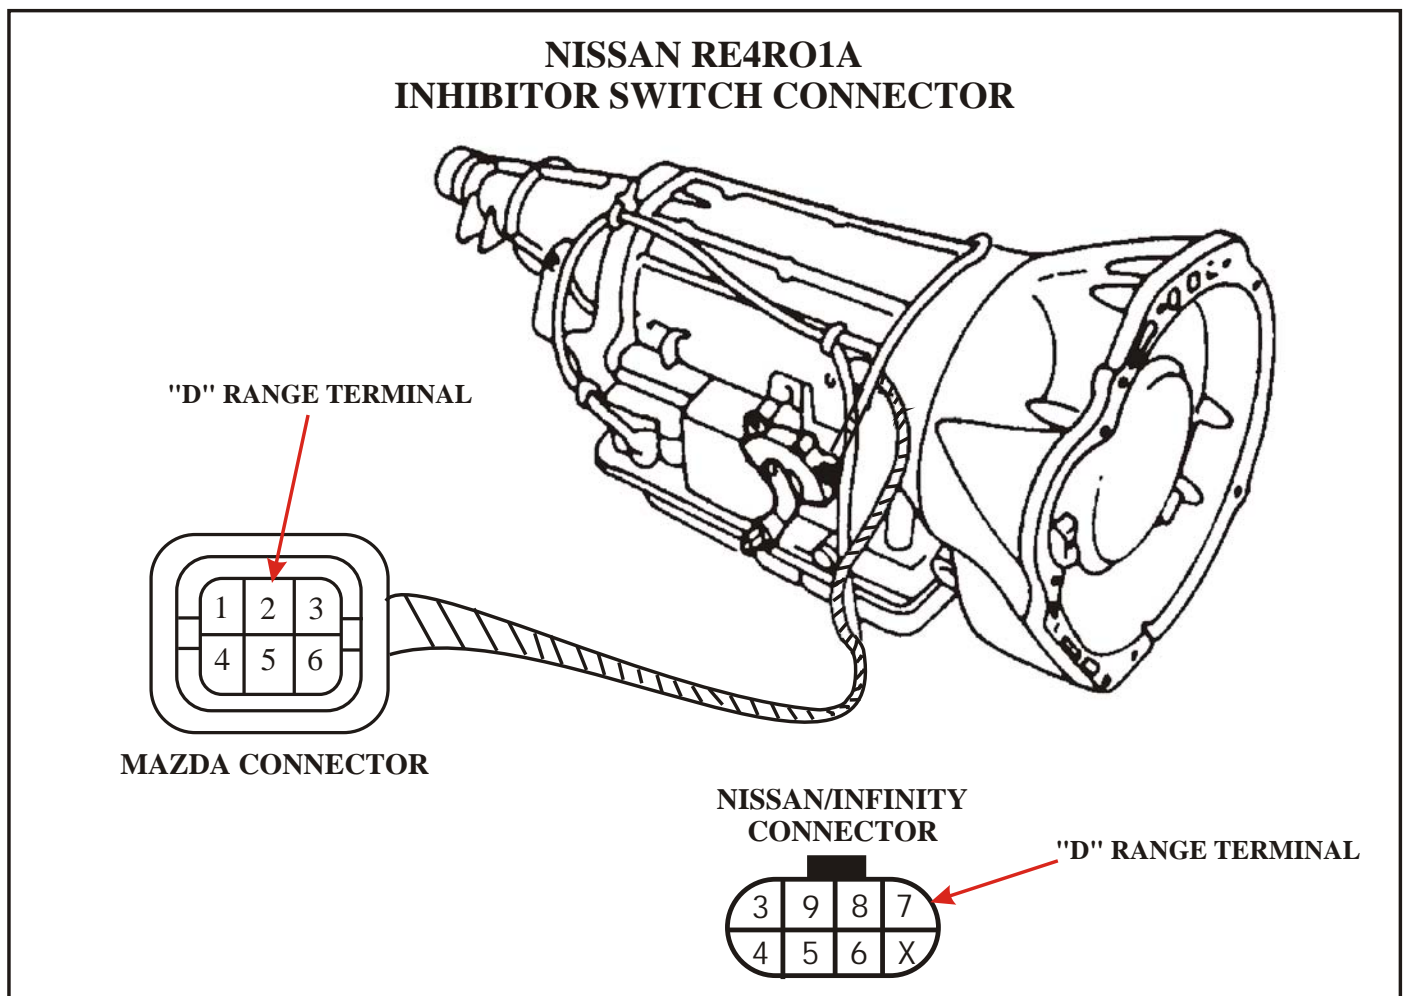
Figure 1

CAUSE: The cause may be, a loose or broken, "D" range signal wire to the inhibitor switch, a bent or corroded pin in the harness connector, or a defective inhibitor switch.

CORRECTION: Check the inhibitor switch and the connectors for any bent and/or corroded pins. If the connectors and pins are good, inspect the wires in the harness from the computer to the inhibitor switch, for any opens or shorts to ground with your DVOM. Refer to Figures 1 and 2 for locations of the inhibitor switch and views of the connectors on the RE4R01A and RE4F04A.

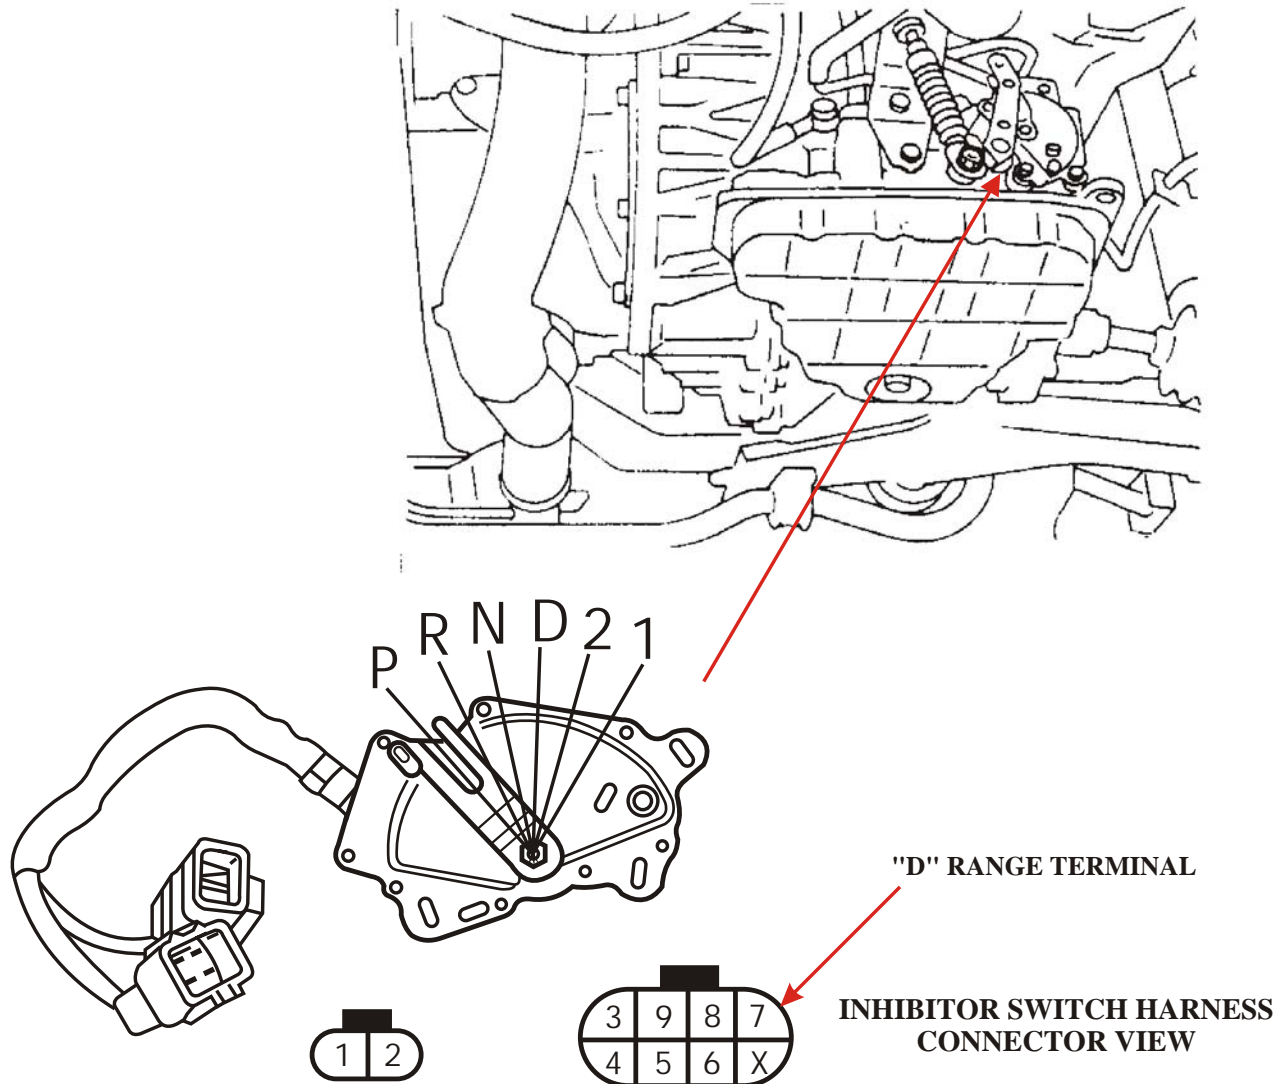
Figure 2

NISSAN RE4FO4A INHIBITOR SWITCH CONNECTORS
