Technical Service Information

THM 440-T4 2ND GEAR STARTS

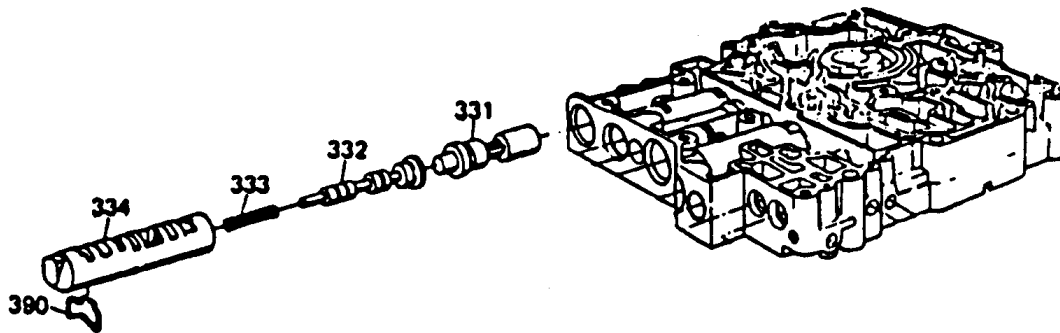
- 331 1-2 SHIFT VALVE
- 332 1-2 THROTTLE VALVE
- 333 1-2 THROTTLE VALVE SPRING
- 334 1-2 THROTTLE VALVE BUSHING
- 390 1-2 THROTTLE VALVE BUSHING RETAINER

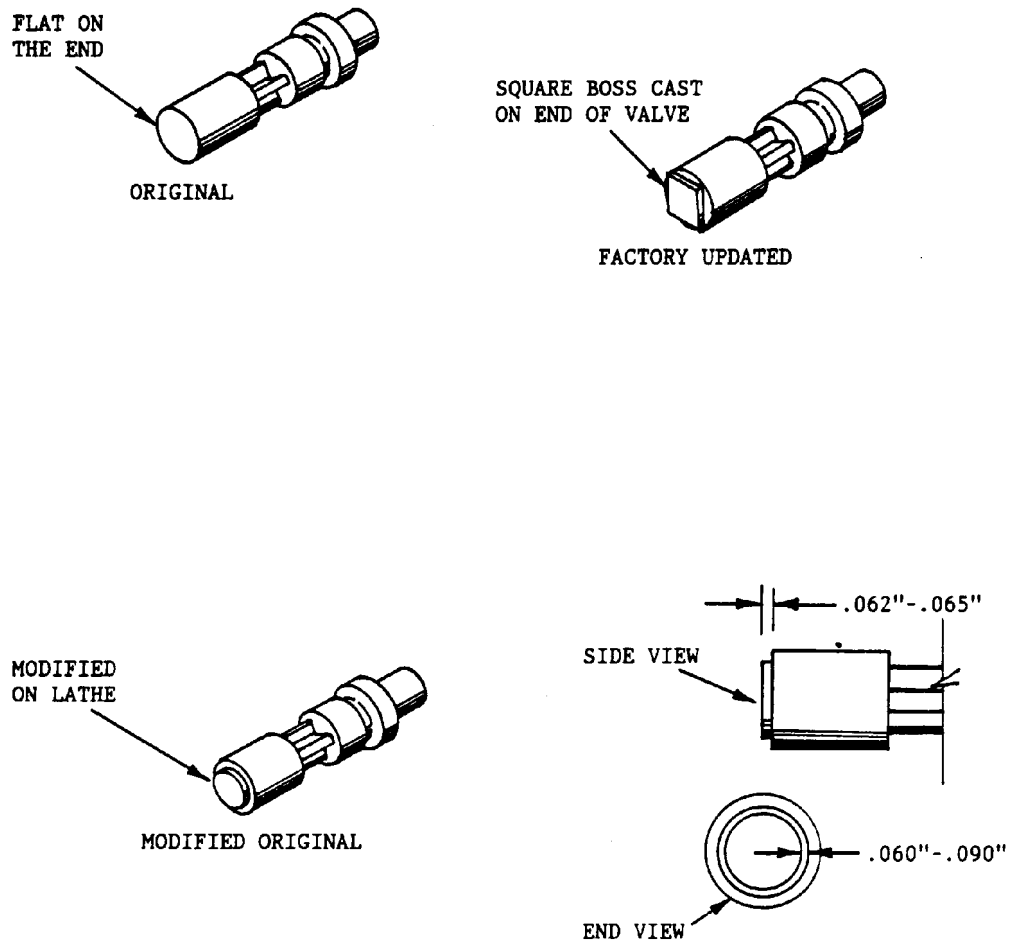
Figure 1

CAUSE: The cause may be the 1-2 shift valve sticking in the upshifted position (See Figure 1). The 1-2 shift valve is aluminum and might have a tendency to "Mushroom", caused by hitting the valve body casting in the bottom of the bore.

CORRECTION: Modify the original 1-2 shift valve as shown in Figure 2. This is a very simple machining operation on a lathe. The factory has upgraded the 1-2 shift valve with a "Boss" cast on the end of the valve (See Figure 2).
