Technical Service Information

FORD 4F27-E MAZDA FN4A-EL 1-2 FLARE AND 3-4 NEUTRAL

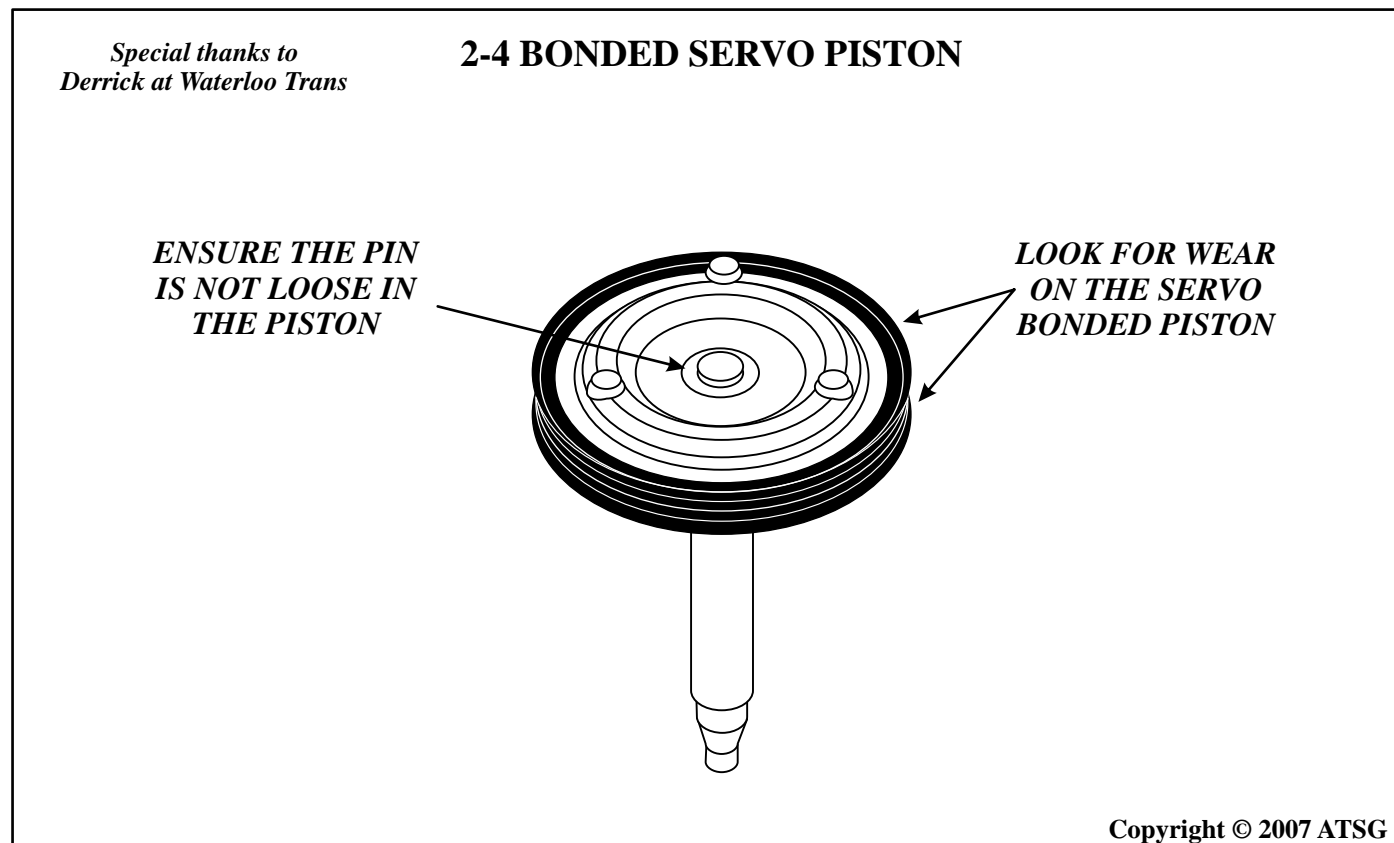
Figure 1

CAUSE: The cause may be, the bonded 2-4 servo piston is worn or the pin is loose from the piston, as shown in Figure 1. The cause for the piston being worn is because of a rough surface in the servo bore in the case.

CORRECTION: Replace the 2-4 servo piston, as shown in Figure 1. Using some fine sand paper or scotch-brite, lightly sand the bore of the case where the bonded rubber part of the servo rides, to ensure that is smooth. See Figure 2. Re-assemble the servo assembly back into the case as shown in Figure 3. **NOTE: If this repair is attempted in the vehicle, the linkage which is right over the 2-4 servo piston, will have to be removed, which means the mount bolts will have to be removed and the transmission lowered in the vehicle.**
