Technical Service Information

SATURN NEW DESIGN SOLENOIDS

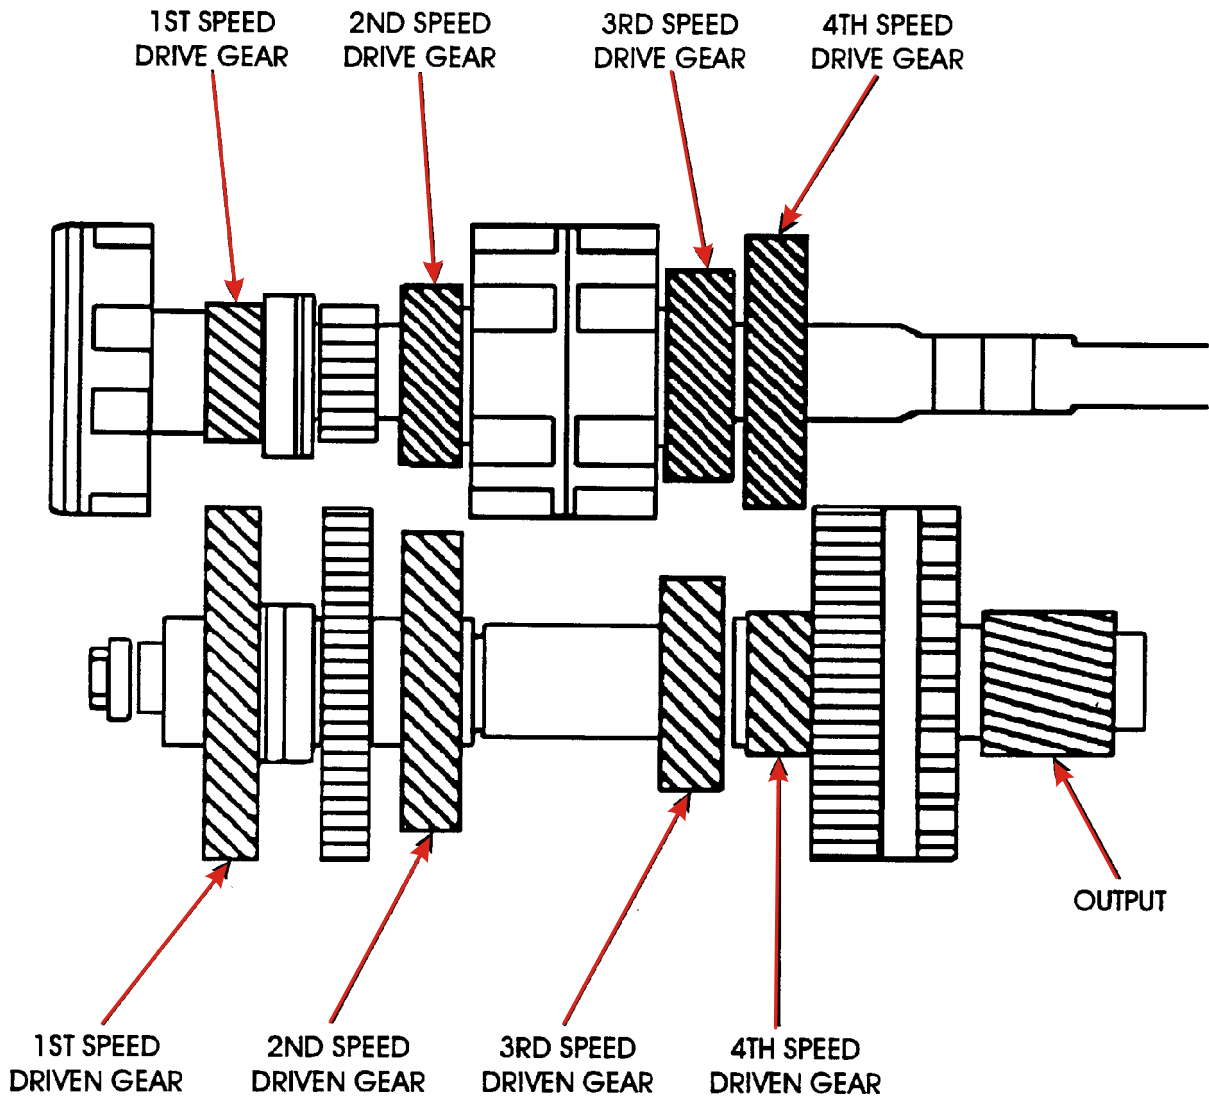
Figure 2

The cause may be, a mis-match of gear train parts (Drive and Driven Gears), between the 1st design "MP6" Base transaxle, and the 2nd design "MP6" Base transaxle, or the "MP7" Performance transaxle. Refer to the charts in Figures 1 and 2 for the proper gear tooth counts for the model you are rebuilding.

GEAR TRAIN IDENTIFICATION

CORRECTION: When rebuilding a Saturn transaxle, and gear train wear is present, "*Always*" ensure that the replacement gears have the exact same tooth counts as the ones that you are removing. Refer to the charts in Figures 1 and 2 for the proper gear tooth counts for the model you are rebuilding.

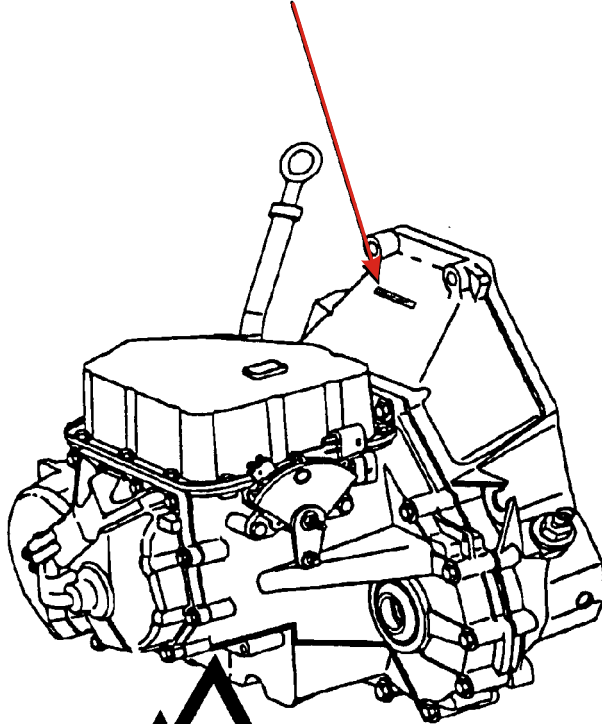
*A STAMPED IDENTIFICATION CODE
CAN BE FOUND IN THIS AREA*

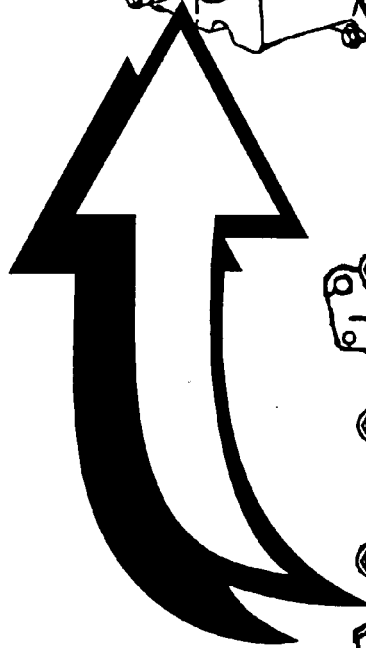
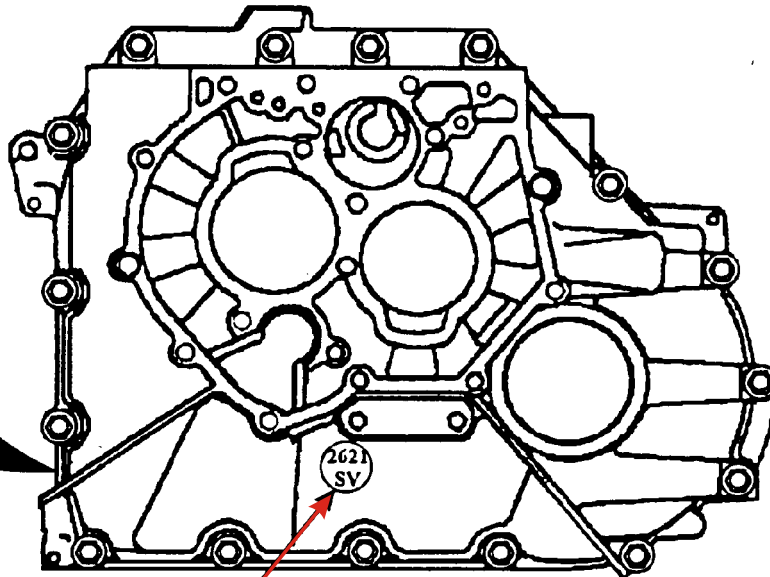
Important Note: Refer to Figure 3 to identify the transaxle design level and type of transaxle. They are as follows:

"MP6" Base = 1st Design
"MP6" Base (With "SV") = 2nd Design
"MP7" = Performance Version

Identification "SV" here for 2nd design level
