Technical Service Information

THM 440-T4

SLIP OR NO DRIVE

MODELS AFFECTED: 1987 DE VILLE, ELDORADO AND SEVILLE

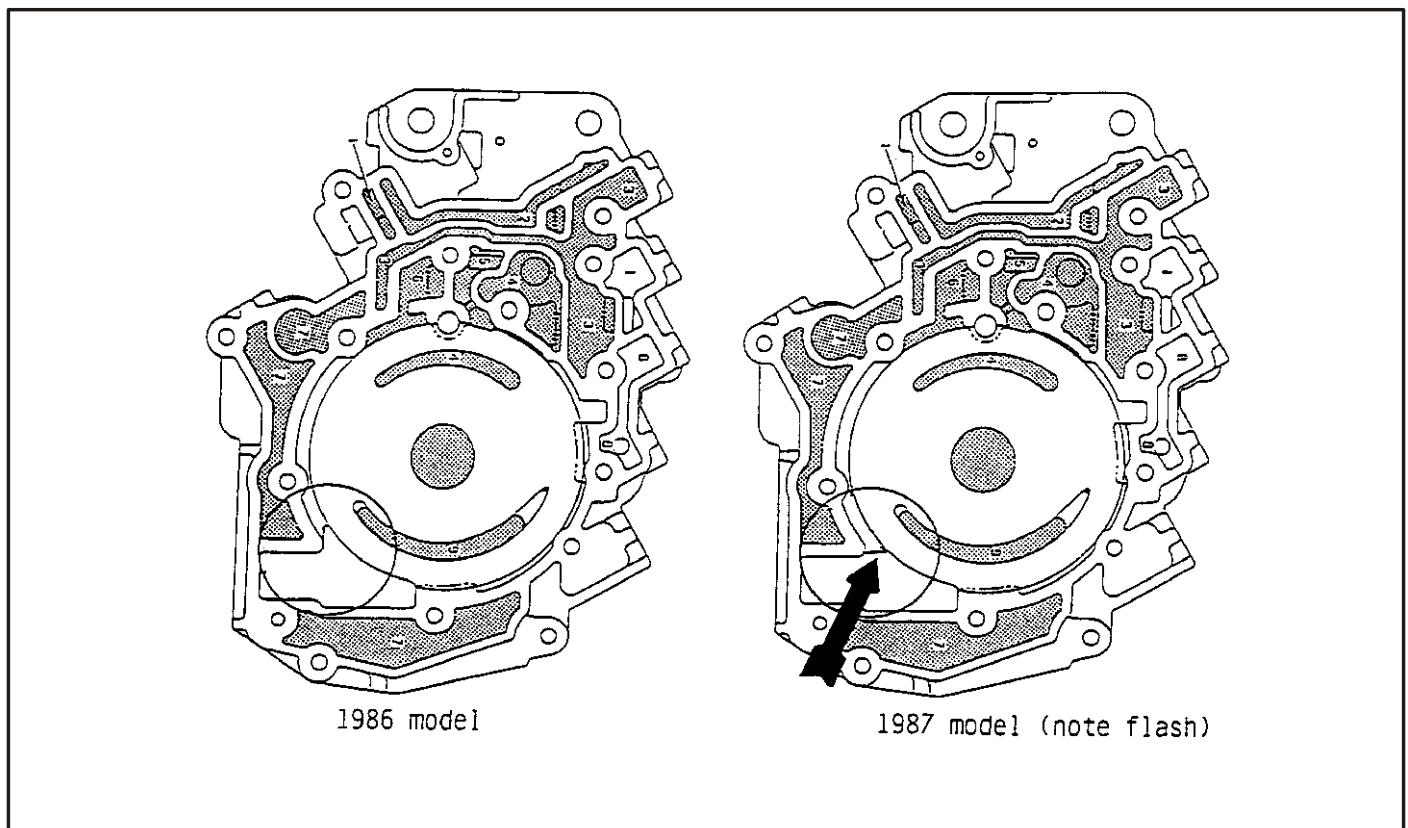
Figure 1

This condition may be caused by the pump slide binding on excessive casting flash when the slide is in the low pressure position.

If pressures do not vary with vacuum signal changes, inspect for pump slide bind by removing the oil pump cover and rotating the slide by hand. If present, excessive flash will cause the slice to bind. If found, replace the oil pump assembly. Or use a dremel tool with a carbide wheel and remove flash from 1987 model 'work area' to contour to 1986 model. Then install slice and check side clearance.
