## KIA F4E-111 HARSH 1-2 AND OR SOLENOID CIRCUIT FAULTS

**COMPLAINT:** 1998 and Up Kia vehicles equipped with the F4E-111 transaxle may exhibit a harsh 1-2 upshift or multiple Solenoid Circuit faults, after overhaul.

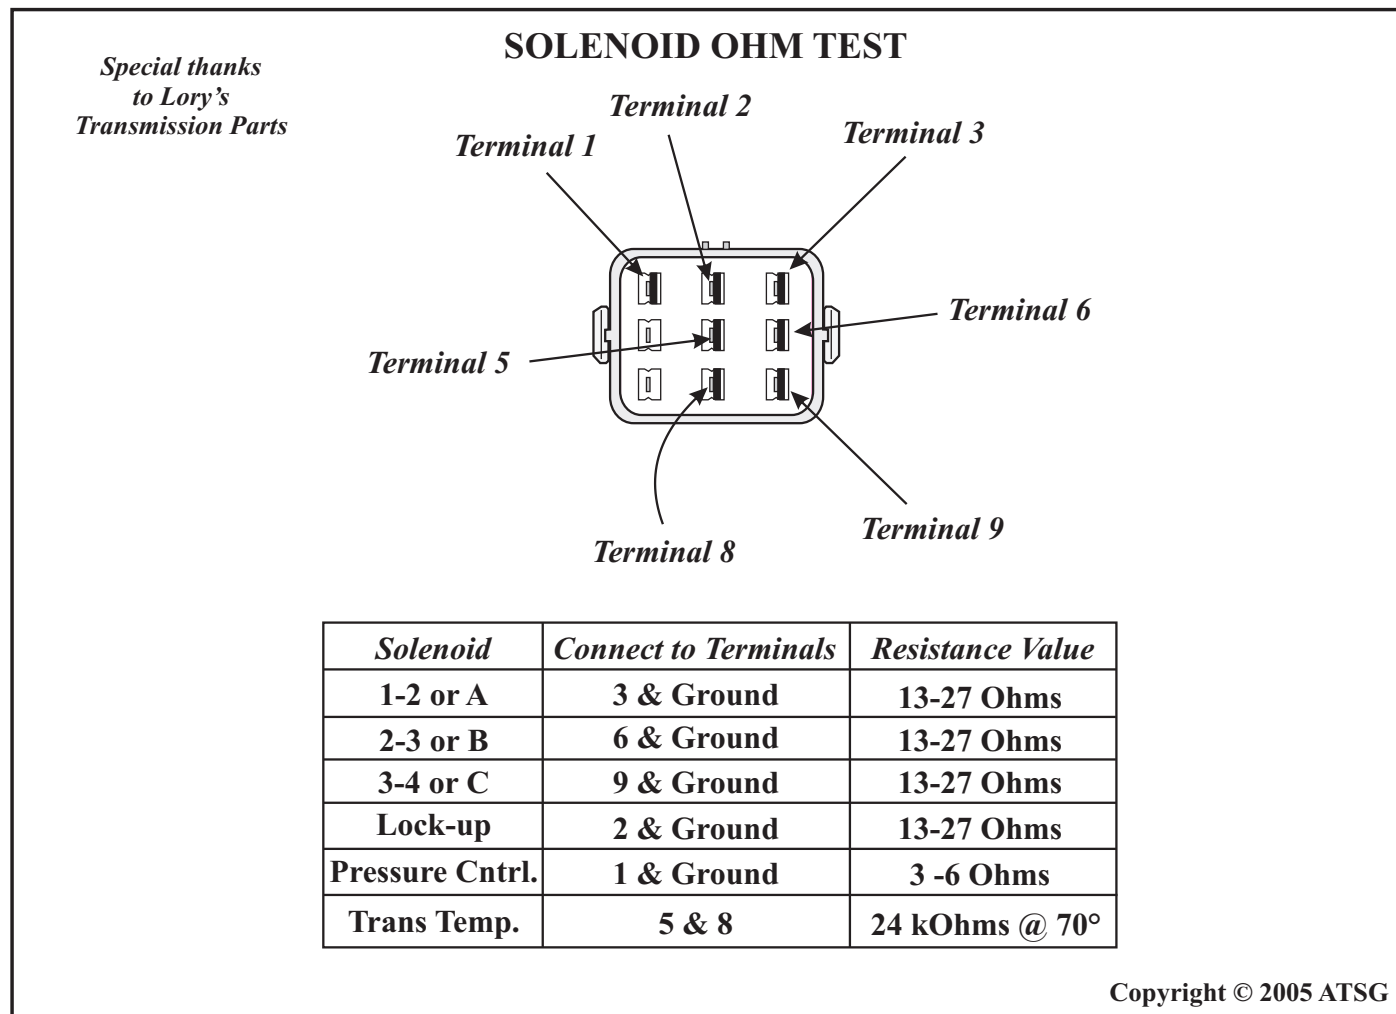
**CAUSE:** The cause may be, that when re-connecting the internal harness to the solenoids on the valve body the Lock-up Solenoid and the Line Pressure Solenoid were hooked up backwards, causing high line pressure and Lock-up on top of the 1-2 shift.

**CORRECTION:** Refer to the solenoid ohm test in Figure 1 and verify that the solenoid ohm value is correct for the specified terminal location. If it is incorrect, refer to Figure 2 for the solenoid location on the valve body and refer to Figure 3 for the internal wire colors, to ensure that the correct connector wire colors are connected. *Note: The internal wire harness connectors match the solenoid connectors on the O.E. Solenoids only.*
