"2001" SEMINAR INFORMATION "PRACTICAL TECH"

AUTOMATIC TRANSMISSION SERVICE GROUP

INTRODUCTION

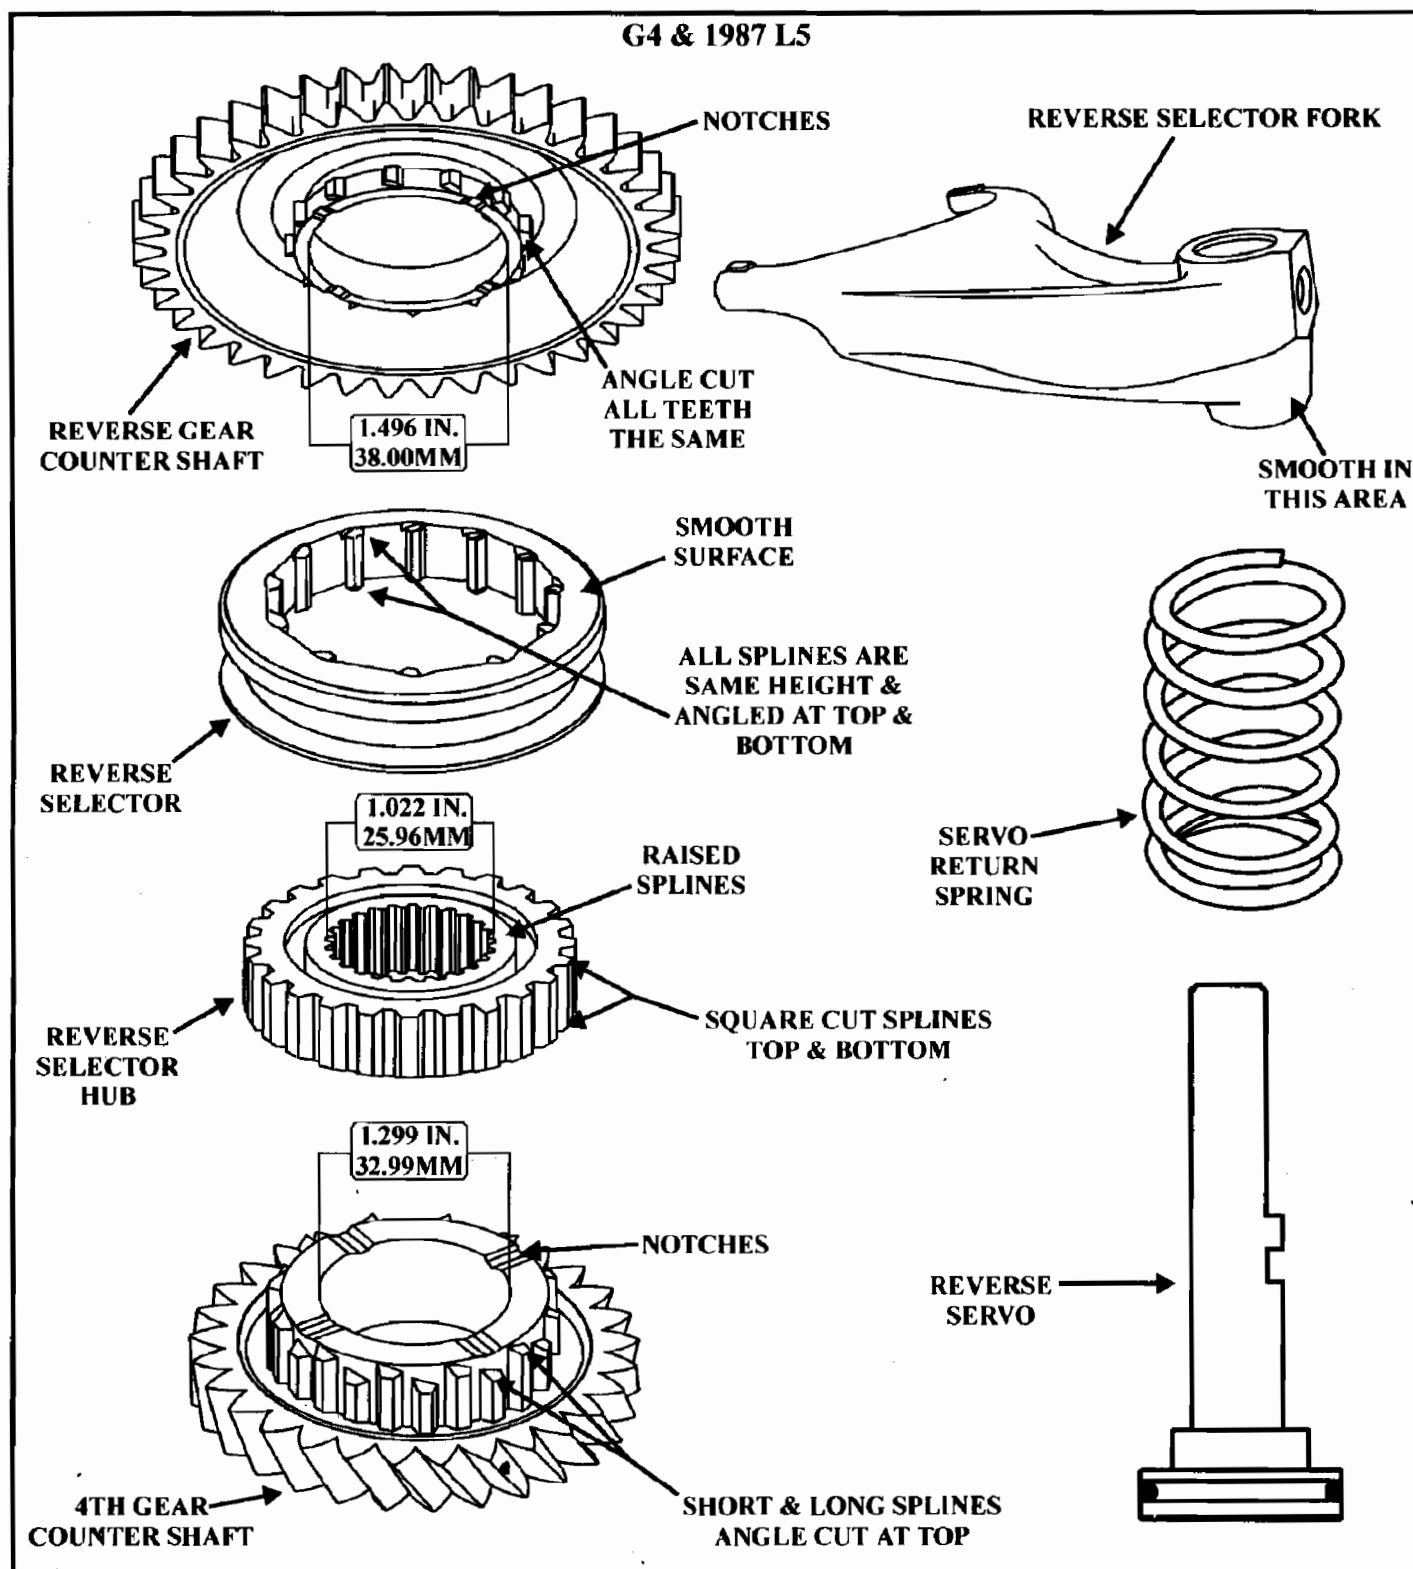
Figure 1

COMPLAINT: When a garage shift is made into reverse, the transmission emits a grinding noise and/or a bind-up condition. This complaint usually occurs when one or more of the reverse selector components on the counter shaft are changed.

CAUSE: Incompatible counter shaft reverse selector components have been installed. These components for the G4, L5 and PL5X, at a glance, look alike, **THEY ARE NOT!**

CAUTION: Honda/Acura internal components look very similar, ***always*** look closely to avoid this or any of the many other complaints that incompatible parts can cause.
Even though parts look the same, there can be slight dimensional differences, because clearances in most Honda/Acura units is .003" to .006" there is little room for error, always check end play before final assembly of the transmission.

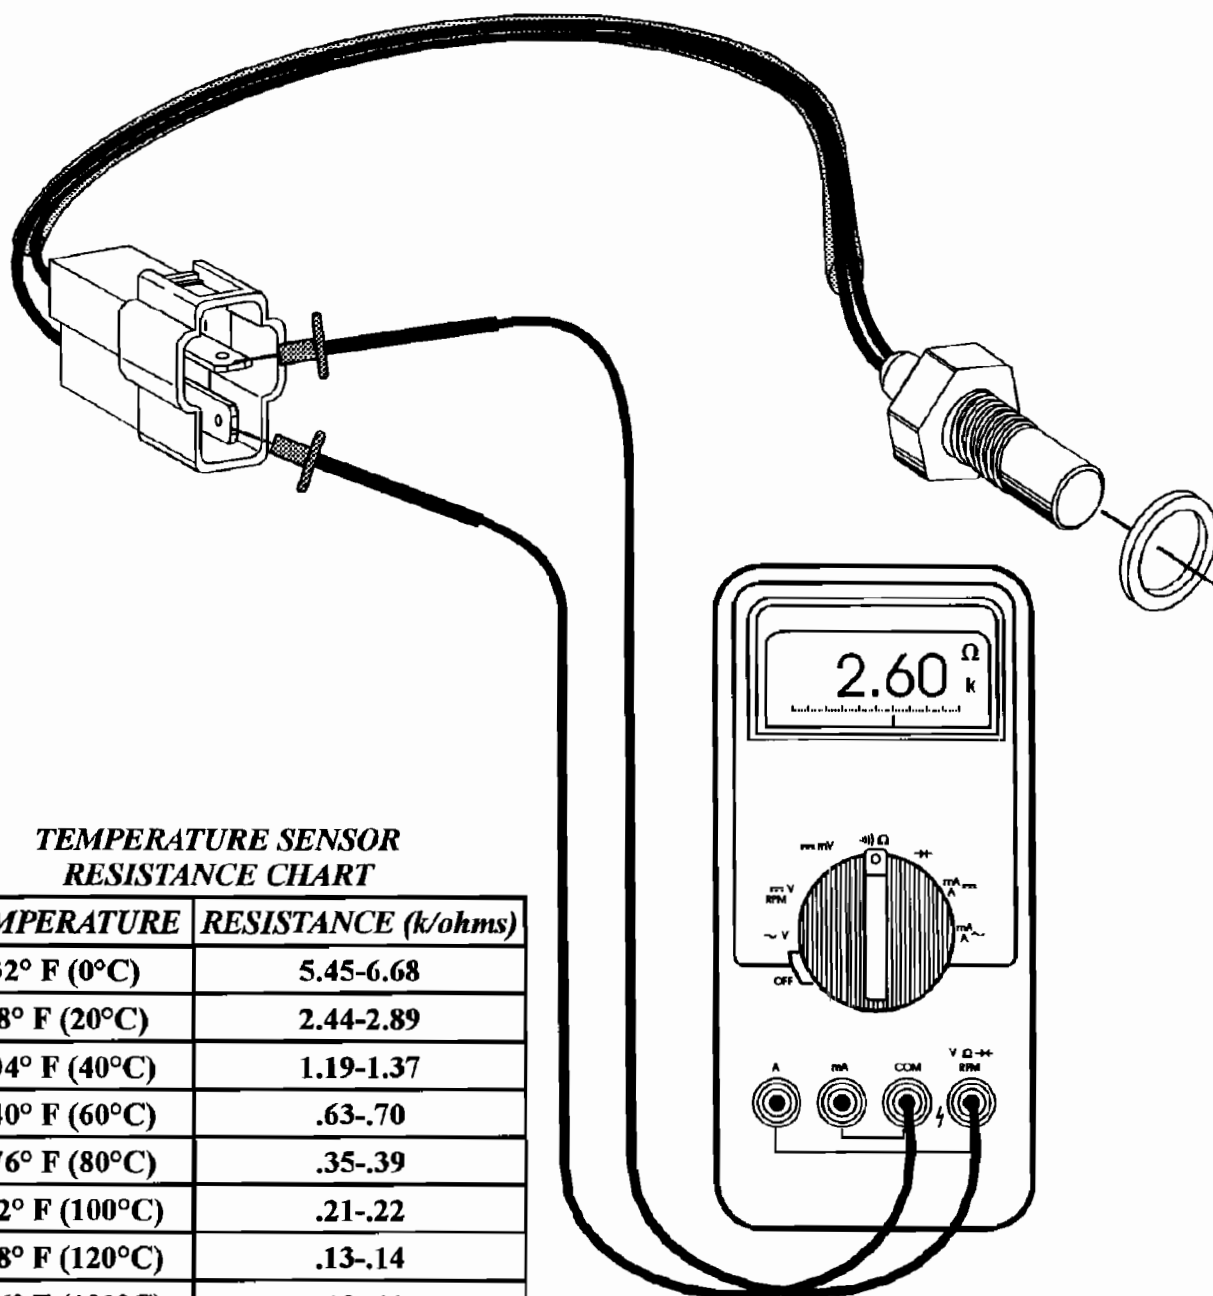
BENCH TESTING TEMPERATURE SENSOR

CAUSE: The cause may be, a faulty Transmission Temperature Sensor. **WHY:** Vehicles equipped with GF4A-EL transmissions have a computer strategy that *commands* line pressure to be maximum when fluid temperature is at or below 10°F. Therefore if the temperature sensor is faulty it may indicate that temperature is at or below 10°F at all times.

CORRECTION: Refer to Figure 1 for the location of the Transmission Oil Temperature Sensor. Refer to Figure 2 for the Ohm value and testing procedure to check the sensor. Refer to Figure 3 for the testing procedure of the sensor at the 10 pin connector. Repair or replace temperature sensor as necessary.

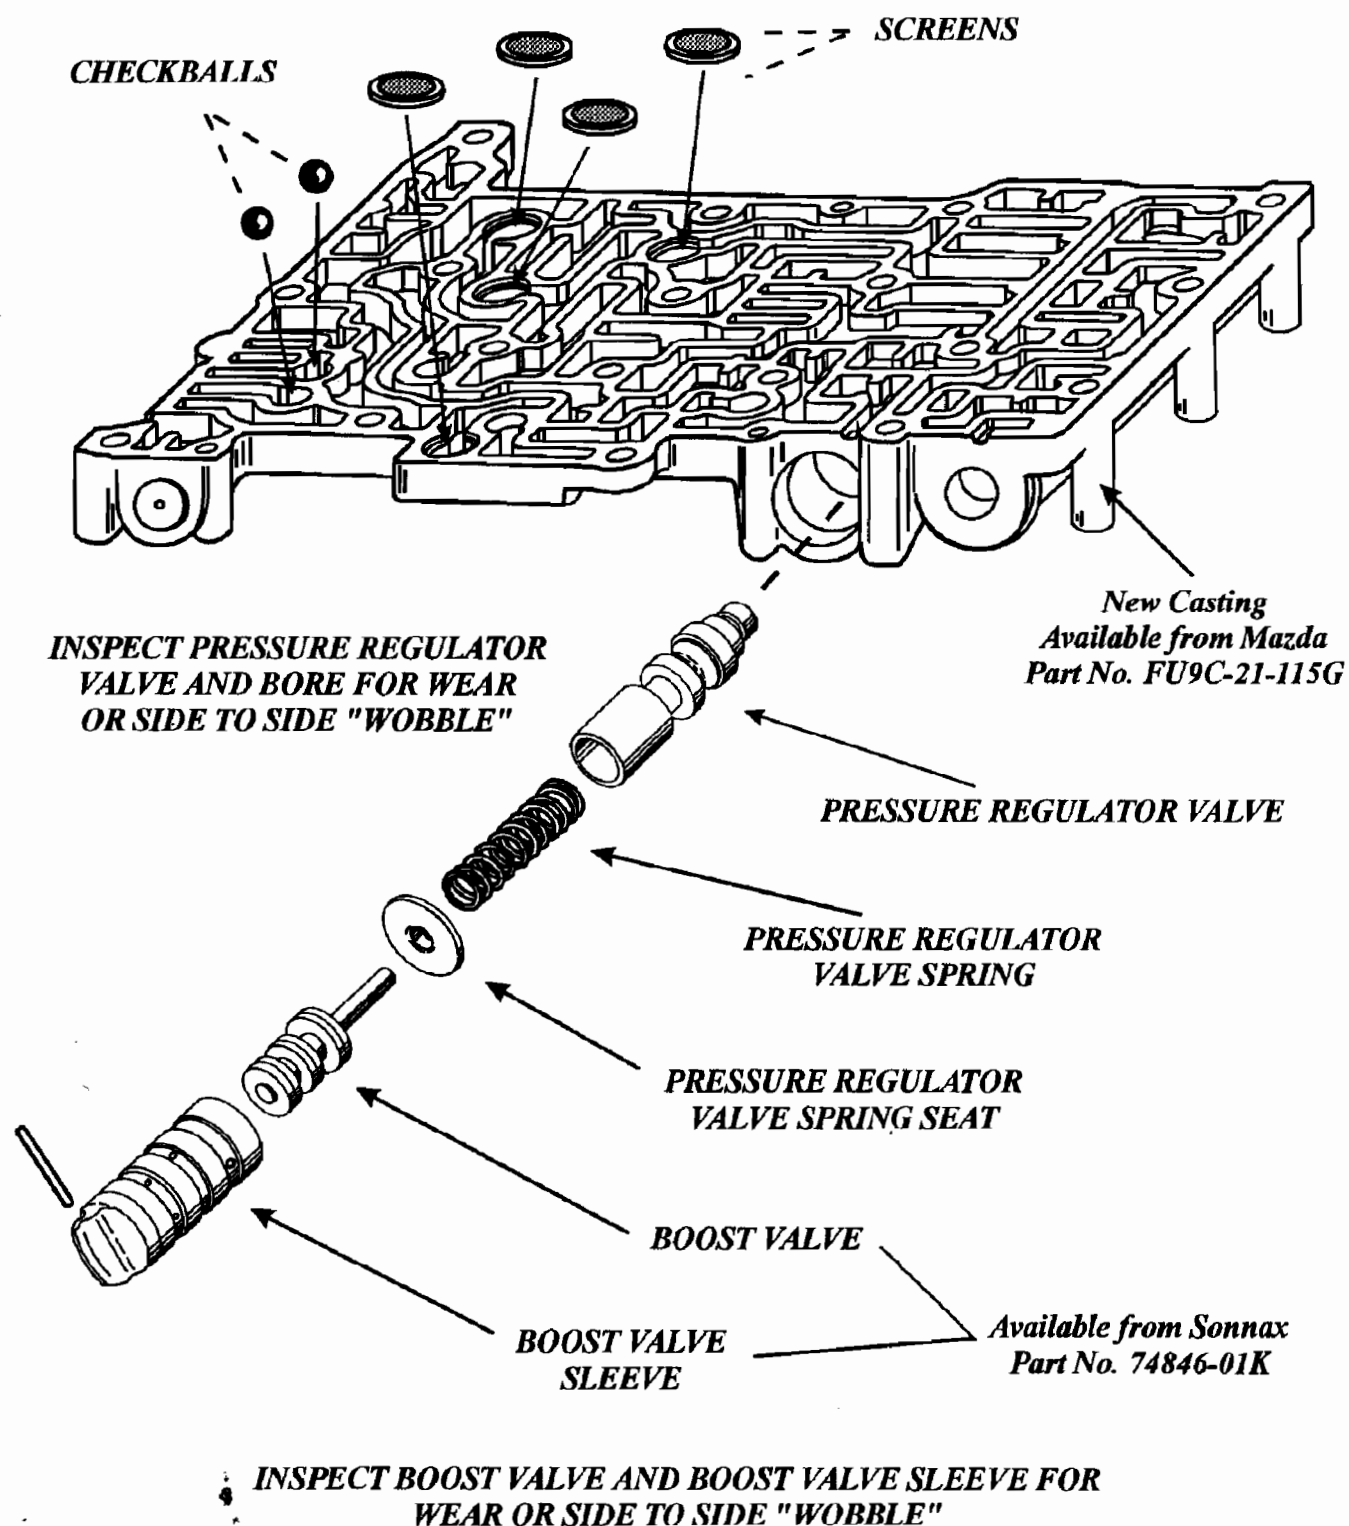
Figure 2

CAUSE: The cause may be, a faulty Pressure Control Solenoid, a worn Boost Valve and Sleeve and/or a worn Pressure Regulator Valve bore which is part of the Rear Control Valve Body.

CORRECTION: Replace the Pressure Control Solenoid as shown in Figure 1, with Ford part number F32Z-7G136-AA or Mazda part number FU9A-21-1G1A. Inspect the Pressure Regulator Valve and the Pressure Regulator Valve bore for wear or scoring as shown in Figure 2. If the bore has "shiny" spots where the Valve rides a "New" Rear Control Valve Body can be purchased from Mazda. Inspect the Boost Valve and Boost Valve Sleeve for wear or scoring, and replace as needed with Sonnax boost valve and sleeve as shown in Figure 2.

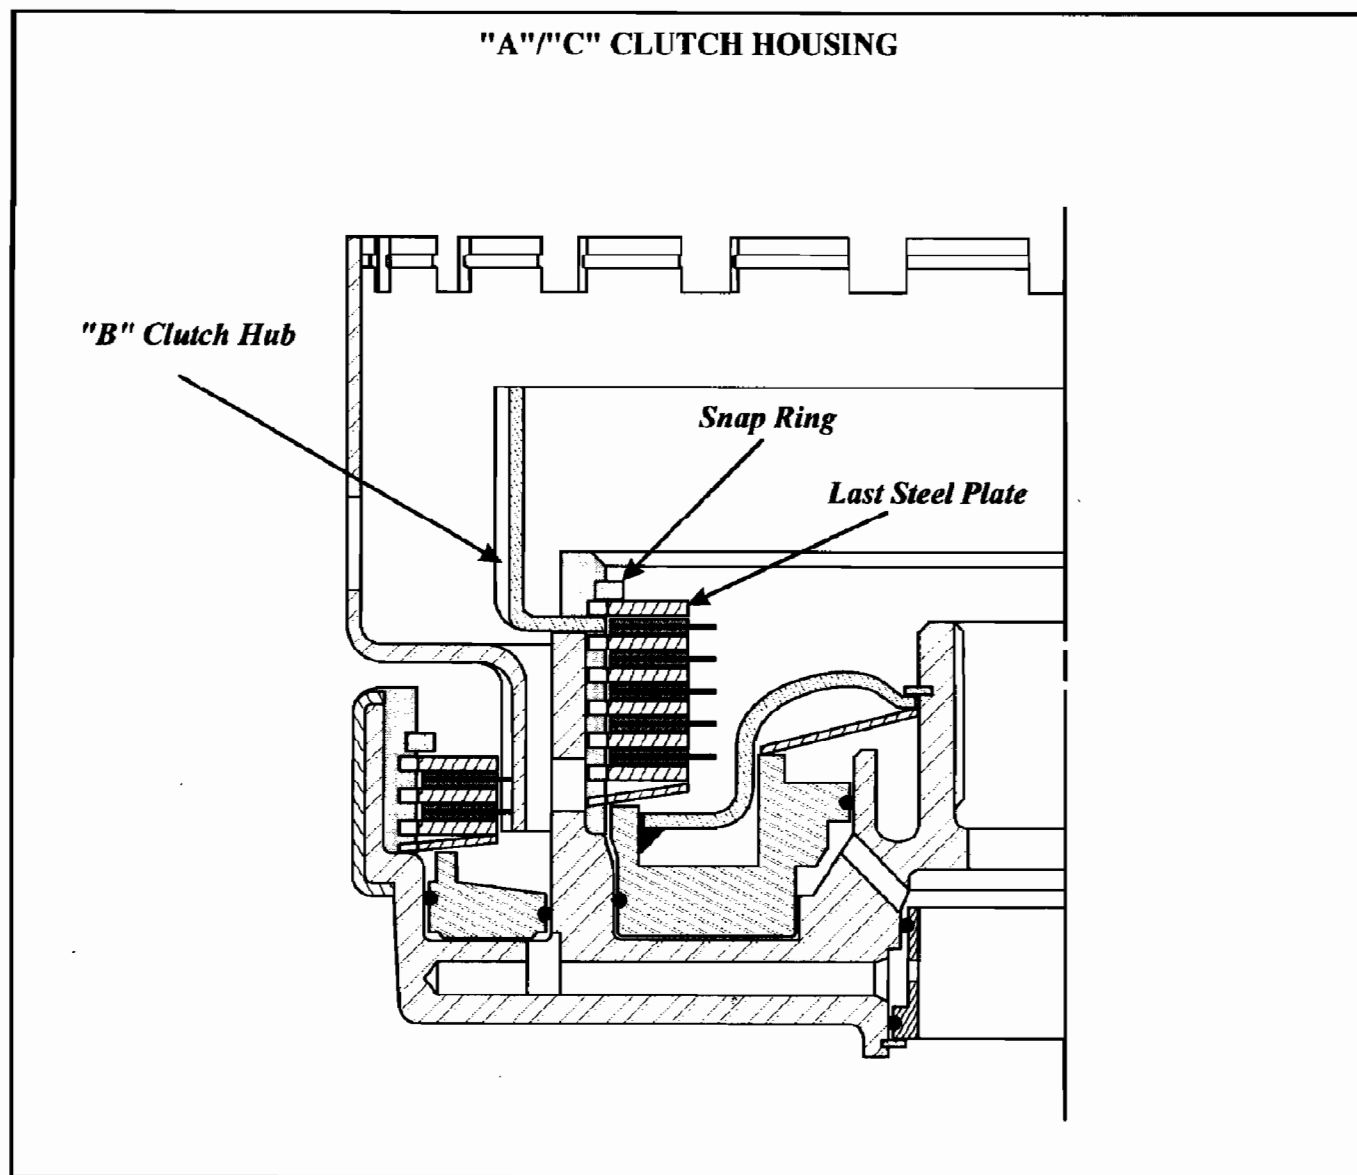
Figure 2

COMPLAINT: 1991 and later BMW vehicles equipped with the ZF5HP30 transmission may exhibit a no reverse condition, when selector lever is placed in the reverse position. This condition usually occurs after overhaul.

CAUSE: This condition can be caused by the incorrect assembly of the "A"/"C" Clutch Housing. If the clutch housing has been severely damaged, aluminum material will be evidenced in the bottom pan upon inspection.
When the unit is removed and the "A"/"C" Clutch Housing is dis-assembled, it is not uncommon for the unit to set for over a week waiting on parts. When re-assembling it is very easy to *mis-assemble* the "B" Clutch Hub (Figure 1, Item 8) on top of the retaining snap ring for the "A" Clutch pack (Figure 1, Item 10). This mis-assembly will create a neutralizing on the 3-4 upshift, and the Trans light will begin flashing.

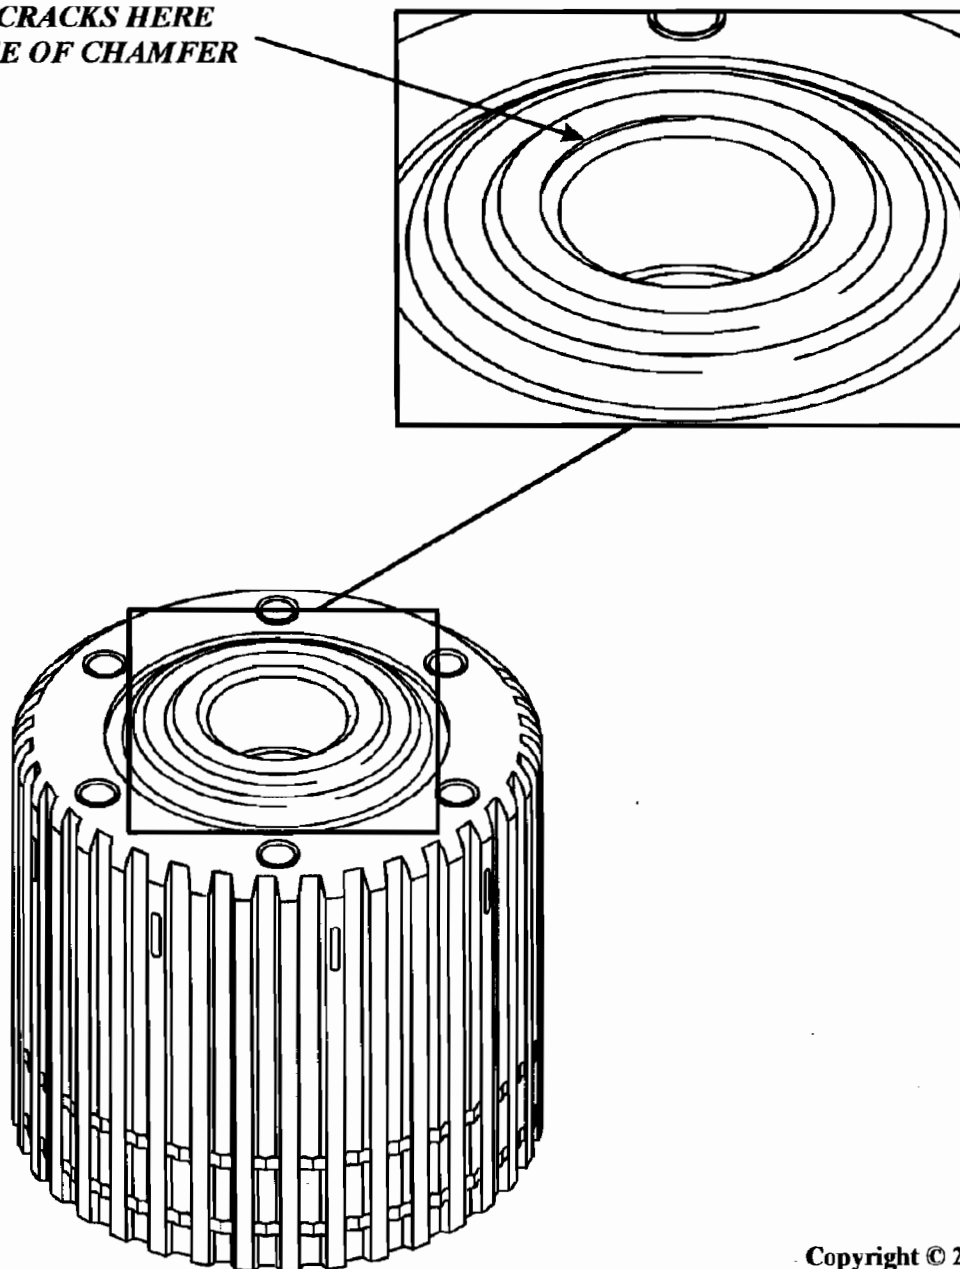
Figure 1

CAUSE: The cause may be, a cracked 2nd clutch housing that is barely perceptible, as shown in Figure 1.

**HOUSING CRACKS HERE
AT TOP EDGE OF CHAMFER**

CORRECTION: Replace the 2nd clutch housing as necessary. Refer to Figure 1.

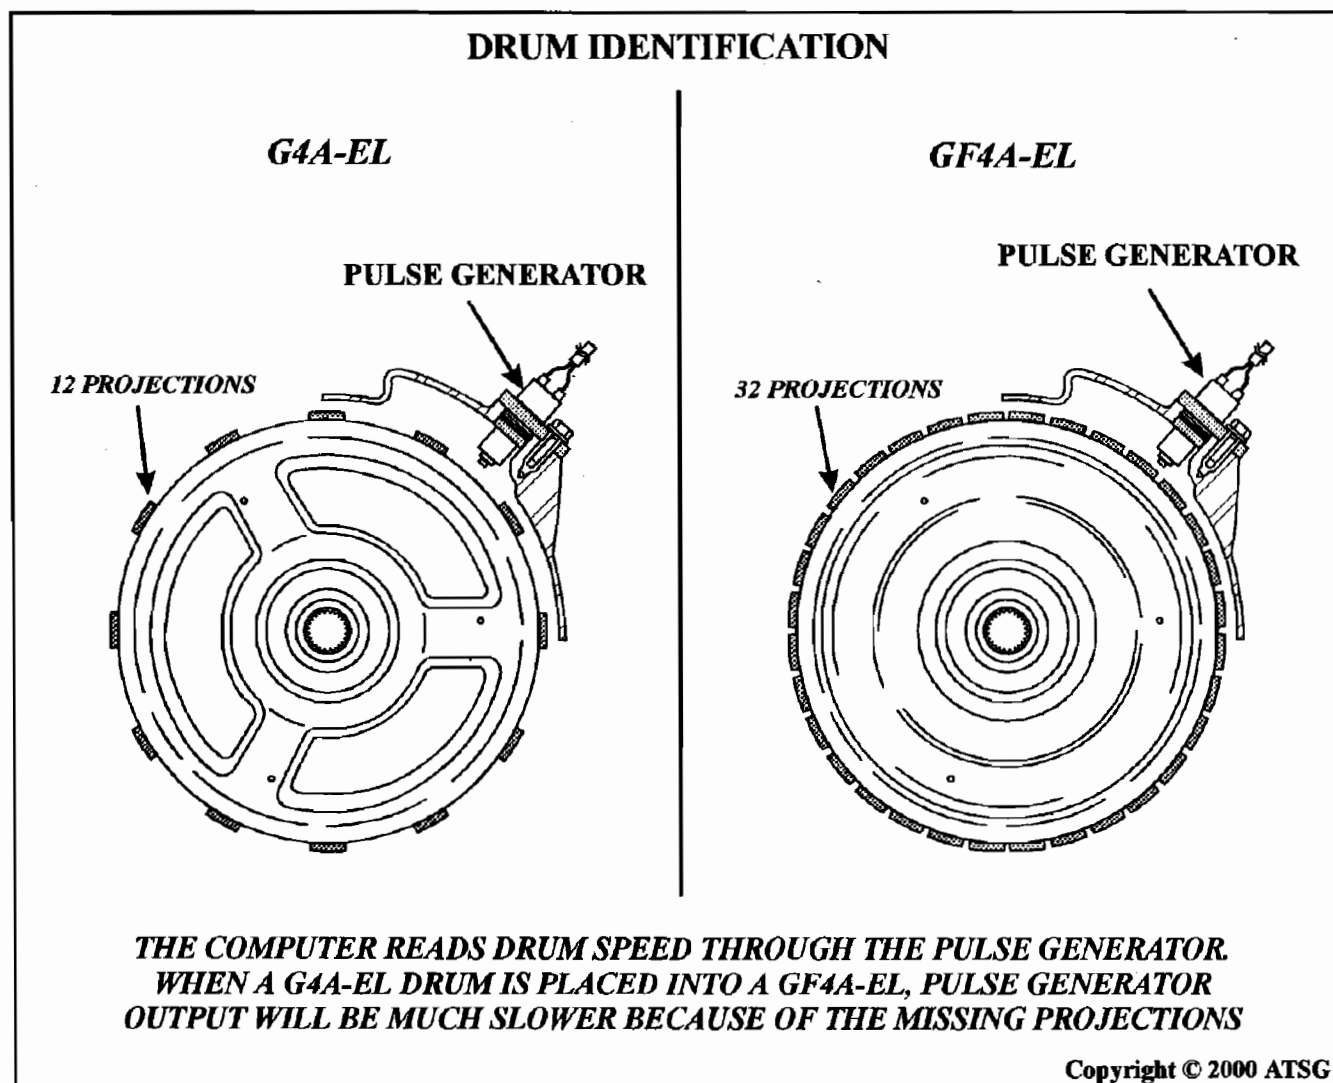
CAUSE: The cause may be, a 12 projection *G4A-EL* Reverse, Forward and Coast drum was installed into a *GF4A-EL* application, which requires a 32 projection drum. When this happens the computer will not command 4th gear because of the missing projections which results in slower drum speed.

CORRECTION: To correct this condition, refer to Figure 1 for drum identification and ensure that the 32 projection drum is installed on all *GF4A-EL* applications.

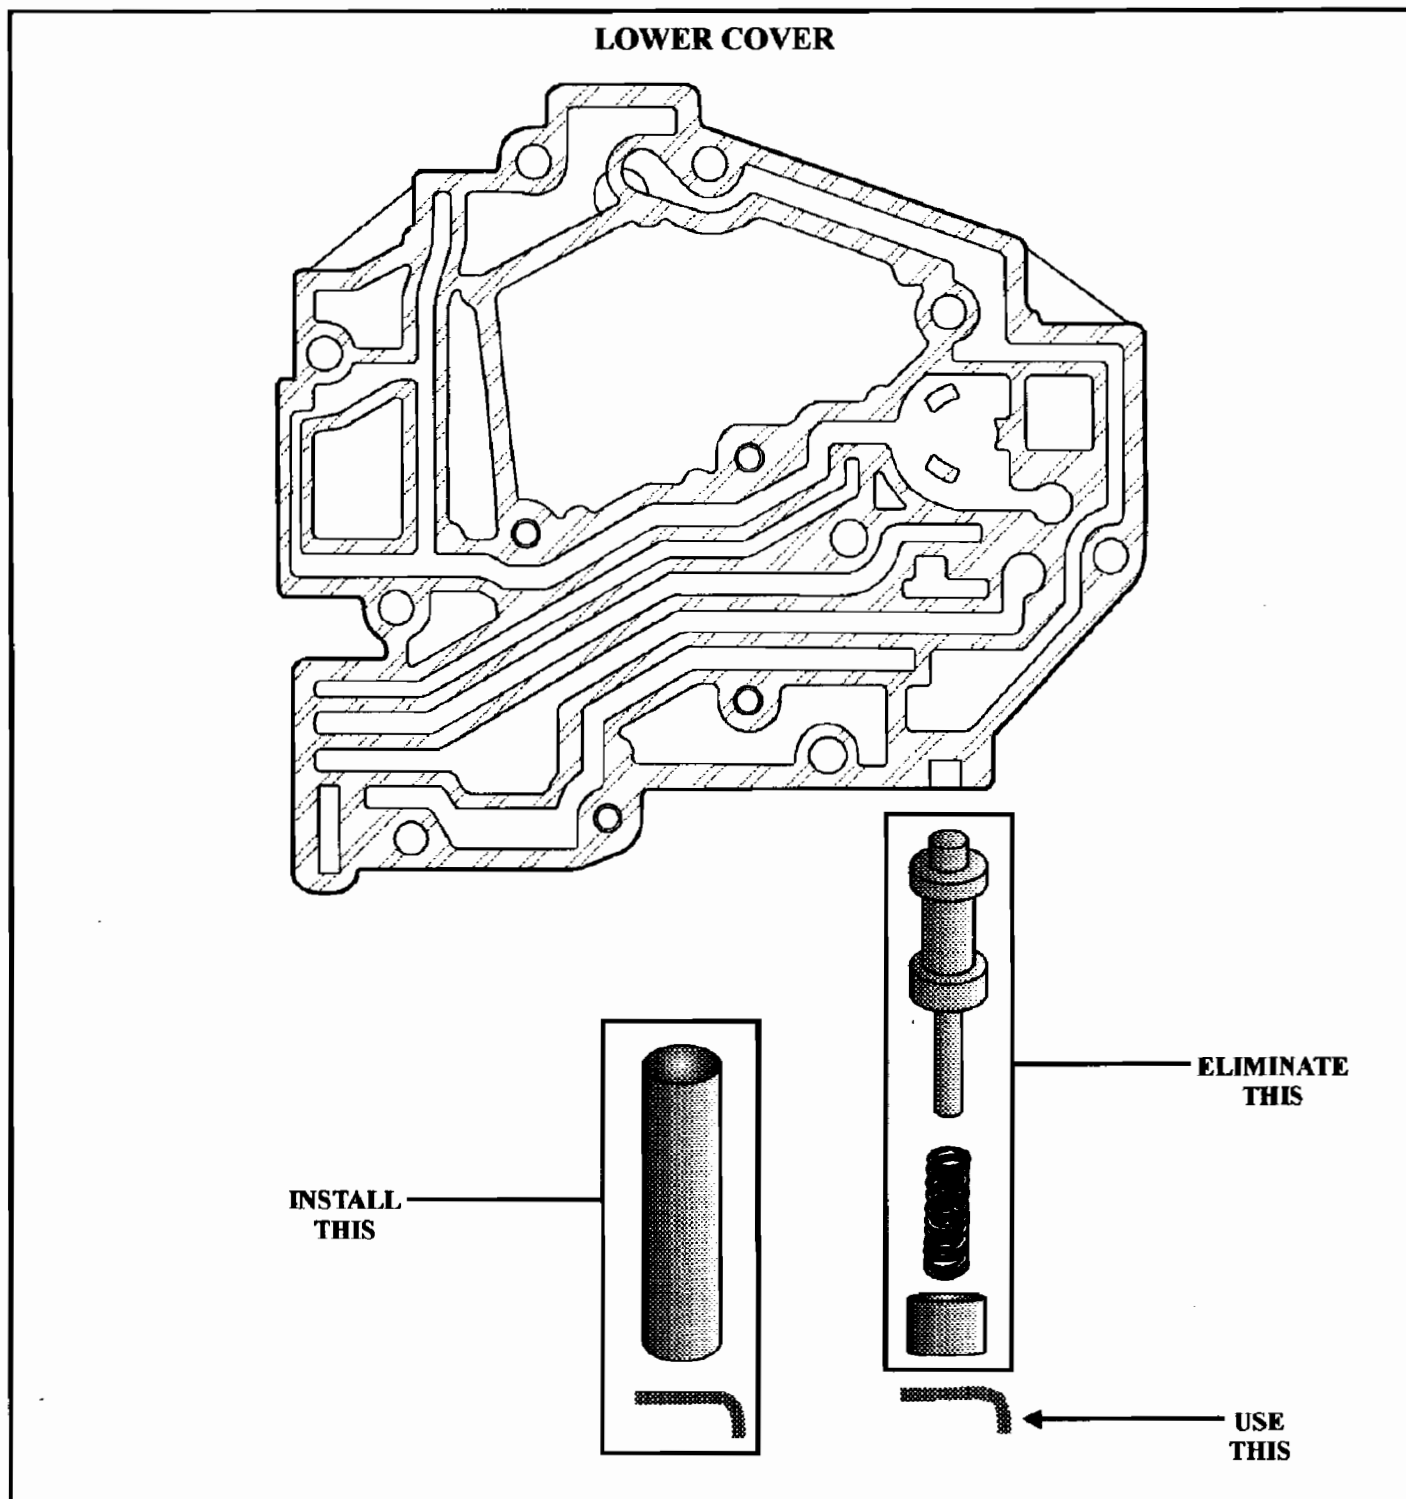
Figure 2

CAUSE: The lower cover section of the valve body still contains the Secondary Pump Shift Valve, See Figure 2. When this valve strokes, it allows B2 apply oil to exhaust, which causes the transmission slip on take-off. This directly affects the application of the B2 band which is necessary for forward movement.

CORRECTION: Install the aluminum plug seen in figure 2, in place of the secondary pump shift valve train, using only the retainer and the aluminum plug.

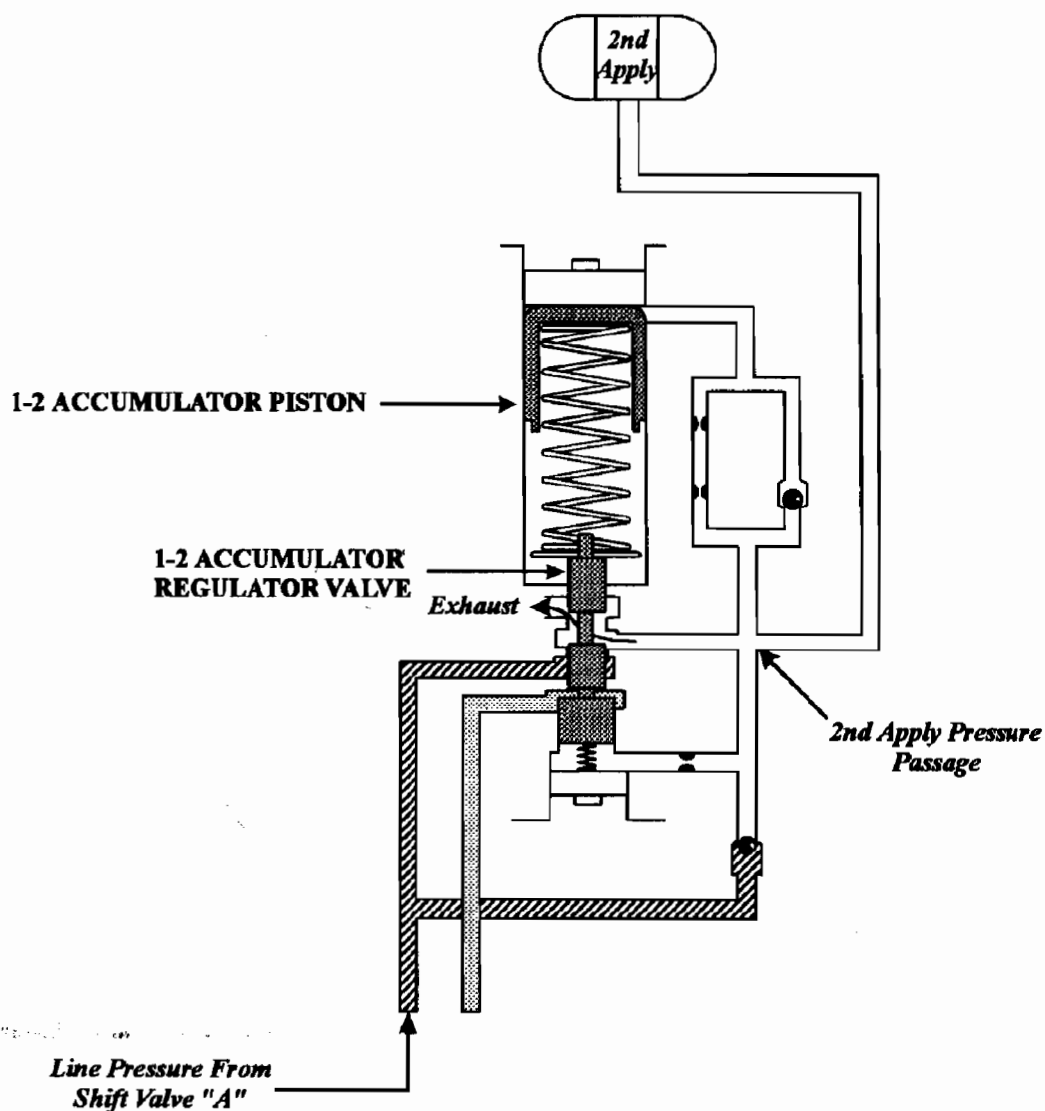
Figure 1

If the 1-2 accumulator regulator valve is stuck as shown here, line pressure cannot pass through the valve and apply the servo. In addition, If the spring for the accumulator piston is too weak, 2nd apply pressure may allow the accumulator regulator valve to stroke toward the piston, and block oil coming from shift valve "A" allowing all apply oil to exhaust through the valve as shown by the arrow.

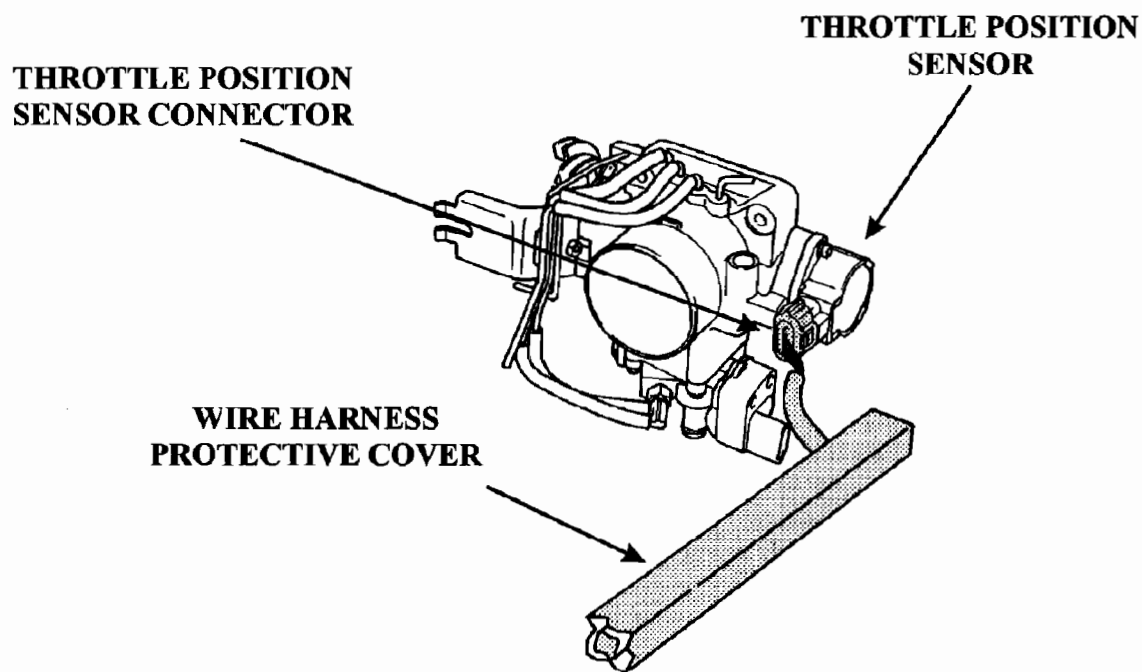
WIRES NORMALLY BREAK AT THE CONNECTOR OR WHERE THE WIRES ENTER THE PROTECTIVE COVER
