KM 175 BIND UP OR 2ND GEAR STARTS

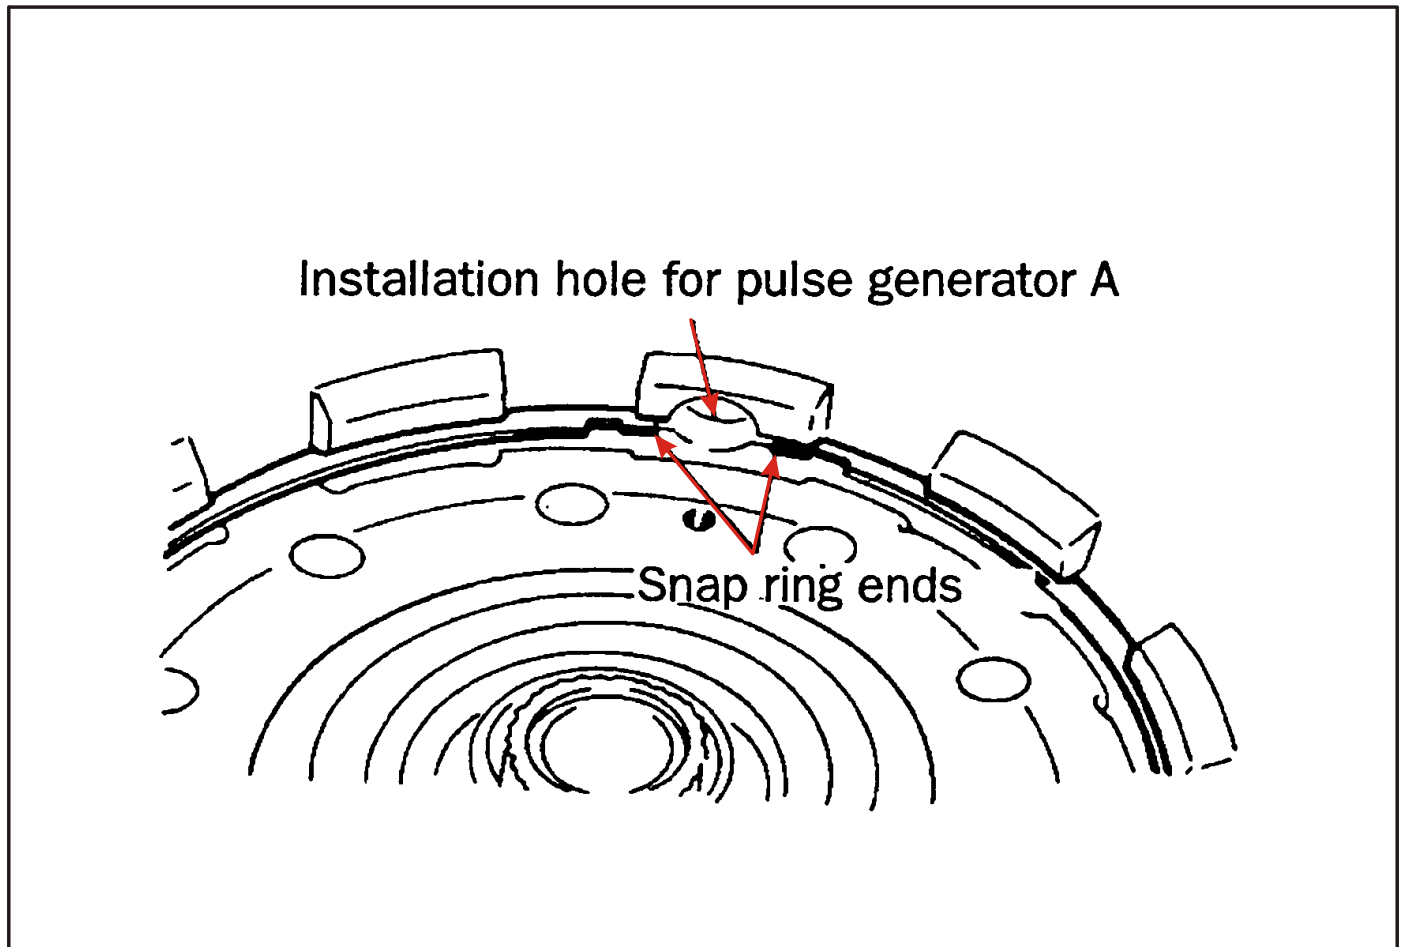
Figure 1

COMPLAINT: A bind up on a 2-3 shift and or 2nd gear starts. Or a bind up in reverse after overhaul.

CAUSE: The snap ring that holds the center support into the case may have been mis-positioned and when pulse generator A was installed, one end of the snap-ring came out of its groove and jammed against the sun shell

CORRECTION: Install the snap-ring so that the open end of the snap-ring faces the entrance hole in the case for pulse generator A. See figure 1 below.
