Ford 4EAT 1989 PROBE

COMPLAINT: Transaxle - 4EAT - Harsh engagement from park into drive and reverse

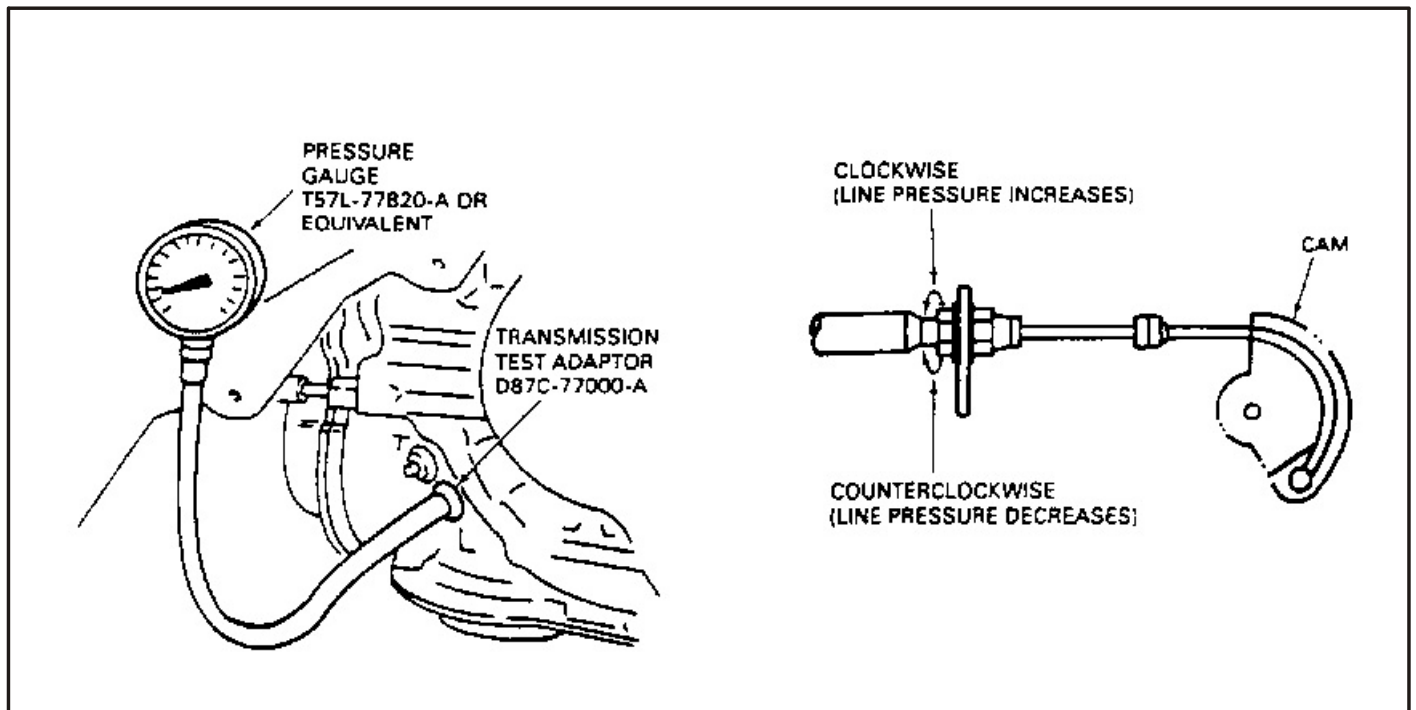
Figure 1

CAUSE: May be caused by transaxle line pressure.

CORRECTION: Adjust the transaxle line pressure to a setting of 54 psi. Refer to the following procedure for service details.

1. Bring the vehicle up to normal operating temperature.
2. Raise the vehicle on a hoist.
3. Remove the left front tire and wheel assembly from the vehicle.
4. Remove the six (6) screws holding the splash shield to the inner wheel well.
5. Remove the square head plug from the transaxle case. The plug is marked with an "L".
6. Install transaxle test adaptor D87C-77000-A into the hole where the square head plug was removed and install pressure gauge T57L-77820-A on the transaxle test adaptor, Figure 1.
7. Partially lower the vehicle.
8. Loosen the locknuts on the throttle cable.
9. Apply the parking brake.
10. Place the transaxle in "P" park and idle the engine at 700-800 RPM.
11. Shift the transaxle into "D" drive.
12. Adjust the line pressure to 60 psi by moving the locknuts either clockwise or counter-clockwise, Figure 2.
