VW/AUDI, 01M, 01N, 01P UNCONTROLLABLE HARSH 1-2 UPSHIFT

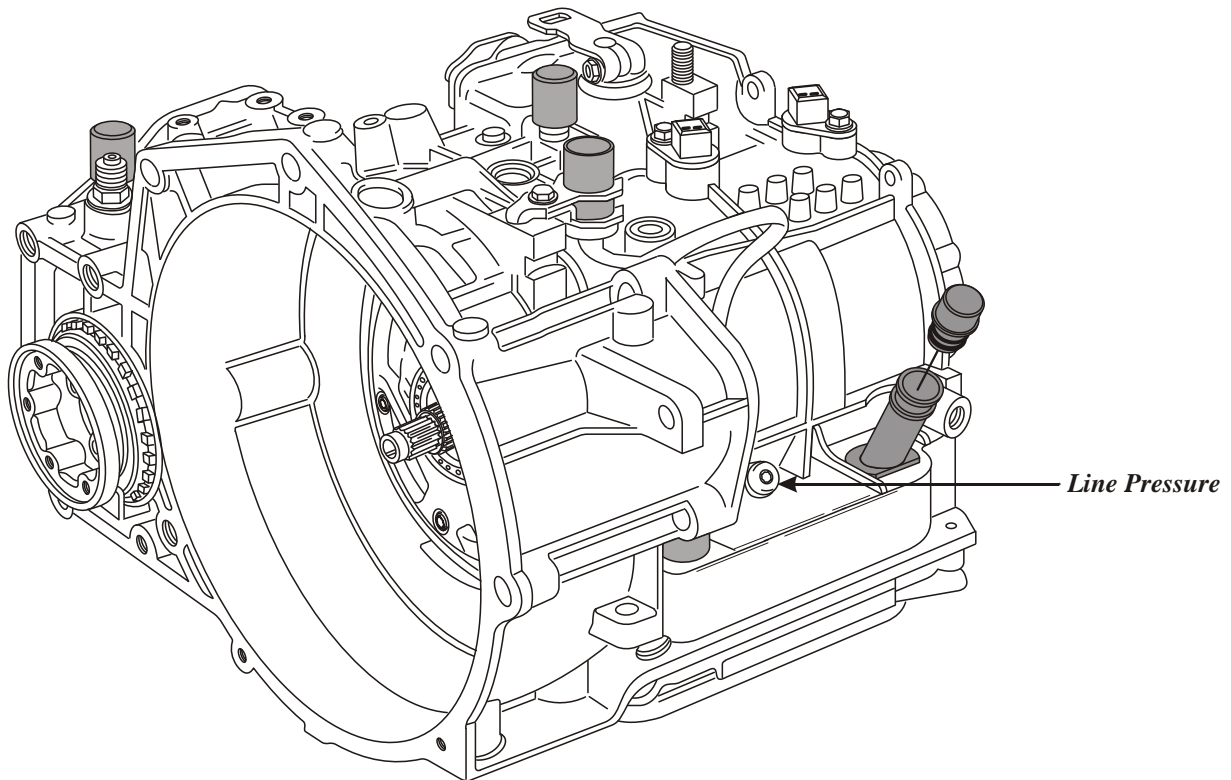
Figure 1

***LINE PRESSURE SHOULD INDICATE 60psi. AT IDLE IN DRIVE
LINE PRESSURE WILL INCREASE TO BETWEEN 120-150psi. AND
SHOULD CUT BACK TO 65-75 ON EACH SHIFT***

1. Connect a pressure gage to the line pressure port as shown in Figure 1. Line pressure should indicate 60 psi. in the Drive position at idle and should increase to 120-150 psi. at stall. Line pressure should cut back to between 65-75 psi. on each shift. If Line pressure does not cut back on each shift, or is at 120-150 psi. at all times, or is erratic on the gage, replace the EV6 solenoid and check the Boost Regulator and Main Regulator valve to ensure they are not stuck. Refer to Figure 2 for a description of how EV6 Solenoid operates.
2. Refer to Figure 5 and locate terminal 7 at harness connector. Back probe that terminal to verify that the computer is grounding EV5 during the 1-2 upshift. If the computer is not grounding that terminal, go to STEP A. If the Computer is grounding that terminal go to STEP B.

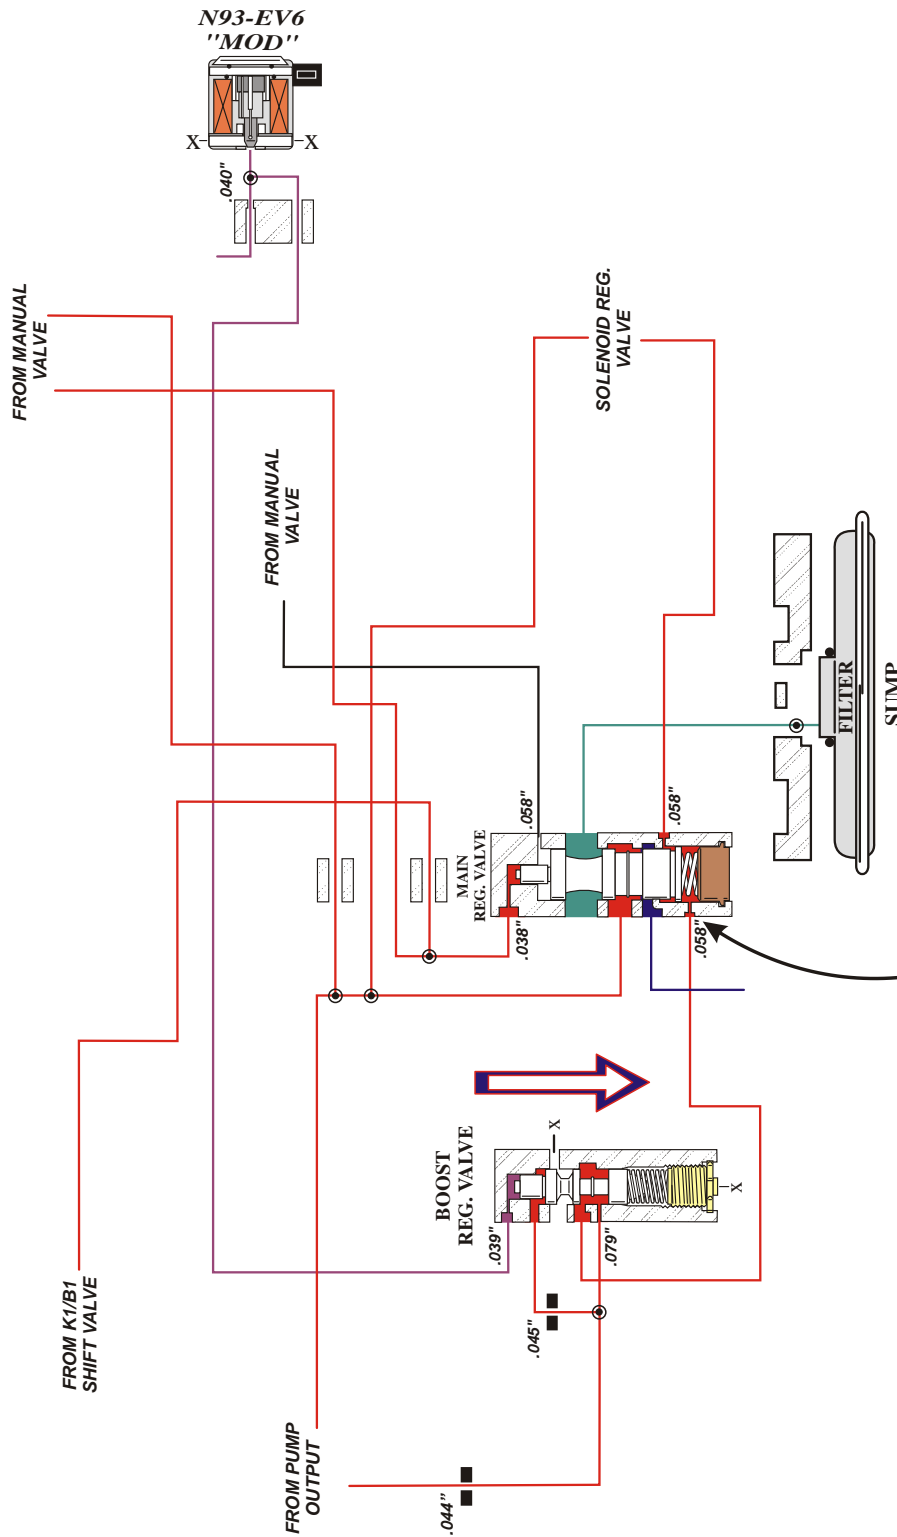
Figure 2

N93-EV6, WHEN MODULATING, STROKES THE BOOST REGULATOR VALVE AGAINST ITS SPRING, REDUCING THE AMOUNT OF BOOST PRESSURE ON THE SPRING SIDE OF THE MAIN REGULATOR VALVE.

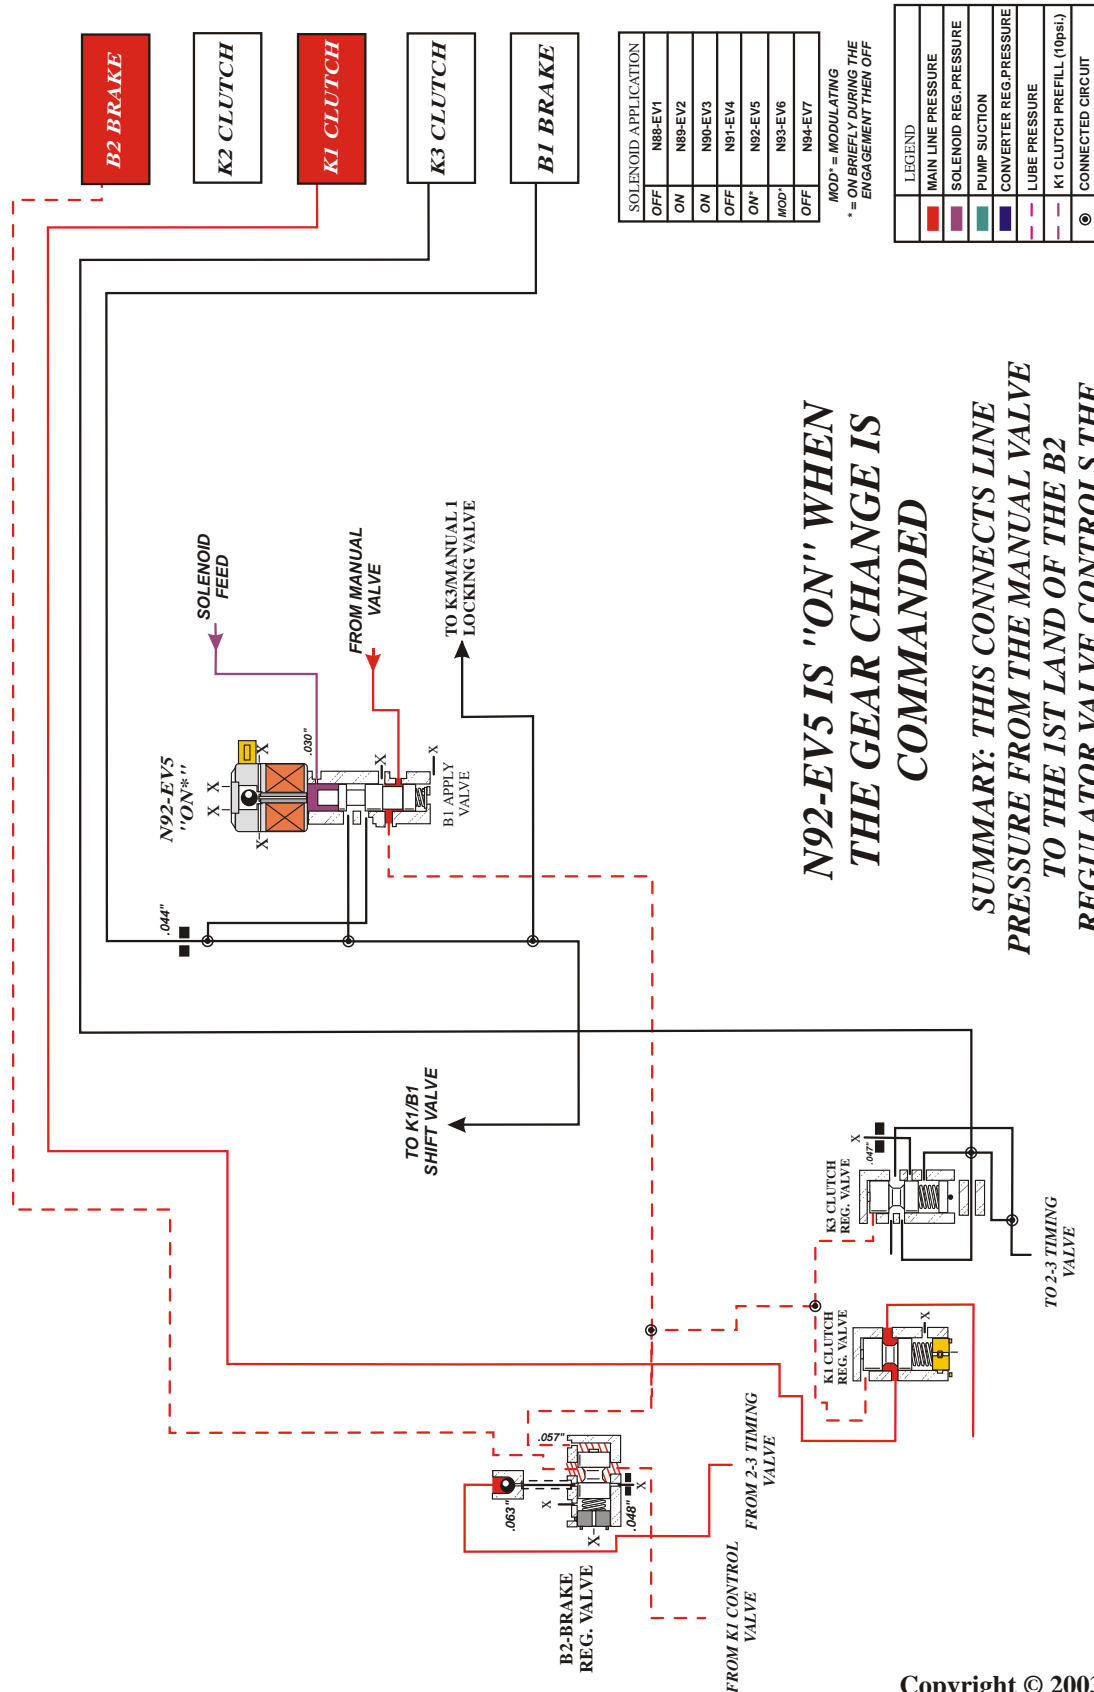
Figure 3

(NOTE: The EV5 solenoid is grounded on each engagement and each upshift and downshift which helps control Clutch apply Pressure for smooth engagements as shown in Figures 3 and 4.)

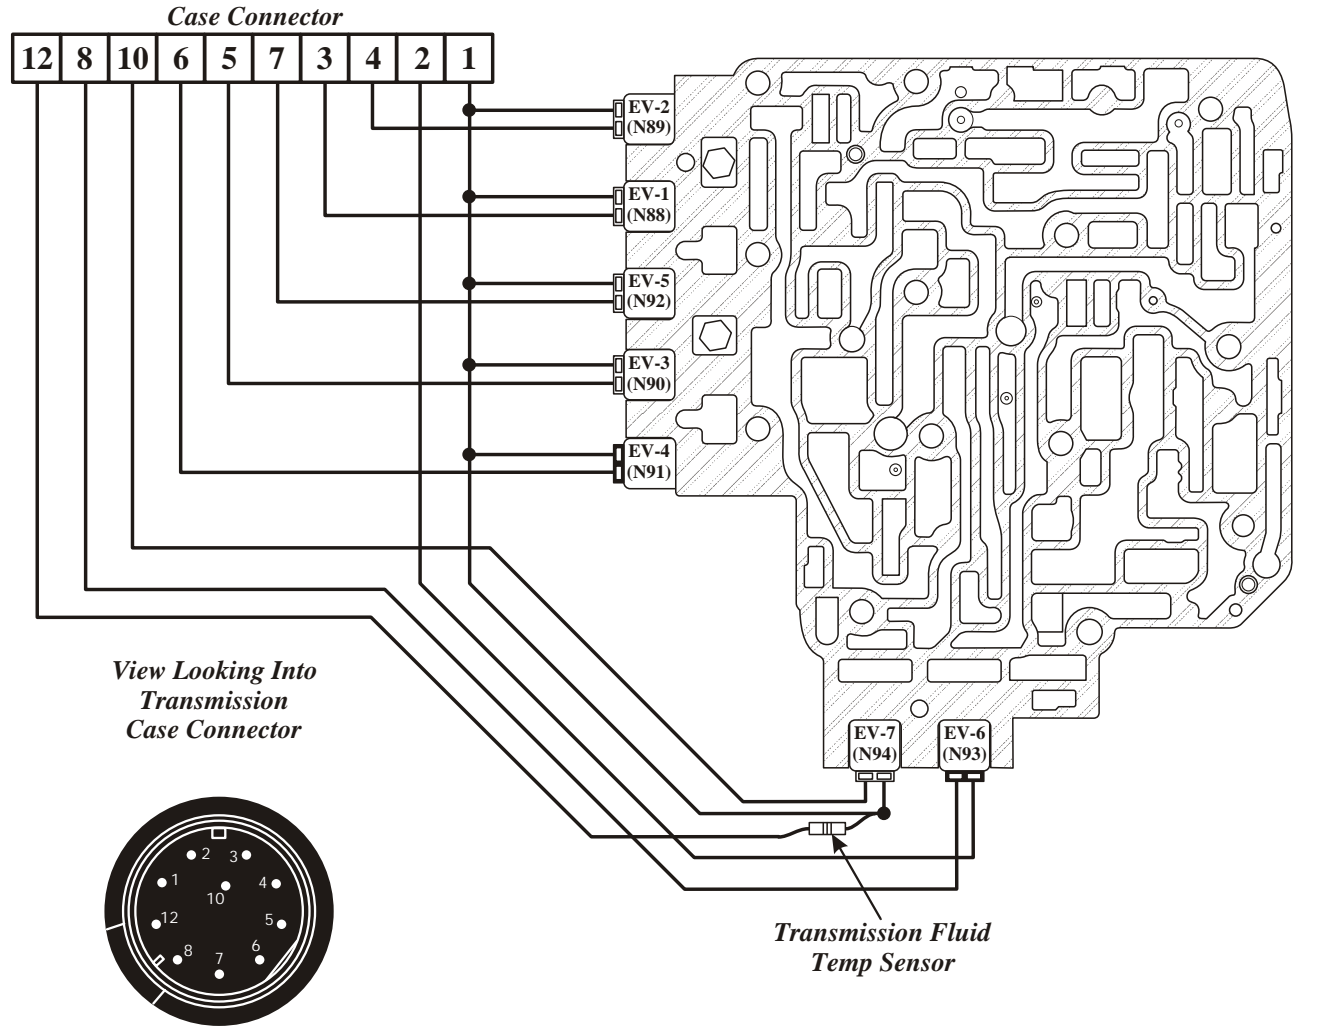
CASE CONNECTOR PIN FUNCTIONS

BACK PROBE
THIS TERMINAL

STEP A. Connect a scan tool to the diagnostic connector and check to see if the TCM has set a trouble code 00266 (VAG) or a P0773 which are EV5 solenoid circuit faults. Repair the EV5 Solenoid circuit as needed. If the TCM has no trouble codes set and does not ground EV5 Solenoid during the 1-2 shift, the TCM may be faulty.
