Technical Service Information

FORD CD4E RIGHT HAND DIFFERENTIAL SEAL LEAK

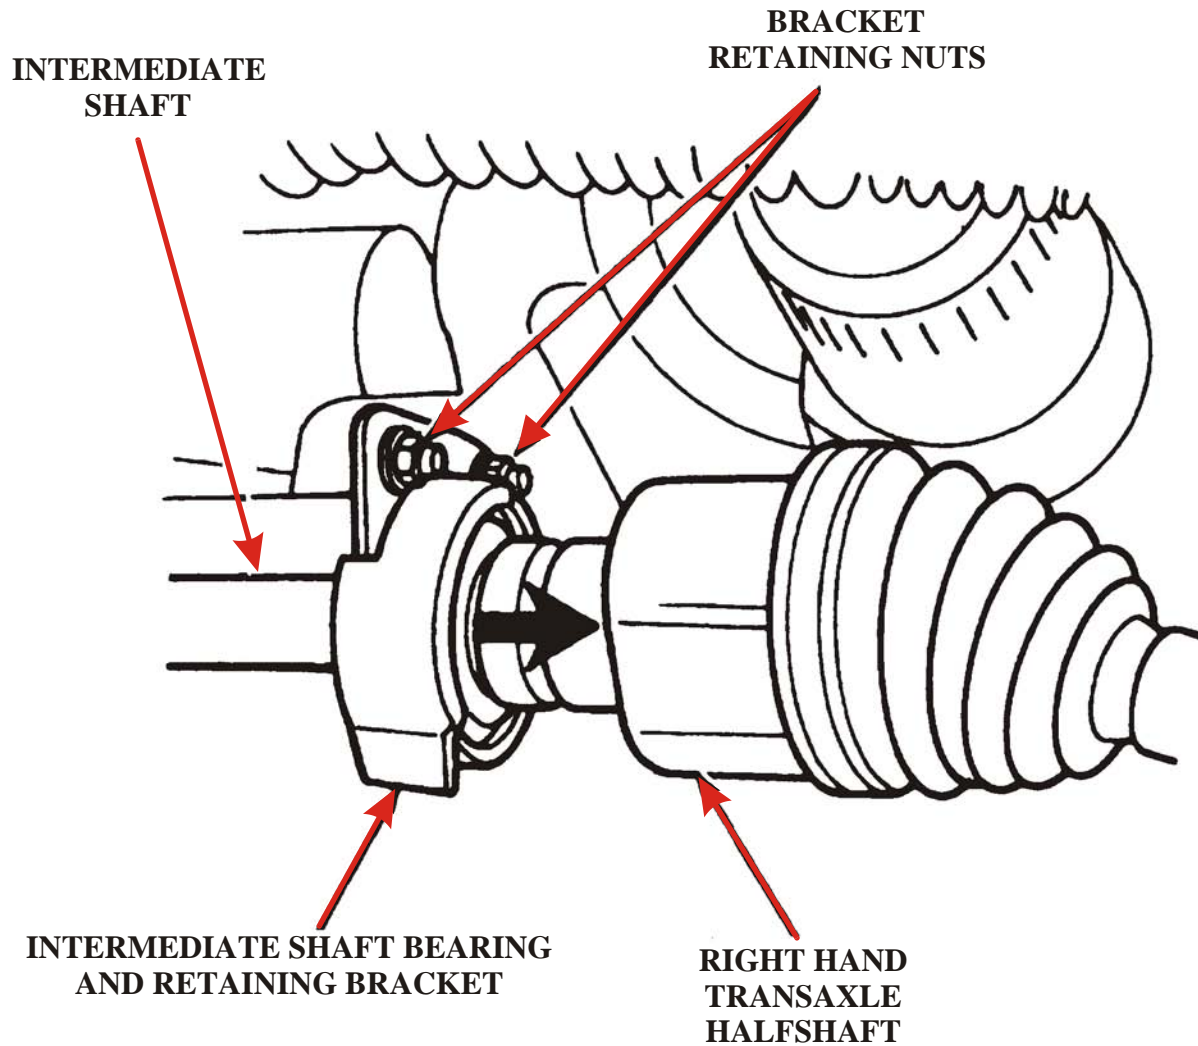
Figure 1

CAUSE: The cause may be, inadvertently using the wrong set of mounting holes when remounting the intermediate shaft bearing and bracket assembly. For location refer to Figure 1. The original 1st design style of intermediate shaft bracket had two sets of mounting holes, one for CD4E applications, and the other set for MTX-75 (Standard Shift) applications, as shown in Figure 2.

SHAFT ASSEMBLY AND BRACKET LOCATION

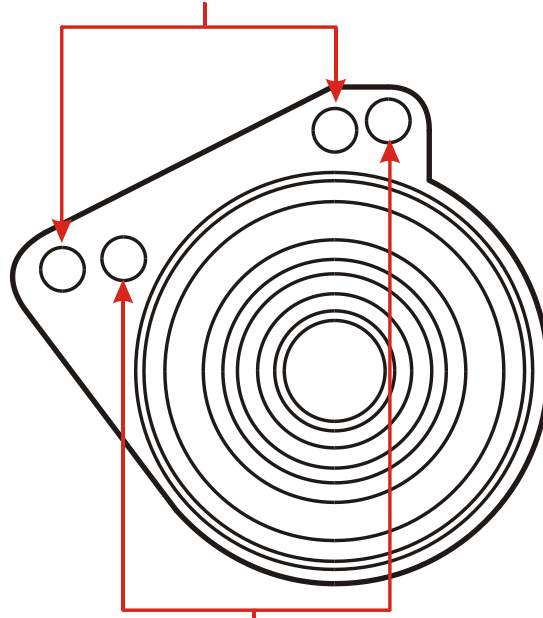
Figure 2

1ST DESIGN "UNIVERSAL" BRACKET

USE THESE TWO HOLES
FOR STANDARD TRANSAXLE

USE THESE TWO HOLES
FOR CD4E TRANSAXLE

CORRECTION: There are now unique support brackets to correct the concern and prevent mis-mounting the bracket in the wrong holes, one support bracket for CD4E applications, and one for MTX-75 applications. Refer to Figure 3. These new style support brackets were used in production during the 1996 model year. The support bracket is serviced as part of the Intermediate Shaft Assembly, and could contain either the 1st design bracket as shown in Figure 2, or the 2nd design bracket as shown in Figure 3. Use care if the 1st design bracket with four holes is supplied to mount it using the proper holes, as shown in Figure 2.

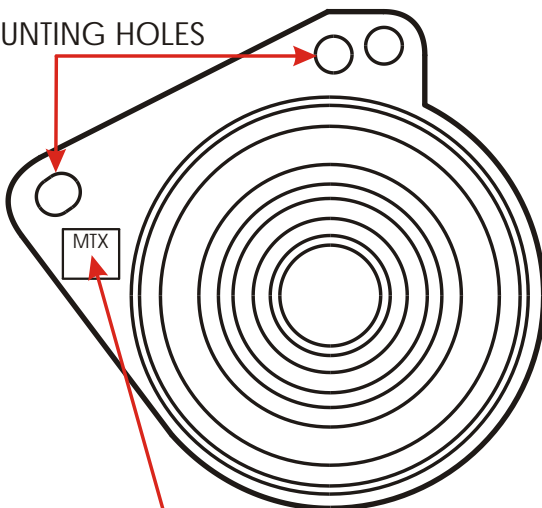
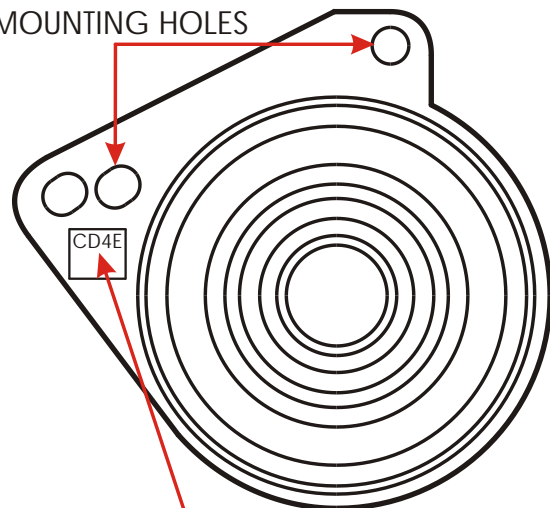
Figure 3

2ND DESIGN SEPERATE BRACKETS

FOR STANDARD APPLICATIONS

FOR CD4E APPLICATIONS
