Technical Service Information

THM 200C

SLOW TCC, TCC SHUDDER OR NO TCC

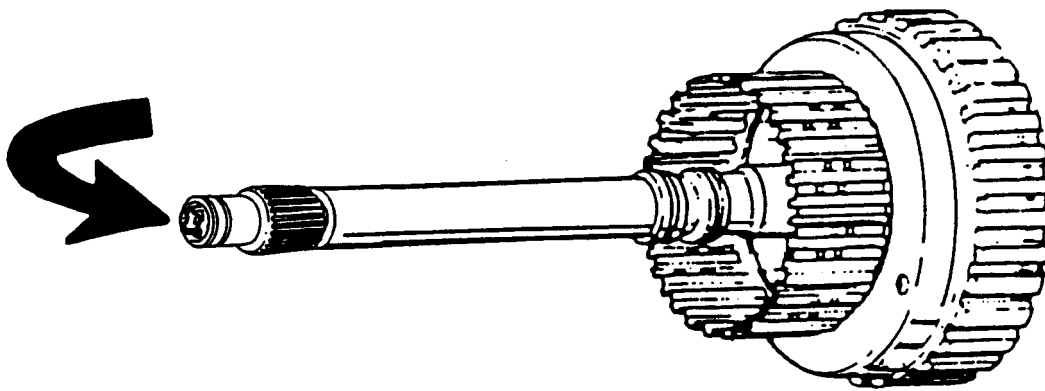
Figure 1

CAUSE: The plug, Item 222 (Figure 2) not having been removed from the pump stator support or cover. When the new turbine shaft with the ball capsule (Figure 1) was introduced in ,the 1987 models, October 8, 1986 (Julian Date 281), the cup plug should have been removed from the pump cover.

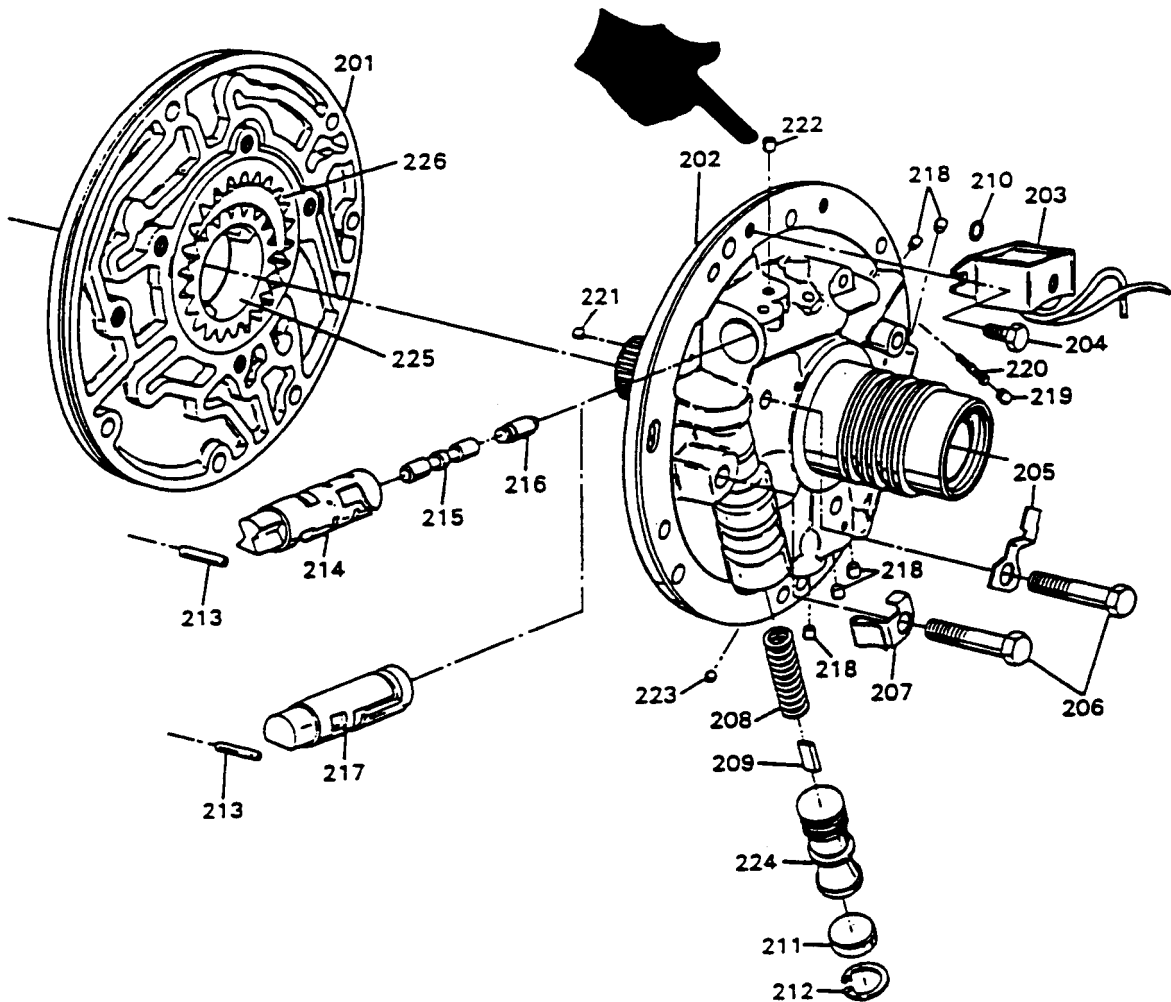
Figure 2

COMPLAINT: Slow converter clutch engagement, shudder or no engagement apply in all 1987 Vehicles equipped with a THM 200C transmission.

CORRECTION: Remove the cup plug, Item 222 (Figure 2) from the cover assembly..
