## TOYOTA A240 SERIES 4-3 DOWNSHIFT OR DRIVE ENGAGEMENT CLUNK

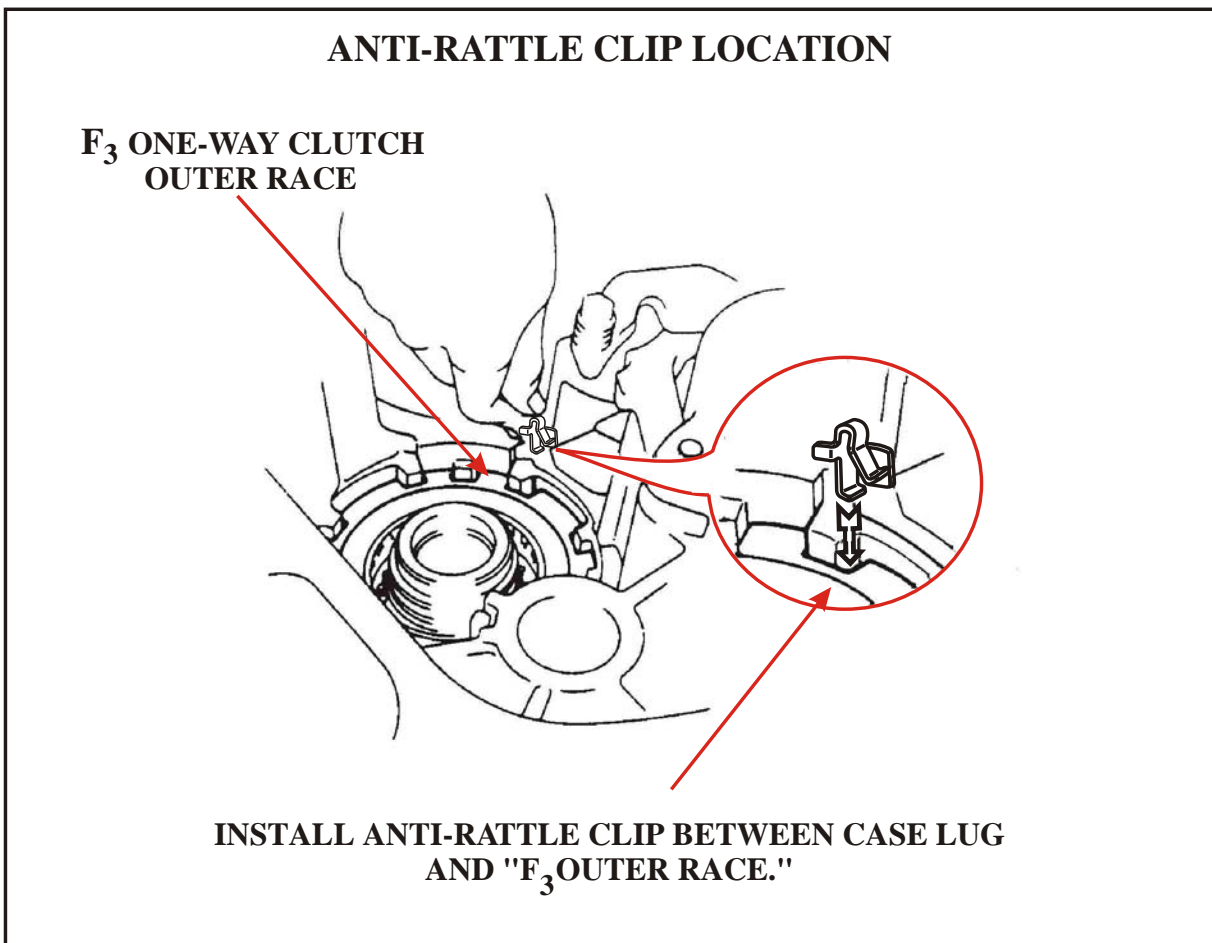
**COMPLAINT:** After overhaul, vehicle exhibits a metallic 4-3 downshift and/or Drive engagement "clunk."

**CAUSE:** The cause may be, that the "Anti-rattle" clip, shown in Figure 1, was mis-placed or was left out on

**CORRECTION:** Refer to Figure 1 for the location and installation of the "Anti-rattle" clip.
