## **"2007" SEMINAR INFORMATION INDEX**

# ***"Tech is Rev'n in 2007"***

## ***Seminar Information***

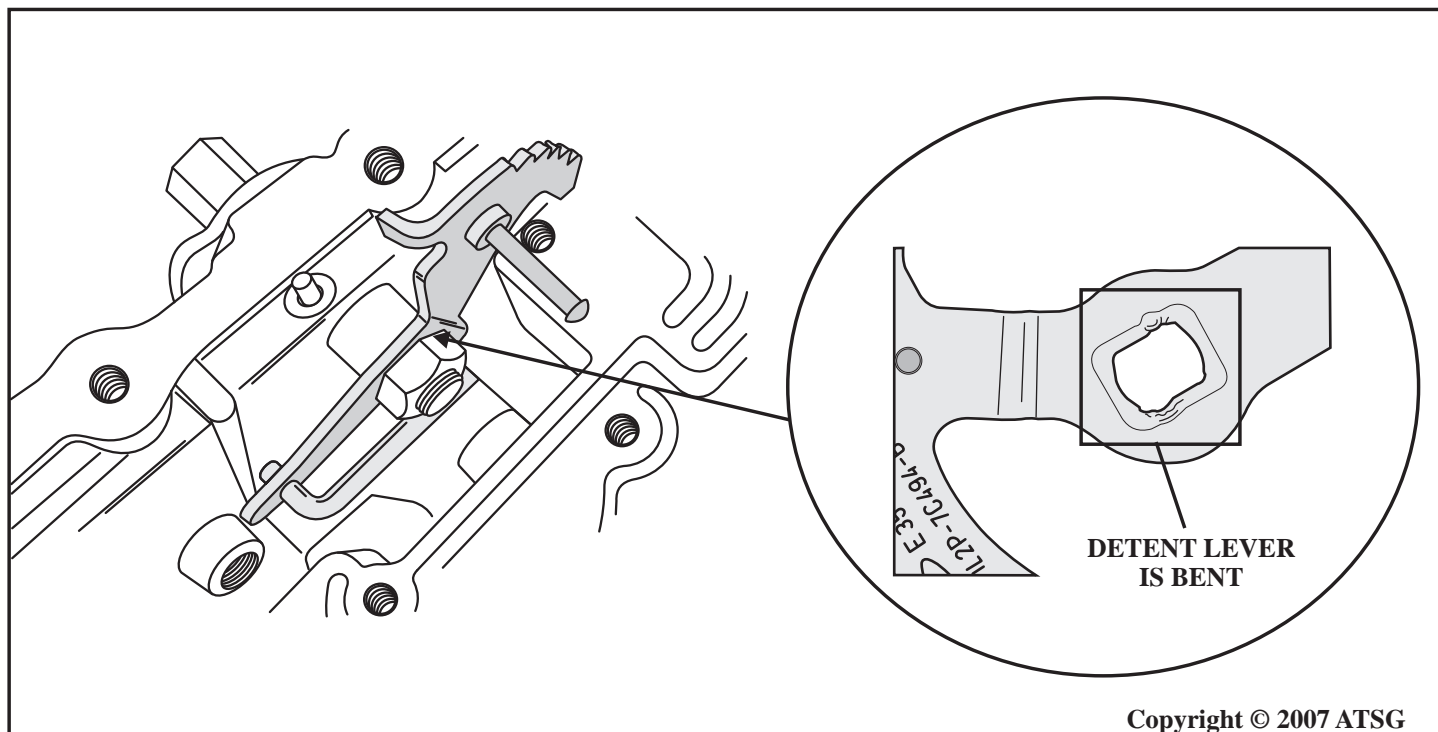
Figure 1

**CAUSE:** The internal linkage detent lever has been bent, (Refer to Figure 1), this causes a mis-alignment of the manual valve, and in some instances the manual valve may be bent as well.  
The main cause of bending the internal linkage is the manual selector shaft nut. This nut has thread lock on it from the factory, this thread lock compound creates a situation where the nut that retains the manual selector shaft is so tight, that the technician has exerted enough force to bend internal linkage components.

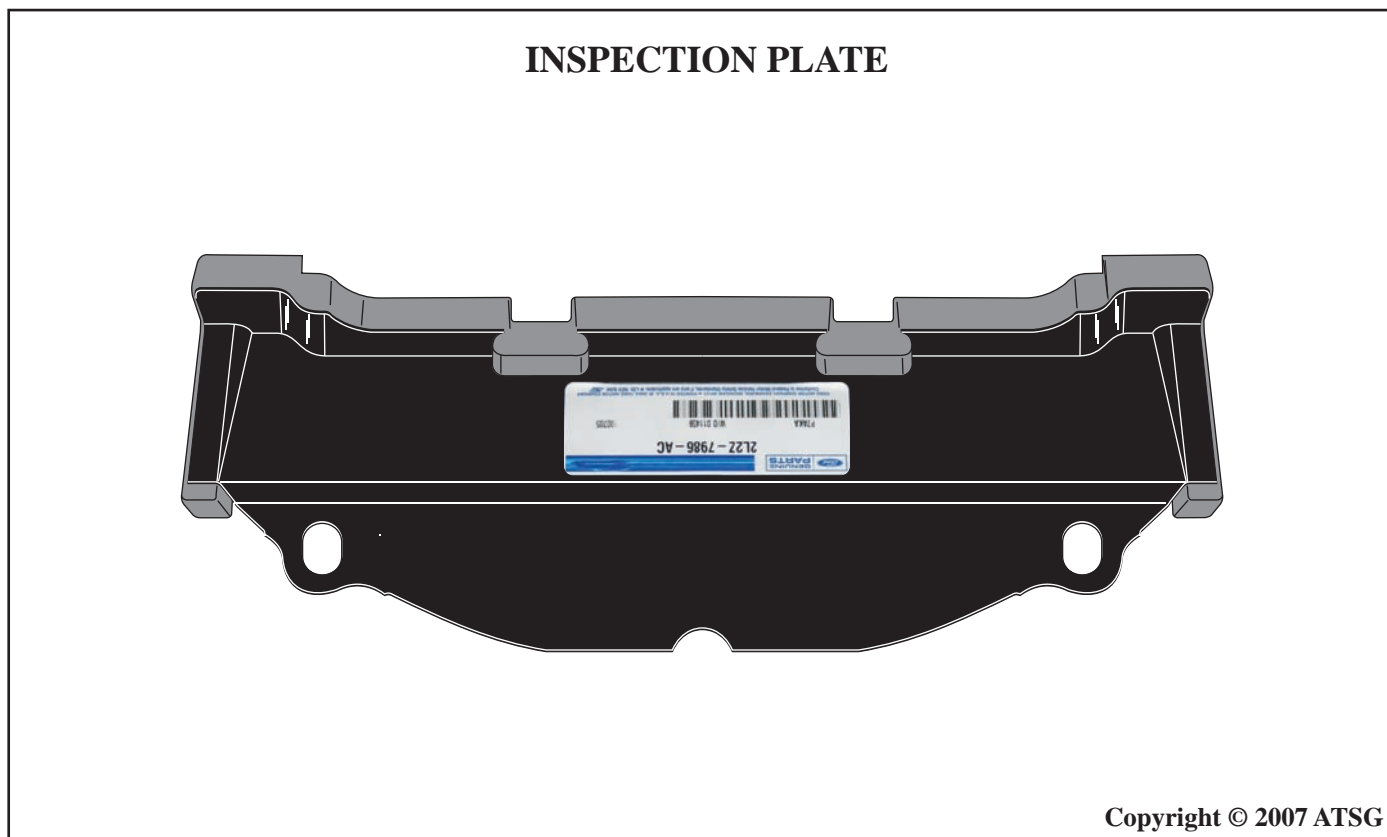
Figure 1

**COMPLAINT:** Explorer and Mountaineer models equipped with the 5R55W/S transmissions may exhibit a ticking or rattling noise coming from the bellhousing of the transmission. This noise can be commonly mistaken as a cracked flywheel or a mis-alignment of the flex-plate to the torque converter.

**CAUSE:** The cause may be, the plate between the engine block and the bellhousing is flexing, with increased engine rpm, causing the noise.

**CORRECTION:** Ford Motor Company has released a new style inspection plate, which is located at the bottom of the bellhousing, that has foam rubber to insulate the plate between the engine and transmission to keep it from flexing. Replace the inspection plate with new design as shown in Figure 1.

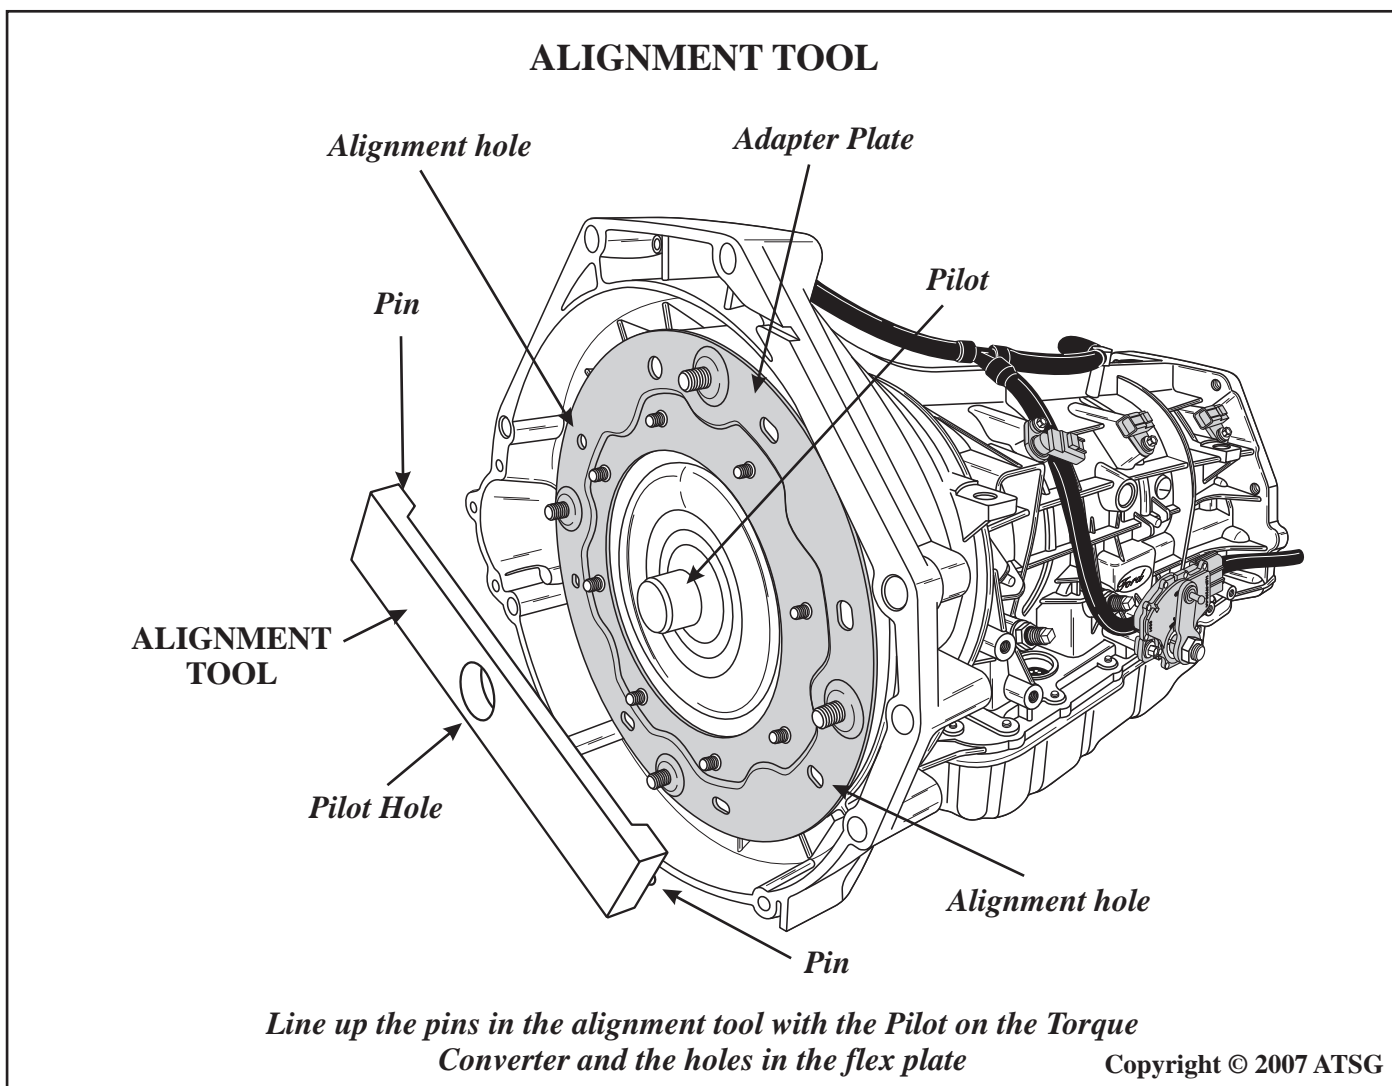
**COMPLAINT:** After Overhaul, vehicles equipped with the 5R55W/S may exhibit a metallic ticking noise coming from the bellhousing of the transmission, similar to the sound of a cracked flex plate or flywheel.

**CAUSE:** The cause may be, the adapter plate and the Torque Converter are not aligned correctly.

**CORRECTION:** Use the Factory alignment tool, Ford Flex Plate Aligner #307-403, or an alignment tool from many aftermarket distributors to align the pilot of the Torque Converter to the adapter plate before tightening the retaining nuts.  
Refer to Figure 1 to see which holes, in the adapter plate and the Torque Converter Pilot, to align with the tool. Refer to Figure 2 to see the Tool installed. Figure 3 shows a view with the tool installed and the tightening of the retaining nuts.

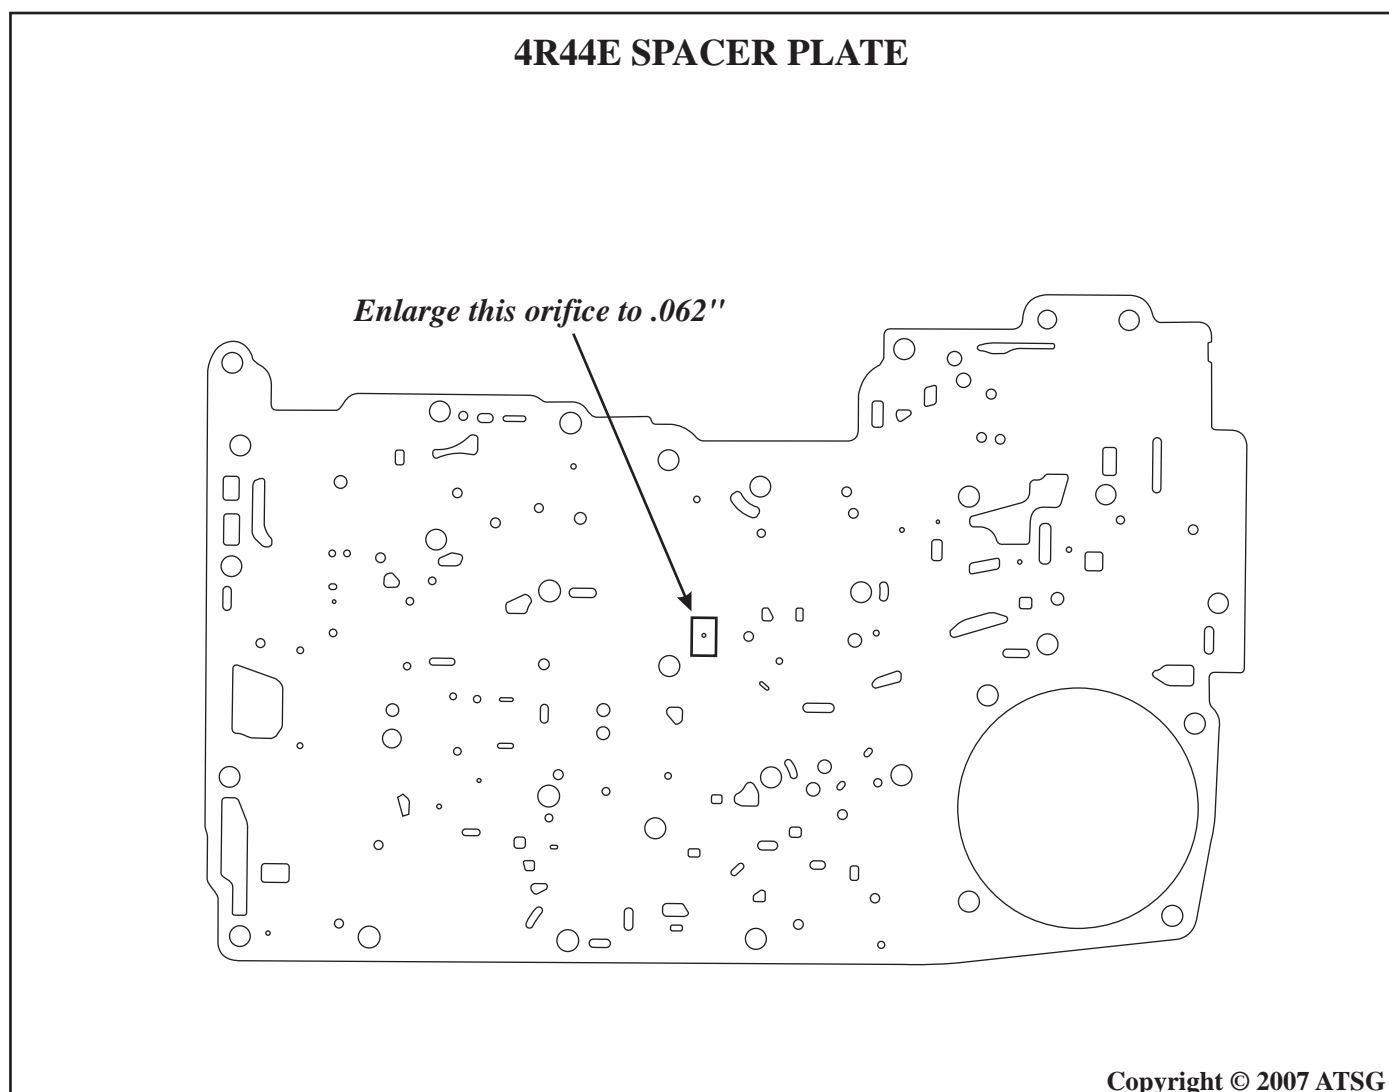
Figure 1  
Automatic Transmission Service Group

**CAUSE:** The cause may be, insufficient Direct Clutch pressure during the 2-3 upshift transition.

**CORRECTION:** Locate the orifice, as shown in Figure 1 and enlarge the hole to .062."

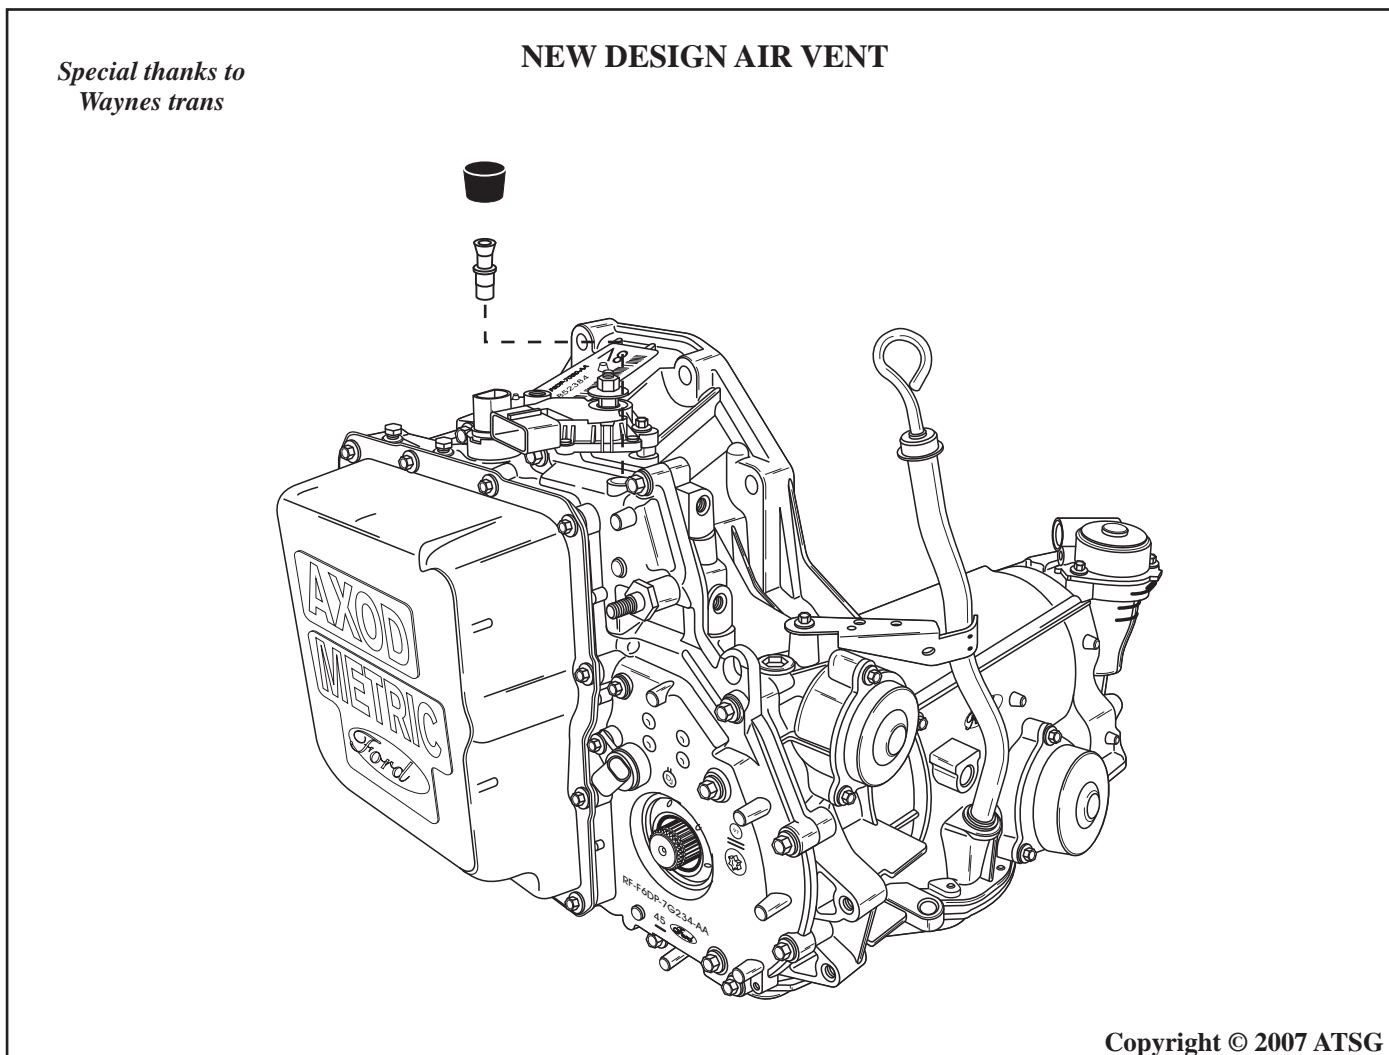
Figure 1

**CAUSE:** The cause may be that the newer design rubber cap air vent is not allowing the transmission to breathe. *Note: This may cause the dipstick to pop out of the filler tube, and depending on the location of the tube, it may allow water intrusion into the transmission fluid.*

**CORRECTION:** To correct this condition, replace the vent assembly, as shown in Figure 1, with the part number listed below in service information.

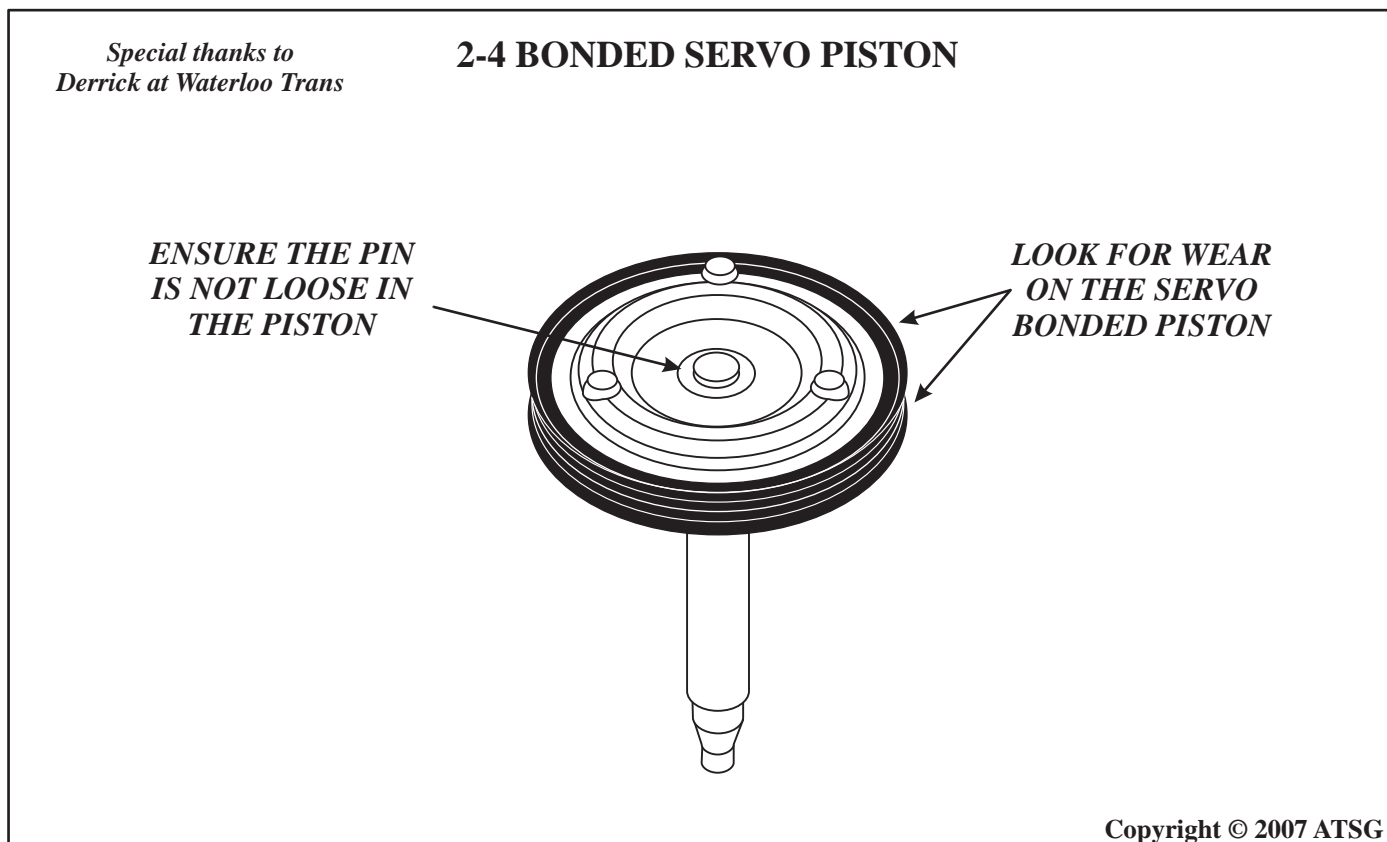
Figure 1

**CAUSE:** The cause may be, the bonded 2-4 servo piston is worn or the pin is loose from the piston, as shown in Figure 1. The cause for the piston being worn is because of a rough surface in the servo bore in the case.

**CORRECTION:** Replace the 2-4 servo piston, as shown in Figure 1. Using some fine sand paper or scotch-brite, lightly sand the bore of the case where the bonded rubber part of the servo rides, to ensure that it is smooth. See Figure 2. Re-assemble the servo assembly back into the case as shown in Figure 3. **NOTE: If this repair is attempted in the vehicle, the linkage which is right over the 2-4 servo piston, will have to be removed, which means the mount bolts will have to be removed and the transmission lowered in the vehicle.**

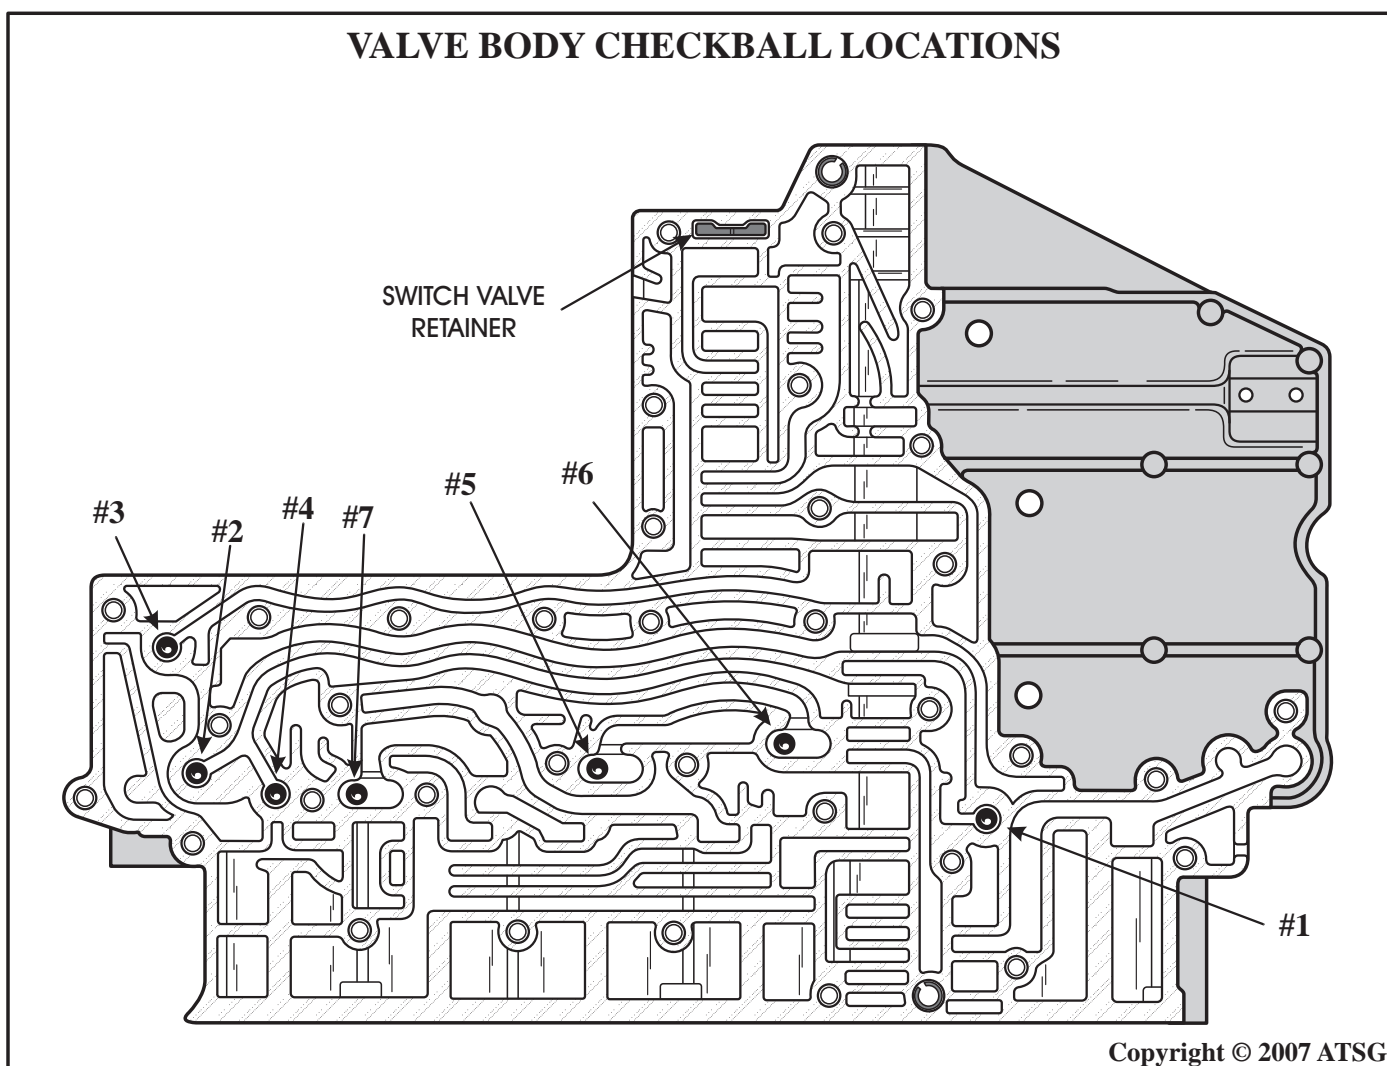
Figure 1

**COMPLAINT:** Chrysler vehicles equipped with the 45RFE or 545RFE may exhibit a binding condition on the 3-4 or 4-5 upshift which may also be accompanied by a pressure switch code.

**CORRECTION:** Replace the checkballs with new plastic checkballs available in aftermarket rebuild kits or from an O.E. supplier. For Valve body exploded views refer to Figures 2 and 3.
