# Technical Service Information

## FORD 4R70/75E TCC APPLICATION ON TOP OF 2ND GEAR

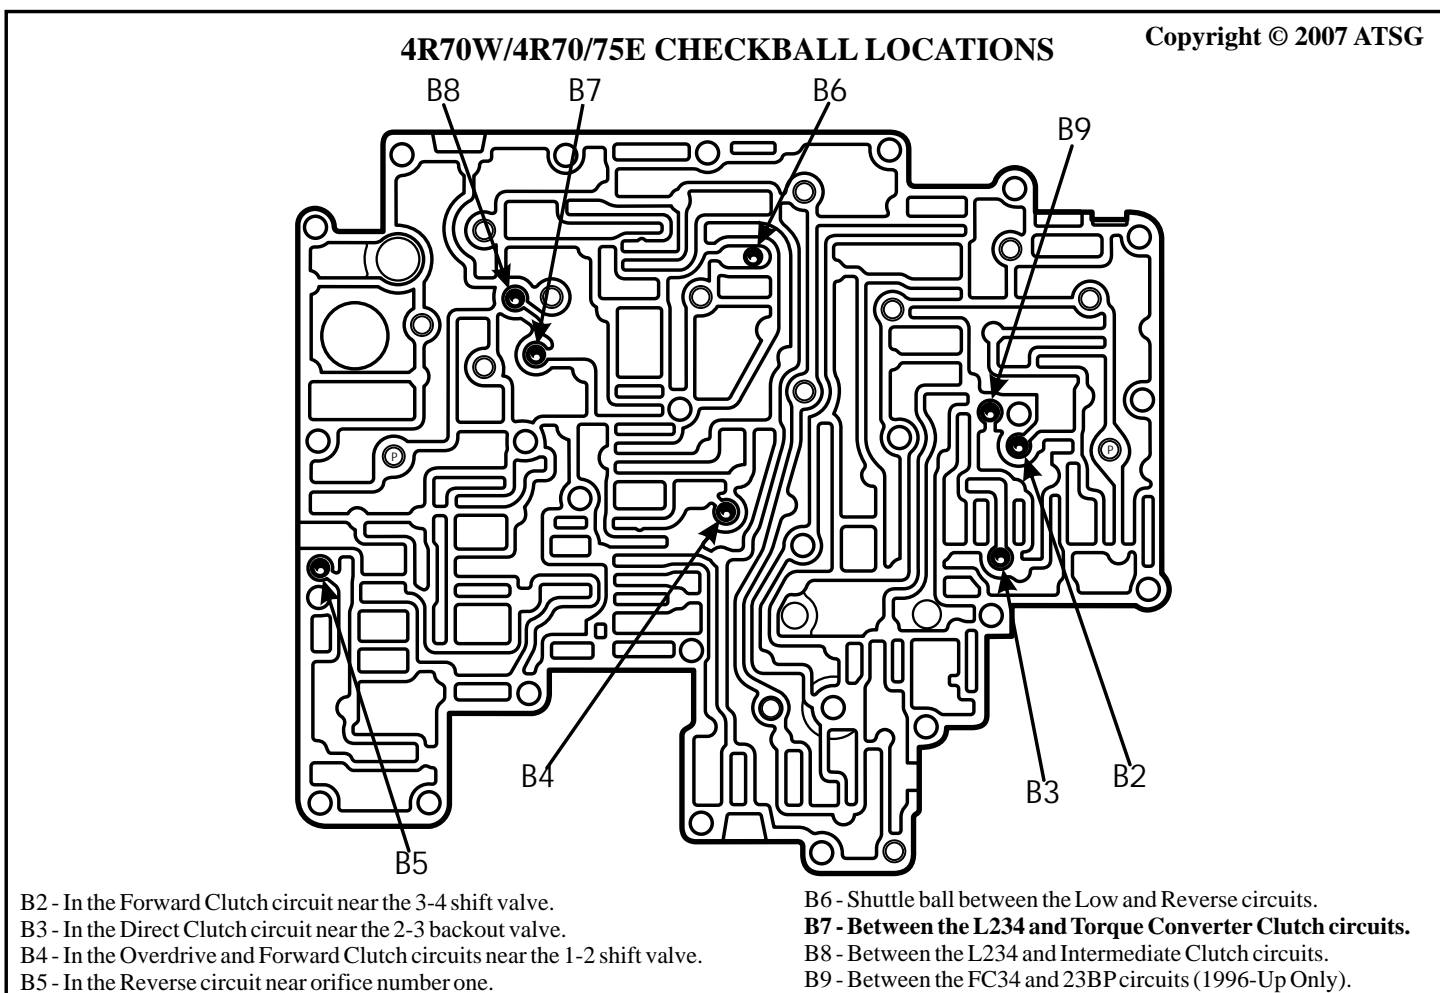
Figure 1

**CAUSE:** The #7 check ball in the valve body, (Refer to Figure 1), has become too small and is allowing line pressure from the 2-3 shift valve to stroke the Bypass Clutch Control Valve which will apply the converter clutch as soon as a 1-2 shift occurs as shown in the hydraulic diagram in Figure 2. The hydraulic diagram in Figure 3 illustrates how the TCC circuit should operate when the #7 check ball is the correct size.

**CORRECTION:** Although this bulletin refers to specific years and models, any 4R70W, 4R70/75E in any vehicle would have the same complaint should the #7 check ball become too small. Replacement of the #7 check ball will remove the complaint and restore TCC to computer control strategies.
