Technical Service Information

KM 175 HARSH UPSHIFTS (TPS)

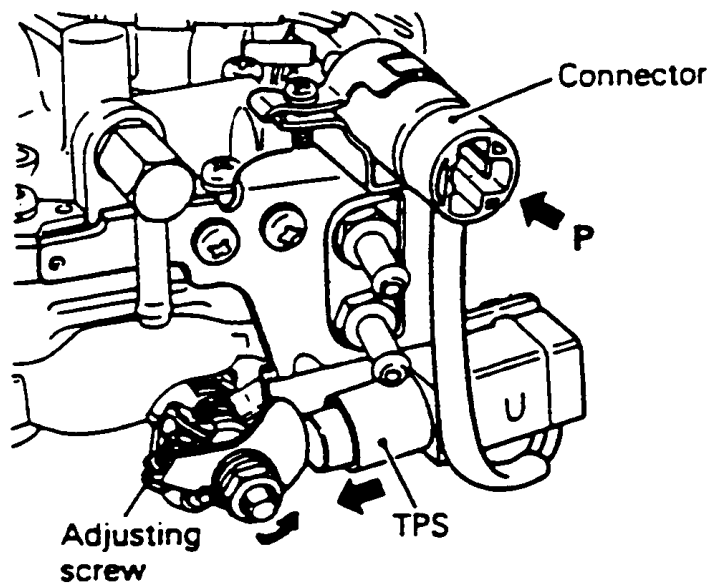
THROTTLE POSITION SENSOR (TPS)

COMPLAINT: Harsh upshift.

CAUSE: Broken or disconnected throttle position sensor wire or wires or faulty sensor or maladjusted.

CORRECTION: Ensure correct operation and adjustment of tps. Replace short harness with modified harness available from Mitsubishi
